# Durability of pretensioned concrete girders in coastal climate bridges: Basis for better maintenance and future design

Magdalena J. Osmolska<sup>1,2</sup>

bridges, coastal climate, corrosion, durability design, durability status, pretensioned girders

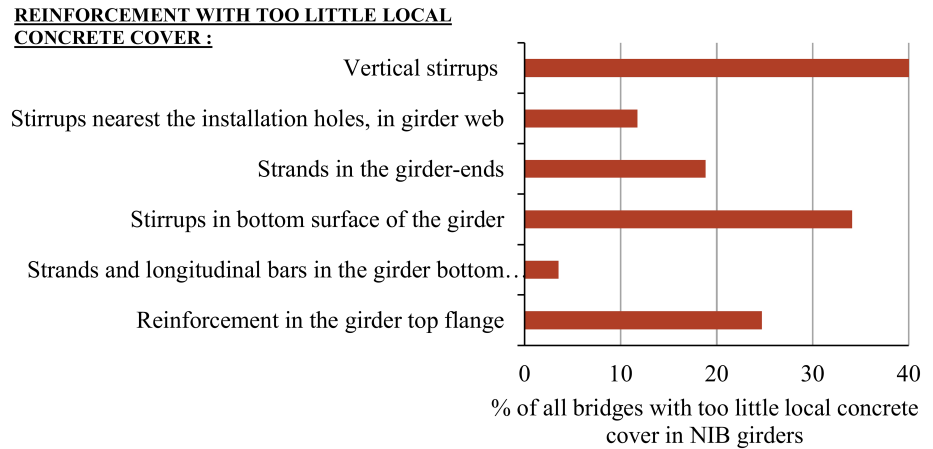
**FIGURE 10** Reinforcement registered with too little local concrete cover in NIB girders

Corrosion damage in the top flanges (see Figure 10), is mainly registered in BRUTUS<sup>1</sup> as spalling caused by

corrosion of reinforcement with too little cover. However, we found spalling in some bridges without visual corrosion signs, so in some cases the actual cause of top flange damage is uncertain and the influence of other parameters, for example, cyclic freezing and thawing, needs further investigation.

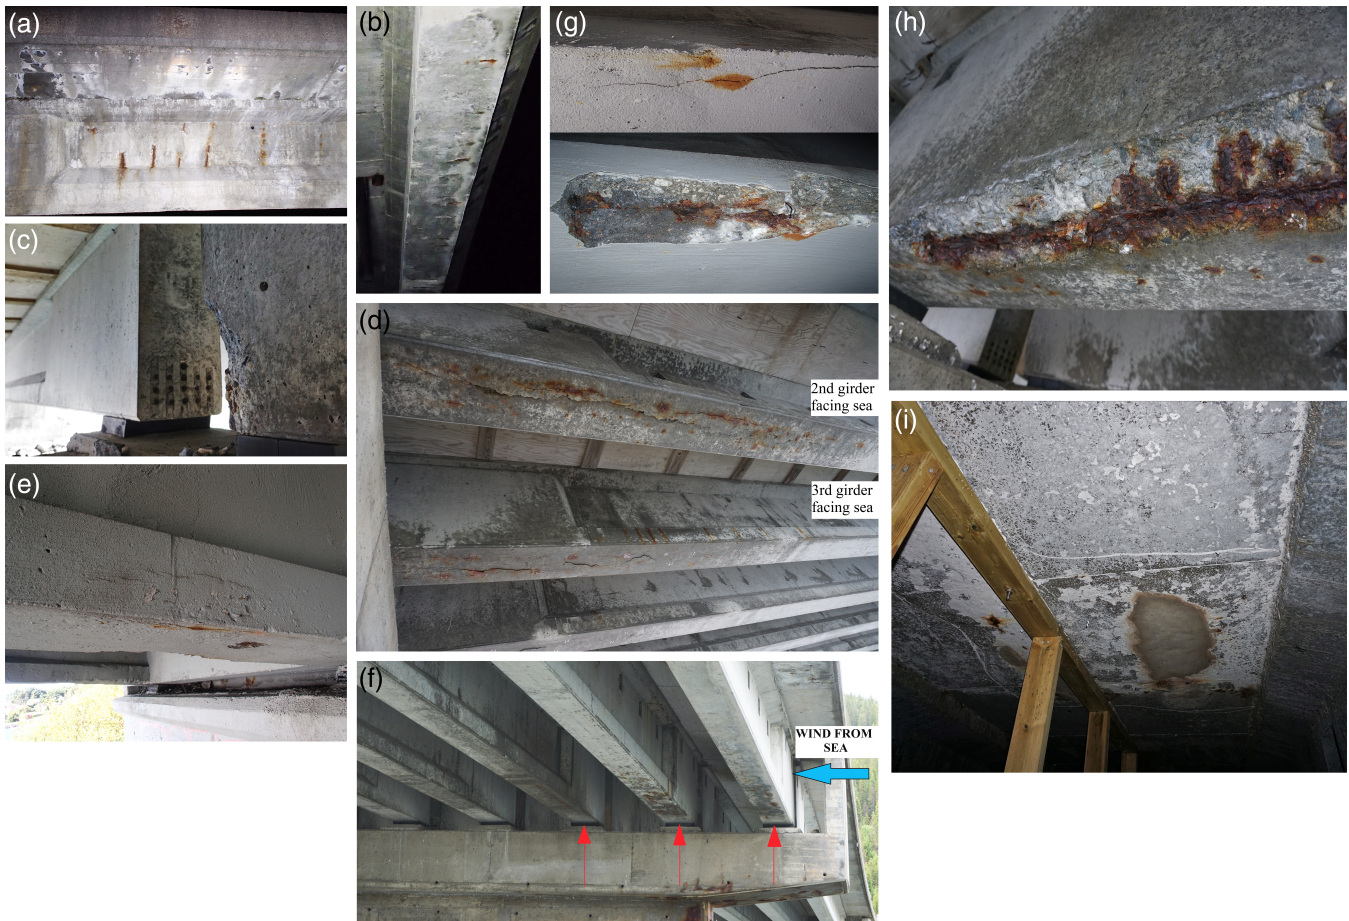
**FIGURE 12** Typical visual corrosion damage in pretensioned NIB girders (a–i)

Our inspection of NIB girder bridges revealed corrosion in NIB girders, for both stirrups and pretensioning strands. Most of the damage we saw corresponded well to the damage reported in BRUTUS<sup>1</sup> for these and other bridges. Examples of typical corrosion damage are shown in photos taken on four bridges (see Figure 12). Corrosion of the shear reinforcement with very low concrete cover (0–5 mm) was probably induced by carbonation or an atmospheric exposure. It extended to a considerable length of the bars and along a great part of the girder span (see Figure 12a,b). The remaining ordinary reinforcement with too little concrete cover is probably corroded due to high chloride content. Lack of concrete cover on the NIB girder-ends led to strand

corrosion and concrete spalling just behind the support plates (see Figure 12c).

The visual damage caused by chloride-induced corrosion was in localized areas, mostly in the bottom flange of the NIB girders (see Figure 12d–f). The most severe corrosion damage was on the inner NIB girders, typically on the second and third ones from the windward side (see Figure 12d,f). Corrosion stains, cracking, and concrete cover spalling were also seen in the bottom surface of the outermost NIB girders. Moreover, most of the corrosion damage was usually in the girder's support-zones and their close vicinity (see Figure 12d–f). This suggests high corrosion risk in these areas.

In girders produced without additional mounting bars supporting the stirrups, corrosion of the strands closest to the concrete surface produced rather horizontal and relatively short cracks. These cracks followed the location of pretensioning reinforcement and were not accompanied by extensive corrosion stains on the concrete surface (e.g., in Hafrsfjord Bridge) (see Figure 12e,g [upper photo]). The concrete cover was removed at several places on selected girders and corrosion on strands and stirrups was detected (see Figure 12g [lower photo]). Moreover, when we removed the

In girders with horizontal mounting bars, corrosion attacks these first (see Figure 12h). The corrosion usually produces two cracks following the location of the bars, and slightly more widespread rust stains on the concrete surface. Nevertheless, the visual damage is still rather local and mostly limited to the girder's support-zones.

The corrosion in the slab of Hulvåg Bridge was found by the NPRA in earlier inspections and treated with patch repair (see Figure 12i). During our inspection, we found new large areas in close proximity to the repairs with corroding reinforcement (marked with white lines in Figure 12i). This confirms that re-passivated reinforcement in the repaired areas might accelerate corrosion in adjacent, unrepaired places.<sup>30</sup>

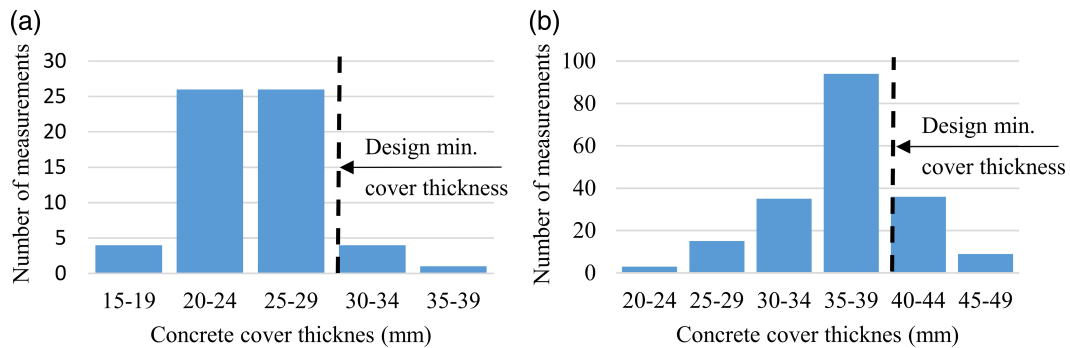
**FIGURE 13** Variation in the concrete cover thickness over stirrups in the NIB girder webs. (a) Hafrsfjord Bridge. (b) Dalselv Bridge

Generally, we found that the concrete cover thickness over the stirrups could differ considerably from the requirements according to the valid standards for the design year. For example, the measurements taken on stirrups in Hafirsfjord Bridge girders revealed a cover thickness as low as 40% of the design requirement (see Figure 13a). In Dalselv Bridge, about 77% of measurements detected inadequate cover thickness (see Figure 13b). The concrete cover over pretensioning strands should vary less because they are anchored in fixed positions before casting.

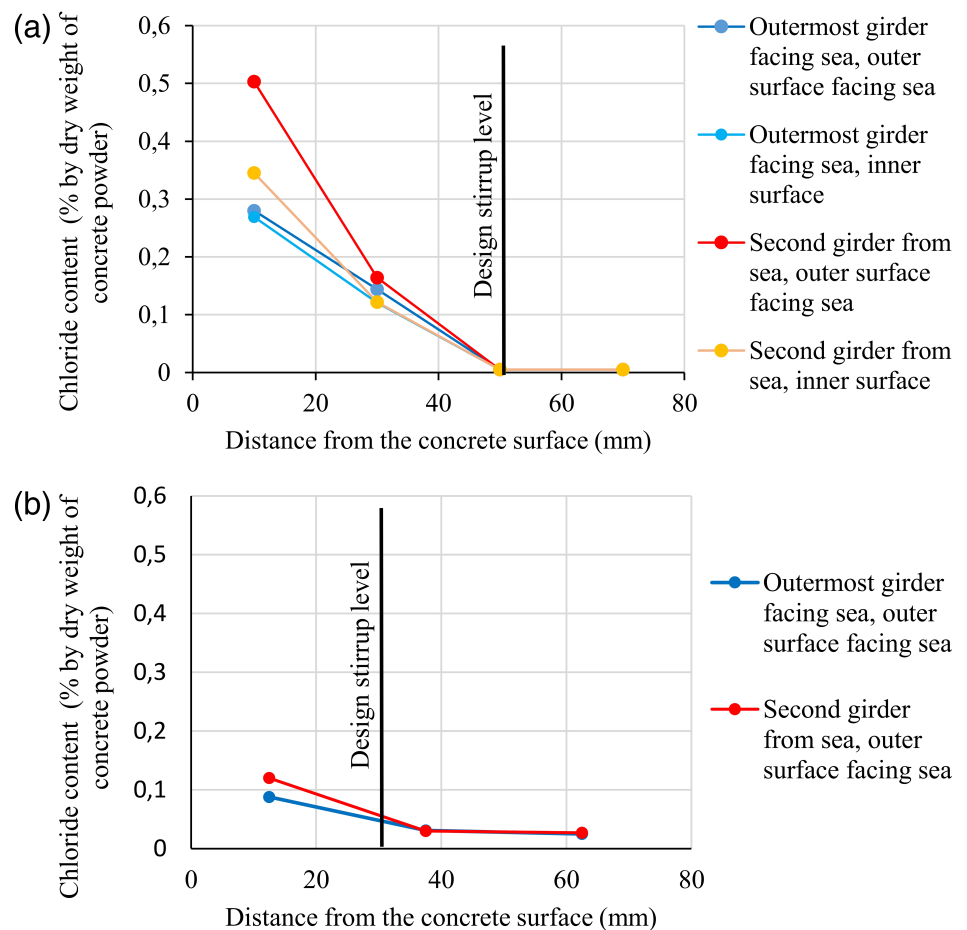
The chloride content at the reinforcement level in Hulvåg Bridge was close to zero, so corrosion is not expected in the NIB girders, which corresponds well to our field observations.
