Implementing post-occupancy evaluation in social housing complemented with BIM: A case study in Chile

This study reports a Post Occupancy Evaluation performed on a social housing complex consisting of 400 apartments, in which symptoms and damage produced by high moisture levels needed investigation. The resulting knowledge is of special interest for other projects designed to be mass-produced such as social housing. Large costs for repairs can be reduced by applying measures to avoid moisture problems in indoor environments. The evaluation was performed over three stages, indicative, investigative and diagnostic. The process was mapped and the data stored using BIM standards so it can be used by stakeholders to take further actions. In the indicative stage, data was collected through questionnaires and surveys, and a quick evaluation was conducted of the affected units. In the investigative stage, an analysis of the entire building complex was conducted through simulation and tested against the building energy standards. In the diagnostic stage, in-situ and laboratory measurements were made and used for calculations. The results show that many factors were involved in the moisture

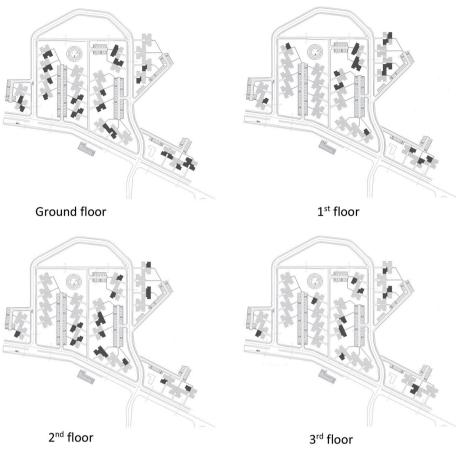
We identified 76 affected apartments, distributed across most of the blocks, storeys, and orientations. Fig. 6 shows the random occurrence of the apartments affected on each storey in the complex. *A priori*, the lack of a relationship between the flats affected suggests that user behaviour could have been the cause of the problems. Although the construction details of the housing complex comply theoretically with the prescriptions of the Chilean building code [83], the energy code is much less strict than the recommended values based on the standard. The particular exposure conditions of the apartments on the site and the design and social housing construction characteristics might be contributing factors in the moisture problems. However, an in-depth study to identify the causes would be needed to provide a scientific diagnosis and definitive solutions.

Fig. 6. Overview of the apartments affected, organised by block, storey, and orientation.

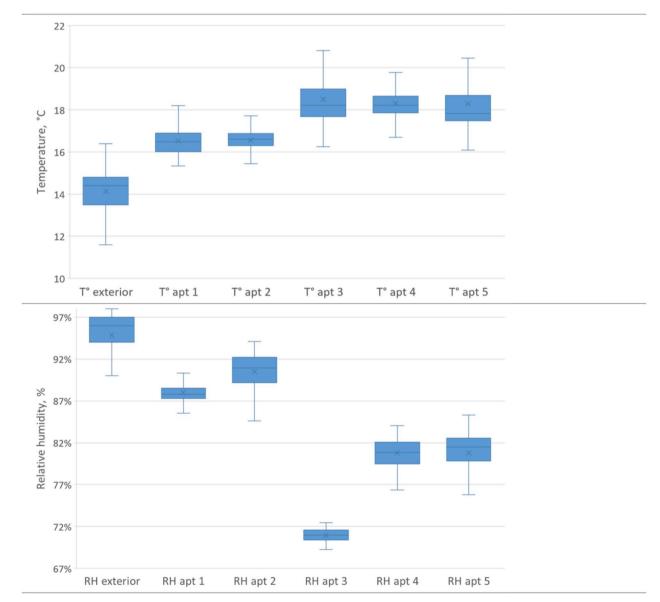
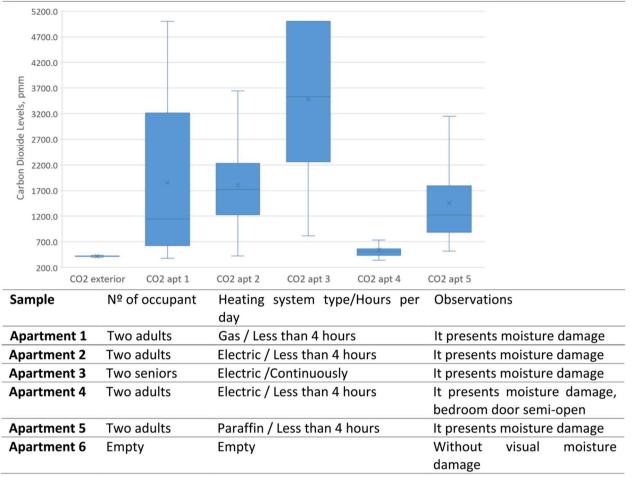
The indoor environmental monitoring during winter can be seen in Fig. 8. The results showed that HR was maintained between 75% and 92% for 95% of the time. The humidity load in Apartments 1,3–5 was between 0.002 and 0.004 kg/m3. According to standard NCh1073, this should be considered as humidity class 3, which is normal for residential buildings. However, the external relative humidity was constantly high during the measurements, and the combination of relatively high external temperatures (12–15 $^{\circ}$ C) with high absolute

humidity made it easy for the air to saturate when it entered the indoor environment. Apartment 2 showed a much higher level of humidity, with more than 0.010 kg/m^3 water most of the time. This corresponds to internal humidity class 5, which is much higher than the standard for residential buildings.

Fig. 8. Sample of indoor temperature, relative humidity and CO2 concentration monitoring in the main bedrooms of five apartments showing great differences mainly because the heating system type and operation hours.

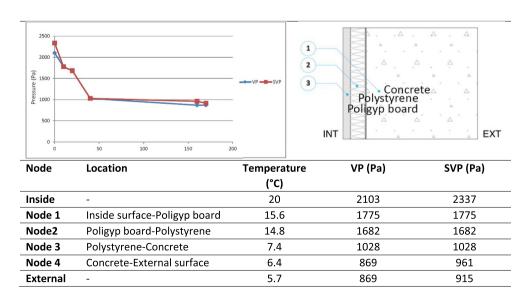
We also carried out a condensation risk analysis using data from material property measurements and indoor environmental monitoring during winter, see Fig. 9. We verified the occurrence of interstitial condensation at the interfaces between the Poligyp-Polystyrene and the Polystyrene-Concrete layers in the apartments evaluated through calculation. The results indicate that the insulation was not sufficient in terms of its thickness or thermal conductivity; that vapour barriers are needed; and that fungus and stains on the wall can be attributed to the interstitial condensation. Even though the properties of the materials differed by 30% with respect to the theoretical values, see Table 7, the results were not considered critical for the local climate in the area.

Fig. 9. Results of the condensation risk analysis.

• The results from the monitoring and construction material measurements used for a condensation risk analysis confirmed interstitial condensation at the interfaces between the Poligyp-Polystyrene and Polystyrene-Concrete layers in the apartments evaluated, which was due to high levels of external humidity, insufficient thermal conductivity (or thickness) of the insulation layer, and a lack of vapour barriers.
