# Inspection and Assessment of Corrosion in Pretensioned Concrete Bridge Girders Exposed to Coastal Climate

To investigate the applicability and accuracy of the above measurement methods for corrosion detection in pretensioned bridge girders, we carried out a study based on experimental data collected during field investigations of Dalselv Bridge, a 33-year-old girder bridge exposed to the Norwegian coastal climate.

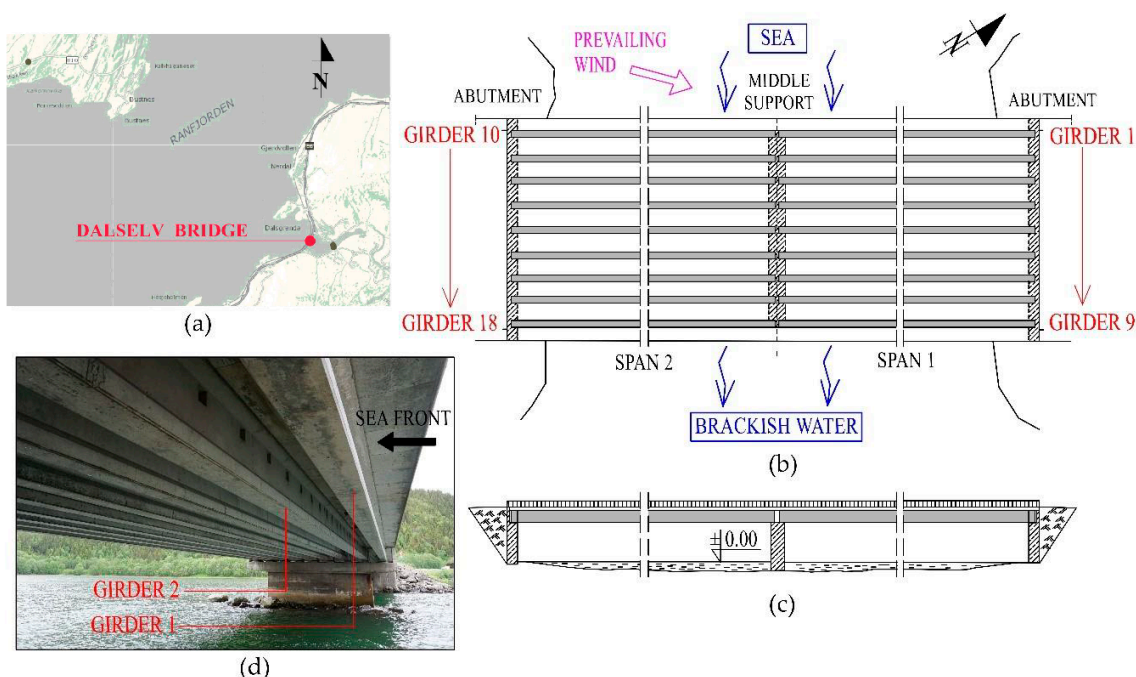
Dalselv Bridge is a 40 m long, two-span bridge consisting of nine simply-supported standardized I-shaped precast pretensioned (NIB) girders in each span; see Figure 1. The bridge was built in 1985 in the inner coastal climate (fjord area) of the northern part of Norway. The superstructure is close to sea level (approximately 2.3–2.9 m measured at high and low tide), which implies high chloride loads on the bridge superstructure. According to data from the Norwegian Meteorological Institute collected in the years 2011–2019, the prevailing winds come from the sea side, from the south-west; see Figure 1a. The average temperature and relative humidity are  $4.6 \text{ }^\circ\text{C}$  and 77%, respectively.

**Figure 1.** Dalselv Bridge: (a) bridge location; (b) bottom view; (c) side view; (d) photo taken underneath the bridge, facing south.

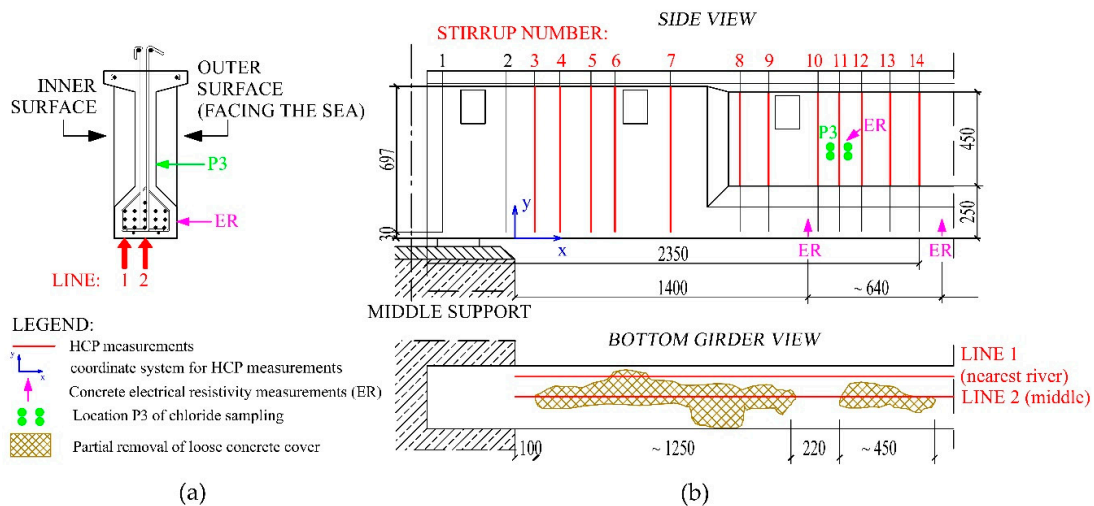
**Figure 2.** Location of half-cell potential (HCP) and electrical resistivity (ER) measurements in Girder 2: (a) measurements in the girder’s bottom flange; (b) measurements (mm) in the web above the stirrups, and removal of loose parts of concrete cover.

To locate areas with high corrosion probability in Girder 2, HCP mapping was performed along the whole span length of the bottom surface of the girder, see Figure 2a. The measurements followed two lines to detect possible variations in corrosion probability between the strands. Moreover, to assess the condition of the vertical reinforcement in the shear zone near the middle support, the HCP was measured above the stirrups (numbered 3–14 in Figure 2b) on the inner and outer vertical surfaces of the girder.

Prior to the HCP measurements, the loose parts of the concrete cover (with a thickness of about 5 to 20 mm) were locally removed from the girder’s bottom flange over a distance of approximately 2.1 m from the middle support, see Figure 2b. The HCP measurement procedure followed RILEM TC 154-EMC recommendations [38]. The electrical continuity of the reinforcement was verified at two points. The second point was used to establish an electrical connection between the reinforcement and the high-impedance voltmeter built into Profometer Corrosion (from Proceq). To reduce fluctuation in the values measured, the concrete surfaces were sprayed with tap water before the measurements. Half-cell potentials were measured against a copper/copper-sulphate electrode (CSE), using a one-wheel electrode type. To increase the probability of corrosion detection, the HCP values were recorded with a fine grid [48], every 50 mm along the lengths measured.

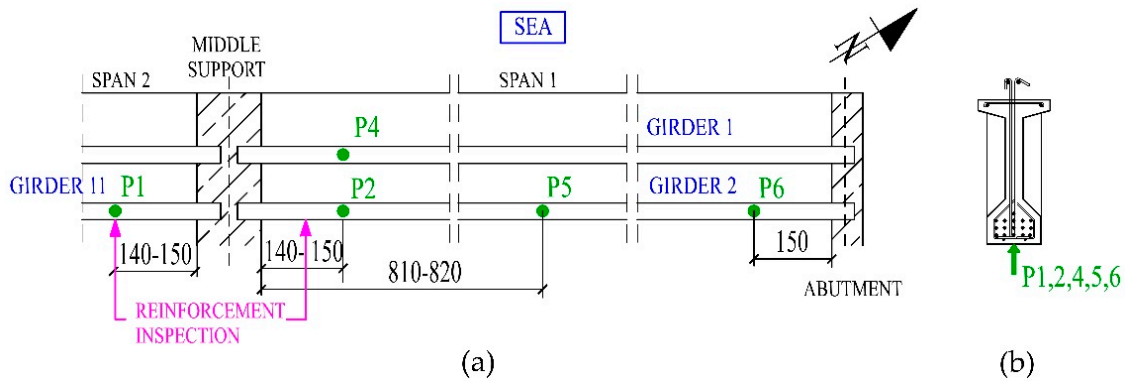
Chloride concentrations in Girder 2 were measured at four locations, three of which were in the girder’s bottom flange: P2 close to the middle support, P6 close to the abutment, and P5 in the middle of the span; see Figure 3. The fourth sampling point, P3, was located in the girder web; see Figure 2b. Additional chloride measurements were taken from the bottom flange of Girder 1 (P4) and Girder 11 (P1) at the same distance from the middle support as P2; see Figure 3a.

**Figure 3.** Locations P1, P2, P4, P5, and P6 for chloride sampling (distances in cm): (a) girder layout; (b) girder cross section.

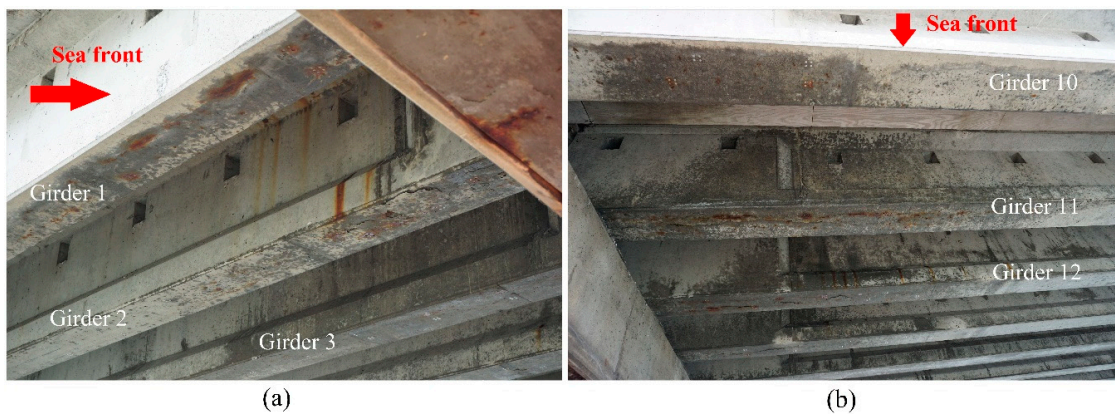
Corrosion was found in the pretensioned NIB girders of Dalselv Bridge, in and near the support zones. The most severe corrosion damage was found close to the middle support, in the second and third girders facing the sea (Girders 2, 11, 12), and in the bottom flanges of the outermost girders facing the sea (Girders 1, 10); see Figure 4. Less severe corrosion cracking was detected in the bottom flanges of girders close to the abutments. Girders 1 and 2 also had severe cracking with visibly corroding strands in the top flange next to the middle support.

**Figure 4.** Corrosion-induced damage and humid areas in NIB girders: (a) in the first bridge span (1st to 3rd girders facing the sea) next to the middle support; (b) in the second bridge span (1st to 3rd girders facing the sea) next to the middle support.

At a certain distance from the middle support, the bottom surface of the first four NIB girders facing the sea had a significantly darker color. Moreover, the inner girders (Girders 2, 3, 11, 12, 13) had a darker color in the web next to the middle support; see Figure 4. We think this color change was due to a greater moisture load in these areas. The bottom flanges of the girders next to the abutments were also humid, although to a lesser extent than near the middle support.

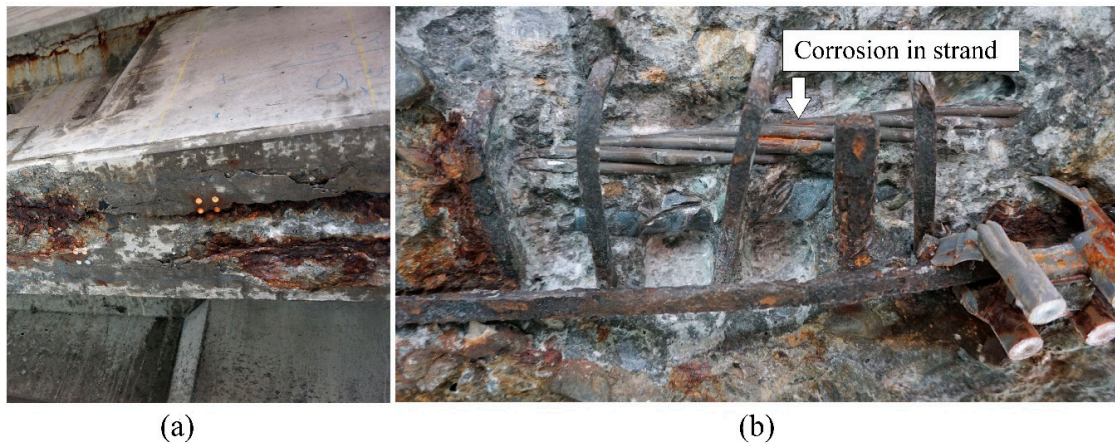
The removal of the concrete cover in the bottom flange of Girder 2 revealed severe corrosion of mounting bars; see Figure 5a. Similar damage was found in the exposed mounting bars in Girder 11. Inspection of chloride sampling location P1 (in Girder 11) also revealed corrosion in stirrups and one strand; see Figure 5b. In the  $\varnothing 6$  stirrups, the severest corrosion had accumulated in and near their bends, with a loss of diameter measured at about 50%. The horizontal part of the  $\varnothing 12$  stirrup shows fairly moderate corrosion.

**Figure 5.** Reinforcement corrosion: (a) next to chloride sampling location P2 in Girder 2; (b) next to chloride sampling location P1 in Girder 11.

Surprisingly, only small corrosion spots were found on the strand itself (see Figure 5), which suggests that corrosion started recently or that the corrosion rate is low. It should be noted that only a short length of strand was exposed and more corrosion spots could probably be found outside this area.

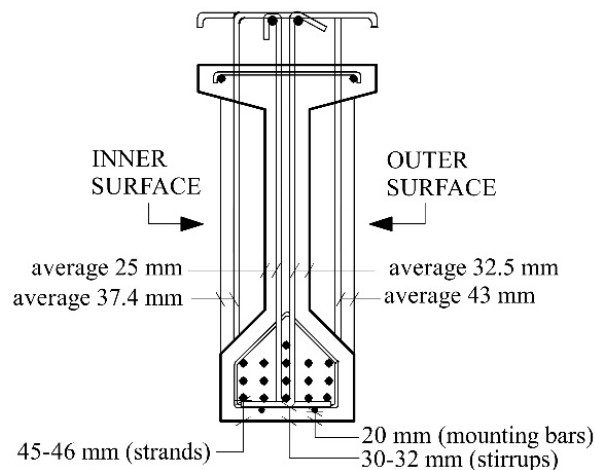
Measurement of the concrete cover up to the stirrups in Girder 2 revealed 5.5–7.5 mm more cover on the outer than the inner surface of the web, see Figure 6. This means that the mold must have moved before casting. During inspection, we also detected two visible mounting bars supporting stirrups in the girder’s bottom flange, with plastic reinforcement chairs supporting the bars.

**Figure 6.** Concrete cover thickness measured in Girder 2.

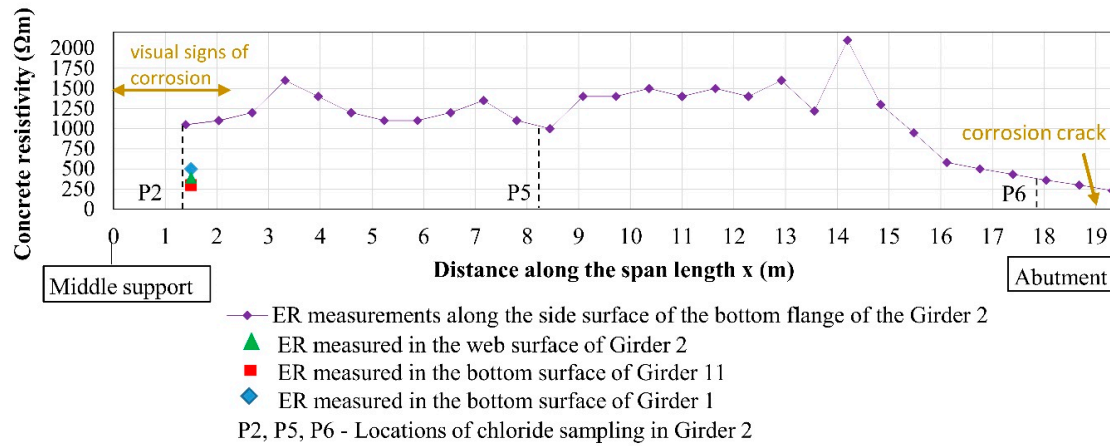
The ER readings scatter significantly along the girder span from 230 Ωm to more than 1000 Ωm; see Figure 7. Overall, the ER measurements were rather high, which can indicate a good concrete quality (low w/c) with low concrete porosity.

**Figure 7.** Concrete resistivity measured along the side surface of the bottom flange of Girder 2, in the web of Girder 2, and in the bottom surface of Girders 1 and 11 (about 1.5 m from the middle support).

For most of the span, the ER was greater than 1000 Ωm, which suggests dry concrete [23]. The ER readings decreased in the last approximately 4.5 meters to the abutment, which suggests a gradual change in moisture conditions; see Figure 7. Although wet areas observed during visual inspection suggested ER would also decrease near the middle support, high ER readings were recorded (more than 1000 Ωm). For comparison, the ER measurements in wet areas of Girders 1 and 11 close to the middle support were considerably lower (500 and 320 Ωm, respectively) than those in Girder 2; see Figure 7. In addition, the ER of 380 Ωm measured in the web of Girder 2 indicates high moisture next to the middle support. The high ER in the bottom flange of Girder 2 near the middle support may be due to delamination of the concrete cover caused by corrosion, the signs of which were visible over a distance of about 2.1 m from the middle support; see Figure 4a. Wind conditions and the location of the measurements on the side of the girder flange could also have had an impact.

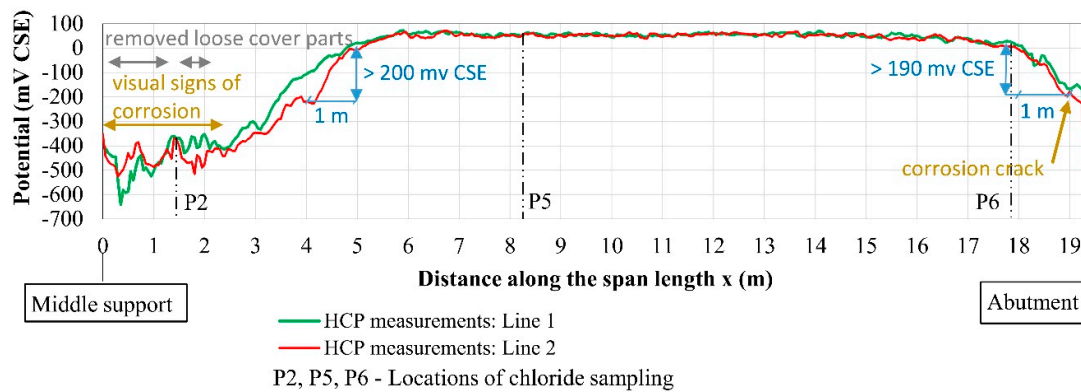
The HCP mapping along the bottom flange of Girder 2 is shown in Figure 8. Lines 1 and 2 both showed positive and stable HCP values (0 to 72 mV CSE) in the middle part of the span between 5 and 18 m from the middle support. Near the girder supports, HCP measurements decreased to their most negative values. The potential gradients near both supports were greater than 190 mV CSE/m, while no potential drops occurred in the middle of the span; see Figure 8. This indicates a higher probability of corrosion in reinforcement near the supports and a low probability of corrosion in the main part of the span.

Figure 8. Distribution of half-cell potentials along the bottom surface of Girder 2.

The local scatter in HCP readings from 0.1 to 1.3 m and from 1.6 to 2.1 m from the middle support is probably due to partially removed loose concrete cover; see Figure 8. Outside the area of removed cover, the HCP readings in Line 2 are slightly lower than in Line 1; see Figure 8. Otherwise, the potential gradients in both lines show the same trend. In this case, therefore, it was not possible to detect variation in corrosion probability between closely spaced (about 50 mm) and electrically connected strands. This can be explained by either active corrosion in both strands or polarization of neighboring strands by a locally active corrosion area. The area polarized depends, amongst other things, on the ER. As the ER decreases, the area polarized increases.

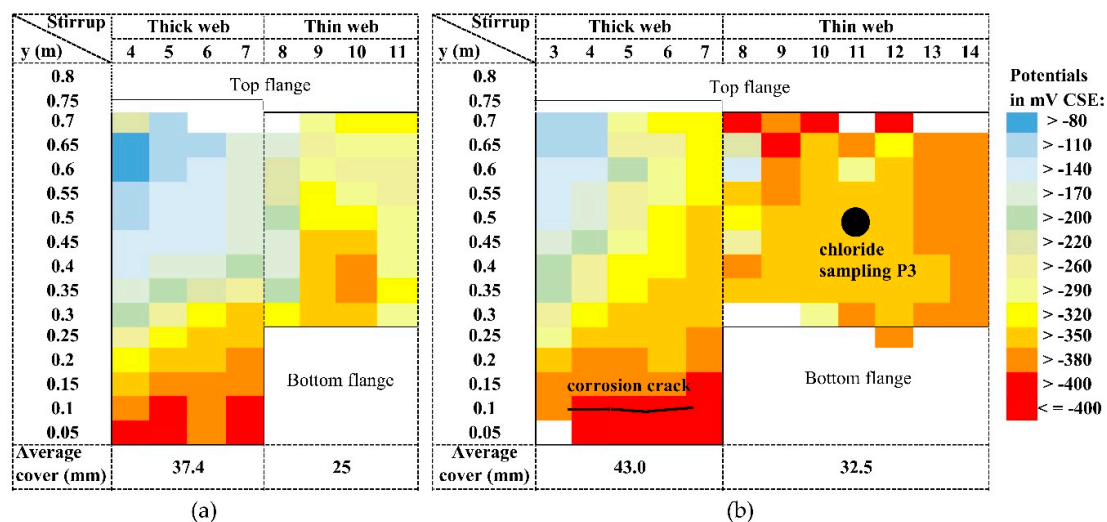
The potentials measured above the stirrups near the middle support (numbered 3–14 in Figure 2b) are shown in Figure 9. The highest HCP values were measured in the upper corner of the girder end cross section, referred to here as the thick web. The potential distribution follows the moisture pattern observed in inner NIB girders close to the middle support (see Figure 4) and confirms the influence of moisture on HCP measurements.

Figure 9. HCP measured above the stirrups in Girder 2: (a) inner surface; (b) outer surface (facing the sea) cf. Figures 2 and 6.

The most negative potentials (less than  $-380$  mV) were found for parts of the stirrups at the bottom of the thick web. These locations correspond to the areas with visible corrosion damage shown in Figure 4a. The HCP readings above the stirrups show more negative values for the outer web surface (facing the sea) than for the inner surface. Despite its thicker cover (by 5.5–7.5 mm), the outer surface facing the sea is more likely to corrode than the inner surface.

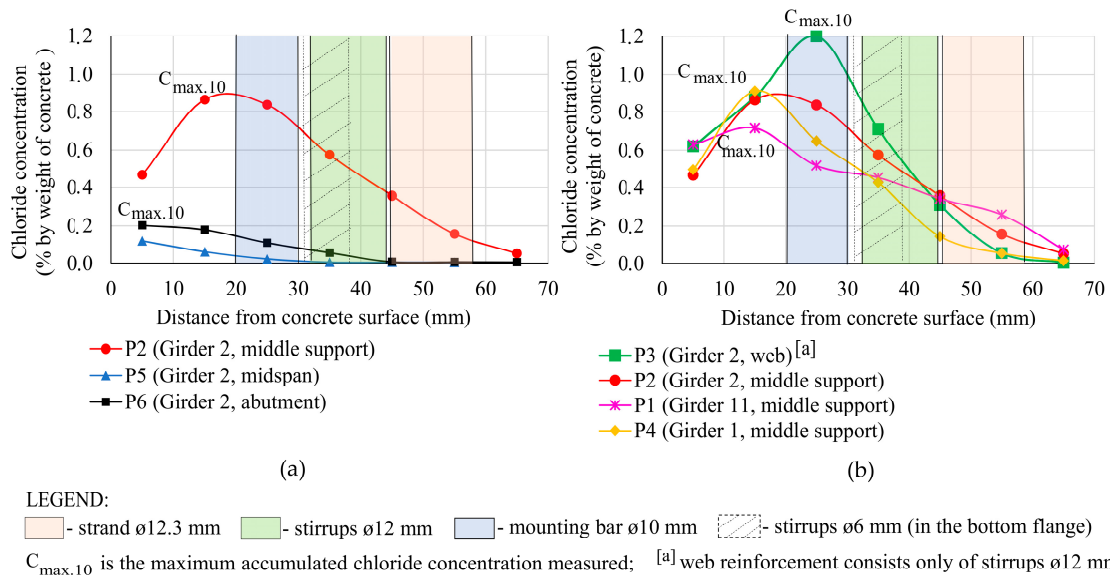
The chloride profiles obtained for all of the sampling locations are presented in Figure 10. The chloride sampling locations on the bottom flanges of Girders 1, 2, and 11 (P1, P2, P4, P5, and P6) are given in Figure 3, and the chloride sampling in the web of Girder 2 near the middle support (P3) is given in Figure 2.

**Figure 10.** Chloride profiles obtained in Girders 1, 2, and 11: (a) along the bottom flange in Girder 2; (b) near the middle support in Girders 1, 2 and 11.

As shown in Figure 10a for the bottom flange of Girder 2, the highest chloride content at the level of the reinforcement was found near the middle support (P2). The chloride content in unsaturated concrete is strongly affected by the accumulation of surface chlorides [55]. The maximum accumulated chloride concentration, based on measurements at 10 mm concrete depth intervals (denoted  $C_{max.10}$ ), was more than seven times higher near the middle support and almost two times higher near the abutment than in the midspan. This resulted in deeper chloride penetrations in the support zones of Girder 2.

The  $C_{max.10}$  values are very high in all sampling locations near the middle support; see Figure 10b. This suggests comparable conditions for chloride ingress in the middle support vicinity.

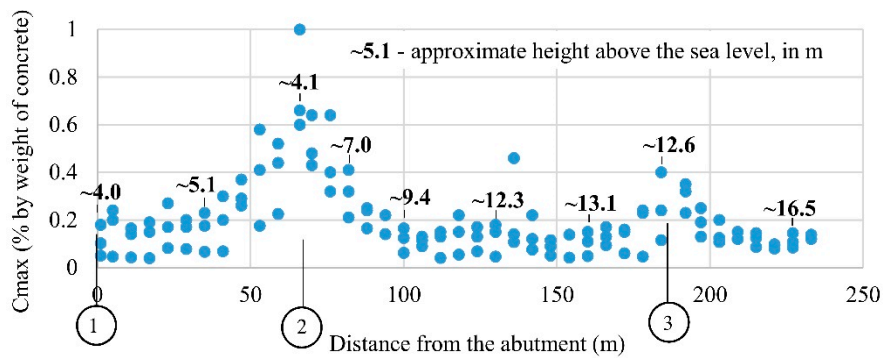
Higher maximum accumulated chloride concentrations close to supports were also observed in the box-girder Gimsøystraumen Bridge in Norway after 11 years of exposure to coastal climate [59]. Figure 11 shows that the  $C_{max.10}$  next to the abutment (axis 1) was lower than that around the middle support (axis 2). The moisture content measured also varied along the box girder, with the highest values next to supports and lowest in the midspans [59], which confirms the findings in this study.

**Figure 11.** Chloride concentrations  $C_{max}$  in Gimsøystraumen Bridge measured in a 10 mm thick concrete layer after 11 years of exposure to Norwegian coastal climate [59].

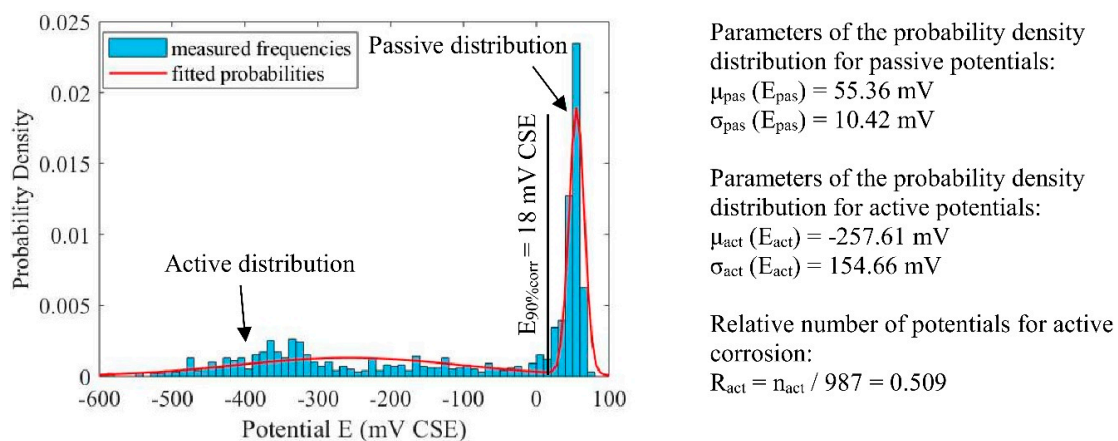
First, we assumed that Girder 2 is a homogenous structure with comparable exposure to chlorides and moisture. All 987 measured potentials were therefore considered in the statistical analysis. Results of regression analysis are presented in Figure 12.

**Figure 12.** Frequency density distribution of measured and fitted potentials assuming homogenous environmental exposure in Girder 2. Parameters of the potential distributions.

A 90% probability of corrosion was found for a potential of 18 mV CSE, as indicated in Figure 12, while a corrosion probability close to 100% was calculated for potentials below 10 mV CSE. We found these values unrealistically high compared to commonly reported thresholds [40,46]. Moreover, no steep

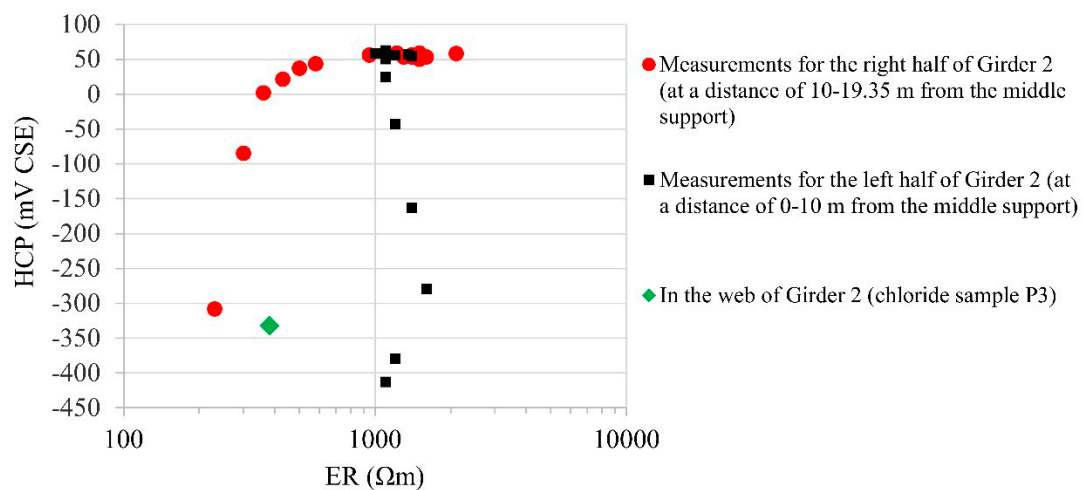
As shown in Figure 13, we found a strong correlation between HCP and ER measurements for the right half of Girder 2. The potential decreases when the ER is below approximately 580–950 Ωm. These values are close to the ER thresholds of 500 and 1000 Ωm, above which the corrosion probability is low and negligible, respectively [23]. However, they are higher than the ER of 350–530 Ωm found by Pailes [46], which may be because NIB girders require a higher quality concrete than bridge decks. For the left half of Girder 2, no clear relationship was found between HCP and ER, see Figure 13. Despite a high ER, decreasing HC potentials with decreasing distance to the middle support showed the same trend as in the right half near the abutment; see Figure 8. We therefore concluded that HCP measurements were more reliable for corrosion assessment than ER results, which should always be verified with visual inspection.

Figure 13. Relationships between HCP and ER measurements.

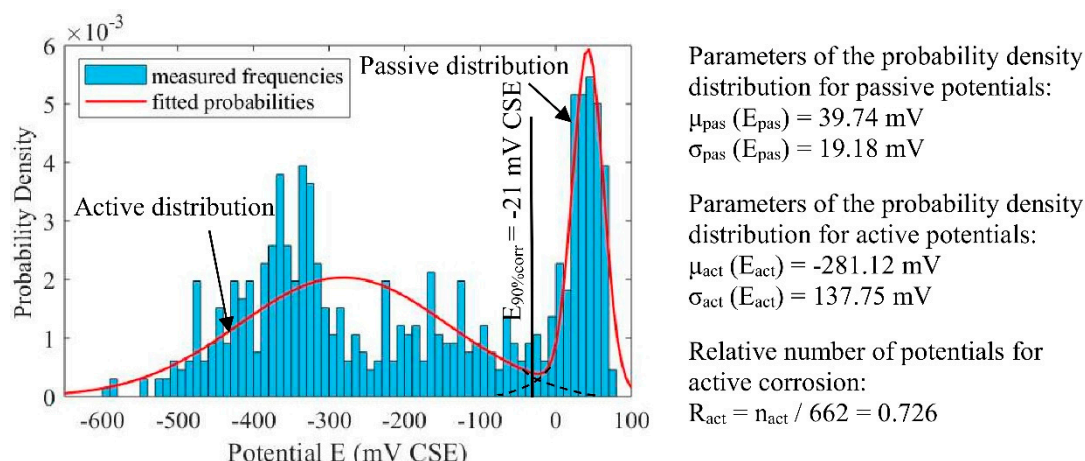
The exact ER threshold that separates zones with dry (non-corrosive) and humid (favorable for corrosion) environmental conditions could not be clearly specified for Girder 2. However, assuming the ER threshold lower than 980 Ωm, the region with elevated moisture was found to extend a distance of 3.8 m from the abutment; see Figure 7. Because low HCP measurements were found for a distance of about 6–6.5 m from the middle support (see Figure 8), the region near the middle support was initially estimated to extend 6.5 m. The results of regression analysis performed on the 642 potentials collected from these areas are shown in Figure 14. The calculated potential threshold for probability of corrosion greater than 90% was equal to −21 mV CSE.

**Figure 14.** Frequency density distribution of measured and fitted potentials assuming similar moisture conditions near supports. Parameters of the potential distributions.

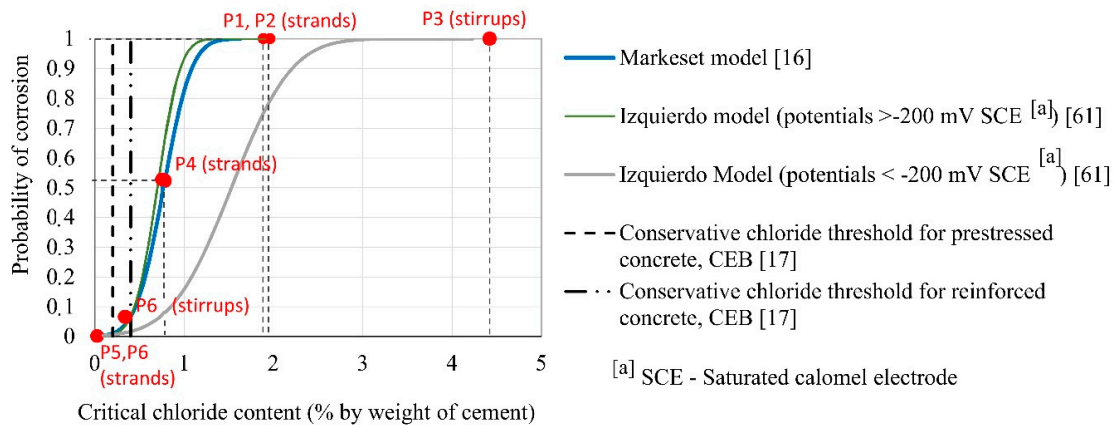
Using this model, we found that the corrosion probability was close to 100% for strands and stirrups close to middle support in the inner girders (P1–P3), whereas strands in the midspan (P5) and abutment vicinity (P6) had a negligible corrosion probability of less than 1%; see Figure 15.

**Figure 15.** Probability of reinforcement corrosion calculated based on the Marqueset statistical model.

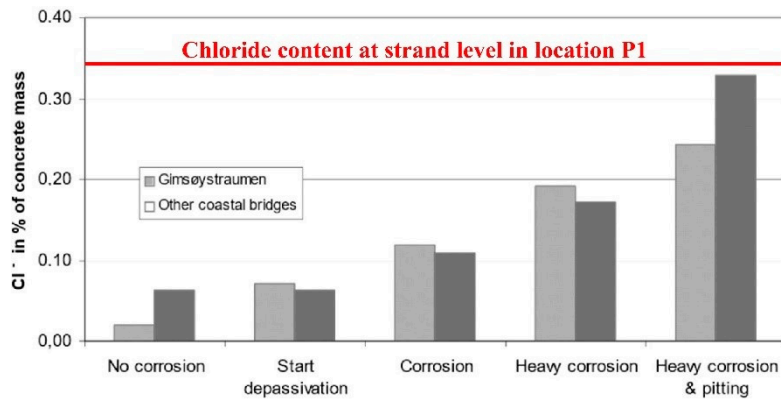
In this study, exposing the reinforcement in location P1 (Figure 5b) confirmed the indicated 100% corrosion probability of the strands. However, for chloride concentrations of 0.344% by weight of concrete (1.81% by weight of cement) only small pitting was detected, whereas heavier corrosion would have been expected based on corrosion bridge studies [62]; see Figure 16. Moreover, for the high chloride content at the level of both strands and stirrups in location P1 (Table 3), stirrups exhibit more severe and uniform corrosion; see Figure 5b. This means that relying on chloride concentrations alone may give unreliable information about not only the probability, but also the severity of corrosion in NIB girder strands.

**Figure 16.** Relationships between corrosion severity and chloride content from more than 300 registrations on various coastal bridges in Norway [62]. Red line—chlorides at the strand level in location P1.

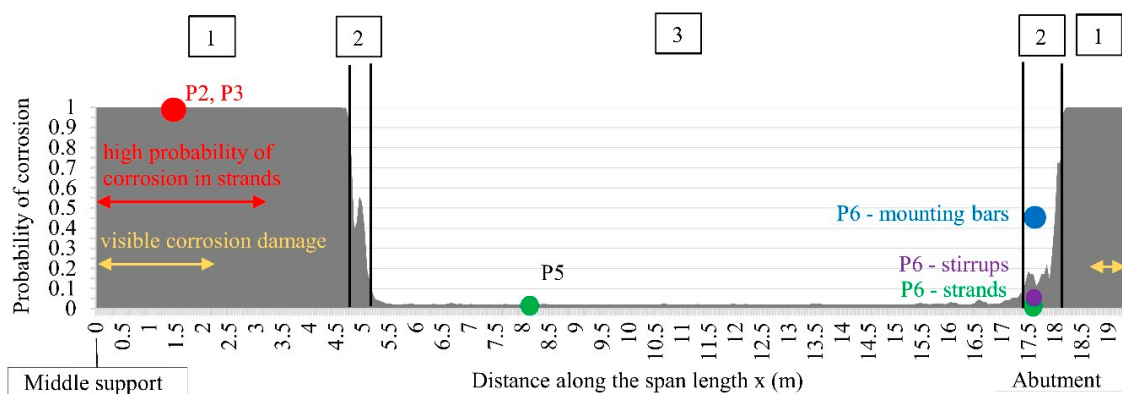
To analyze the correlation between NDT and DT results, the corrosion probabilities calculated for HCP based on statistical distributions in Figure 14 were compared with the probabilities calculated for chloride concentrations based on the Markeset model. The results are shown in Figure 17.

**Figure 17.** Comparison of calculated corrosion probability along Girder 2: grey area—corrosion probability based on HCP collected from support zones; dots—corrosion probability based on chloride concentrations; nos. 1, 2, 3—zones with high (>90%), uncertain, and low (<10%) corrosion probability, respectively.

The corrosion probabilities obtained from both kinds of test on Girder 2 are consistent for all reinforcements in locations P2, P3, and P5, which increases the reliability of assessment in the zones with the highest and lowest corrosion probabilities. Moreover, the zones with a corrosion probability greater

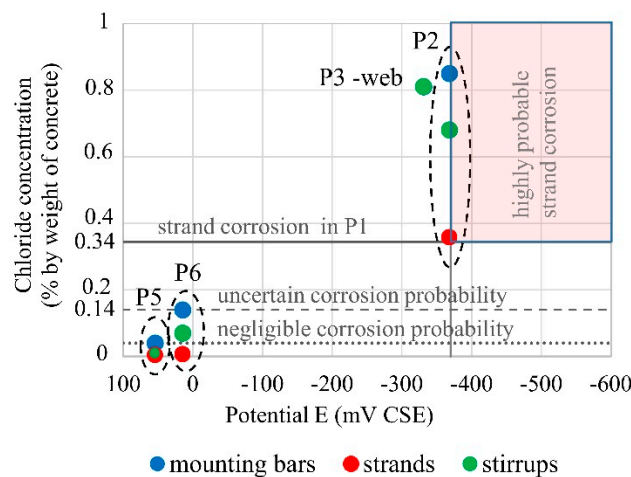
Nevertheless, a negligible corrosion probability was detected in location P5, where chloride content at the level of mounting bars was 0.04% by weight of concrete (0.20% by weight of cement). This means that the CEB [17] chloride threshold for prestressed structures was too conservative for the NIB girder in this study. In location P1, corrosion spots were found in the strands with a chloride content of 0.344% by weight of concrete, so corrosion in strands with a higher chloride level in location P2 is also to be expected; see Figure 18. Removal of cover in locations with severe damage allowed us to estimate the chloride threshold for initiation of strand corrosion. This was approximated at between 0.14 and 0.34% by weight of concrete; see Figure 18. Since strands probably corrode with potentials lower than the  $-370$  mV CSE found in location P2, the area with a high probability of strand corrosion extends about 3.2 m from the middle support; see Figure 17.

**Figure 18.** HCP and chloride concentrations for sampling locations in Girder 2. The chloride concentration at the level of the corroding strand in location P1 (in Girder 11) is included for comparison.

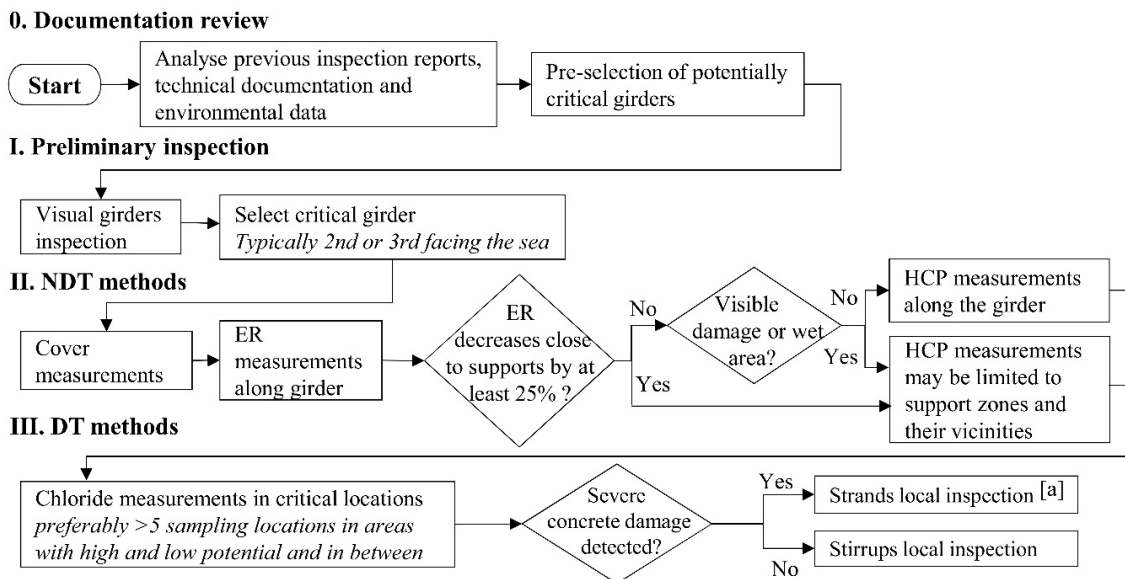
The critical girder(s) for detailed inspection should be based on a visual inspection of all of the bridge girders; see Figure 19. Considering findings in both our previous research [2] and this study, the 2nd and/or 3rd girder facing the sea are typically those with the highest probability of reinforcement corrosion damage due to chloride exposure.

**Figure 19.** Procedure for detailed inspection of pretensioned bridge girders in a marine environment.

[a] Strand local inspection has to be carried out with extreme caution, so as not to mechanically damage the strands. The inspection area has to be limited to minimum (max. 50 mm), preferably selected where concrete cover is already loose.

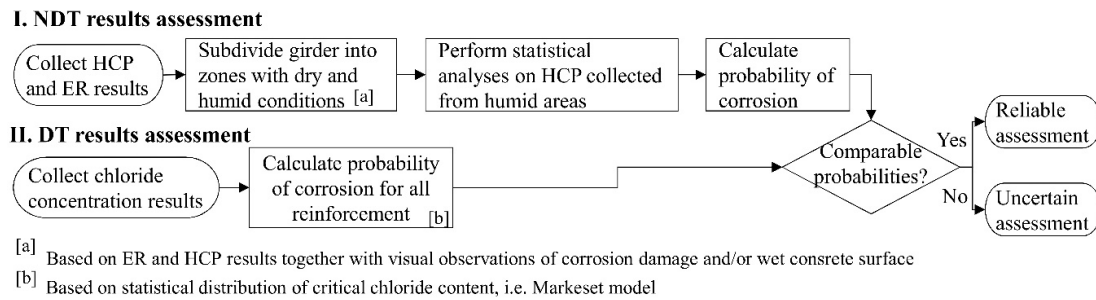
The assessment of the data collected is described in Figure 20. The statistical analysis of HCP should be performed following the procedure developed by Gulikers and Elsener [42] on data collected from areas where an increase in moisture is detected, e.g., support zones and their vicinities. Corrosion probabilities from measured chloride concentrations should be evaluated based on the statistical model for critical chloride distribution for similar structures and environmental conditions as proposed by Marqueset [16]. The estimated corrosion probabilities from both chloride concentrations and HCP collected from areas with similar moisture conditions are then compared. Corrosion probability assessment can be considered reliable when both methods point to the same conclusions and coincide with the visual damage where present. The results can also be supported with reinforcement inspection results.

Figure 20. Procedure for assessment of pretensioned bridge girders in a marine environment.
