Review

Structural Vulnerability Assessment of Heritage Timber Buildings: A Methodological Proposal

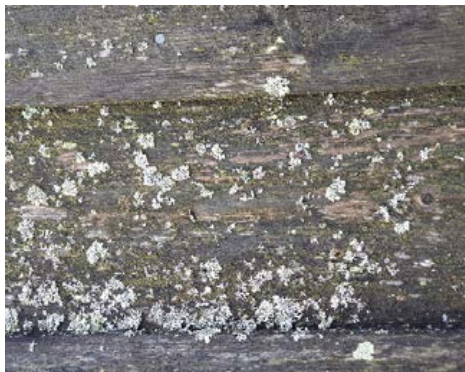
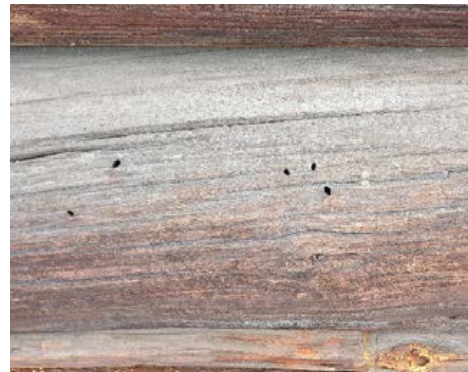
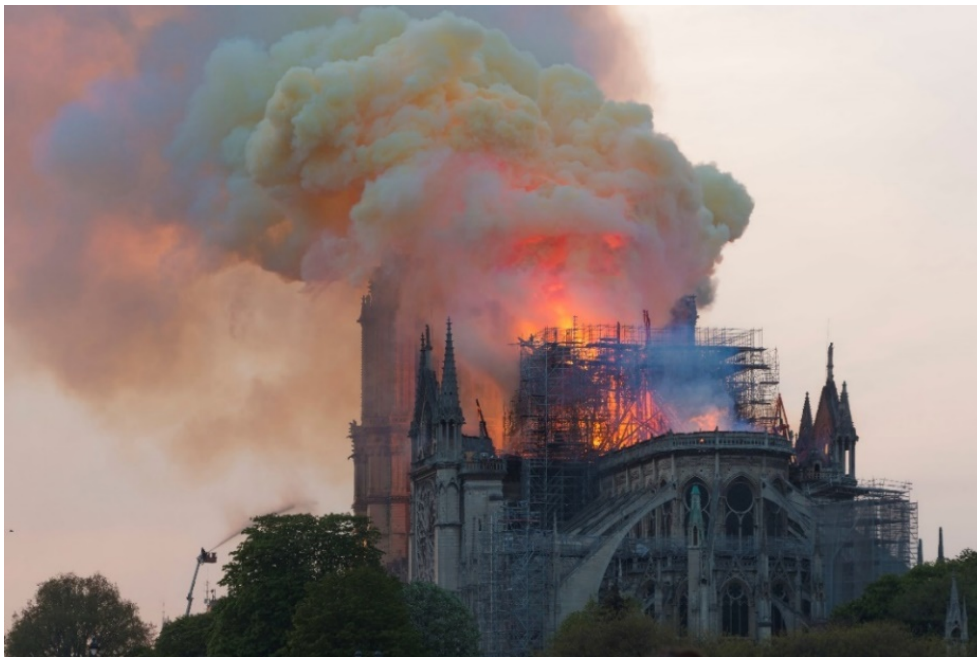
Figure 2. Damage caused by (a) Fungi and (b) Insect attacks in Heierstad Loft, Tønsberg, Norway; (c) Fire in Notre-Dame cathedral timber roof, Paris, France (reprinted from Wikipedia with license CC BY-SA 4.0).

In order to assess the vulnerability of heritage timber structures, potential risks and their effects should be investigated. Timber as a source of food is susceptible to insect or fungi attacks, which can cause voids and which in turn can affect the mechanical properties of the material as shown in Figure 2a,b. These damages can affect the resistance of structures and cause severe damages at full scale [1,4,5].

Timber structures are vulnerable to fire (see Figure 2c), as are other types of structures. When it comes to historic buildings, the value of the whole structure itself and the materials and objects in the building (e.g., fabrics in textile museums or candles in religious buildings) can fuel fires and thus create more severe disasters [3]. Furthermore, experimental studies have revealed that historic timber does not perform as well as contemporary timber in fire in terms of its material performance (char rates and time to ignition) [6]. A suitable fire safety strategy should therefore be considered in order to decrease the fire risks in heritage timber buildings [4].

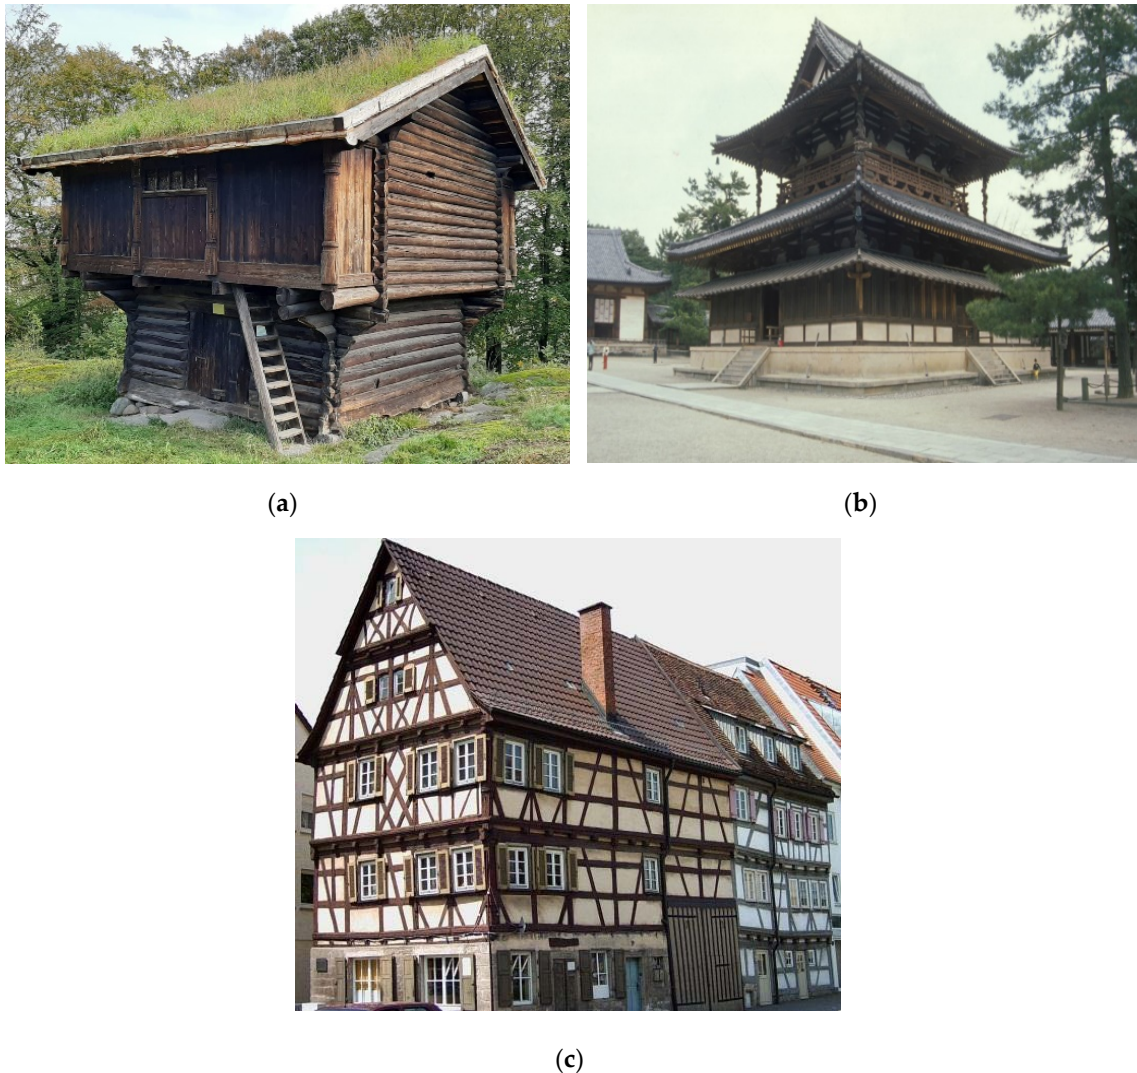
Figure 3. (a) Log house (Heierstad Loft, Tønsberg, Norway); (b) Post and beam (The Golden Hall (Kondo) of the Horyu-ji Buddhist temple, Nara, Japan) reprinted from [4]; (c) Timber frame building (Baden-Württemberg, Germany) reprinted from [19].

The log house method is one of the oldest still-existing construction methods that consists of wooden walls compacted with horizontal laid logs, as shown in Figure 3a [13]. This construction method has been extensively used in the Nordic countries and in the central European Alpine region because of its high insulating values against harsh winters [4,14,15].

In the post and beam building system, vertical structural posts and horizontal beams are connected to form a structural frame, and bracing elements and connections play the critical role in the structure's stability when subjected to lateral loadings. This method was widely used in Southeast Asian countries. The Golden Hall of the Buddhist temple in Nara, Japan, is the world's oldest timber structure to be built using this method, as shown in Figure 3b [4,16].

Timber frame buildings are comprised of timber elements and infill walls, as illustrated in Figure 3c [17]. In this structural system, timber elements are used to reinforce brick or stone masonry walls in order to increase their capacity to resist lateral loadings. The origin of this building method goes back to the ancient Roman empire at the site of Herculaneum, an ancient Roman city [18].

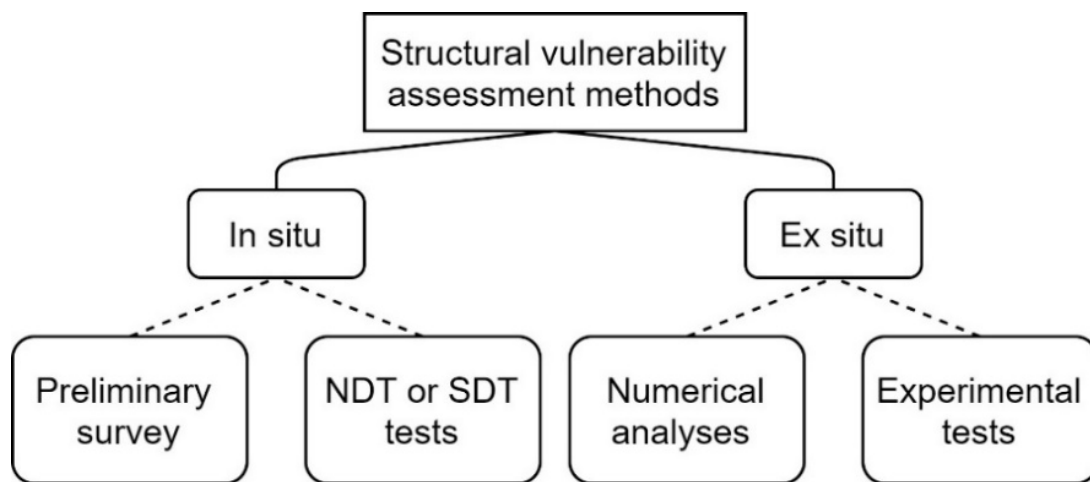
Figure 4. Classification of methods for vulnerability assessments of heritage timber buildings.

In ex situ methods, the structure is modelled, and loads corresponding to different risks are applied to the model to assess the structure's vulnerability. Experimental tests can be utilized in order to investigate the exact behavior of the simulated sub-structures or full-scale structure subjected to different types of loads. The results from the tests can be used to develop numerical models that can, in turn, be used to investigate different scenarios for different types of risks. Figure 4 shows all the methods presented in this paper.

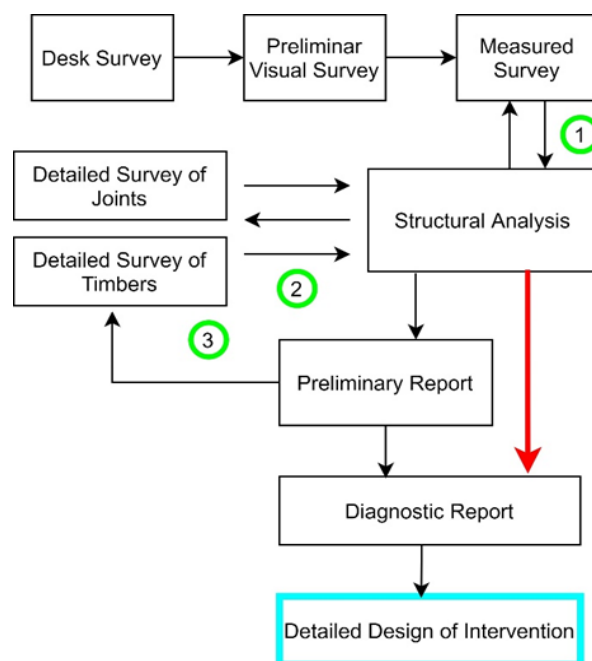
Figure 10. European Cooperation in Science and Technology (COST) action flowchart for vulnerability assessment and conservation of historic timber buildings. Adopted from [20].

In the flowchart, three loops are seen, as shown in Figure 10, but the guidelines do not provide any definitions or explanations about them. The red arrow in the flowchart is an alternative to the structural analysis part of the diagnostic report, which is not clear or separate from the other alternatives. Moreover, the detailed design of interventions is set out under the last step, as shown in Figure 10, but different types of interventions should in fact be checked several times by performing structural analyses in order to choose the best retrofitting technique.

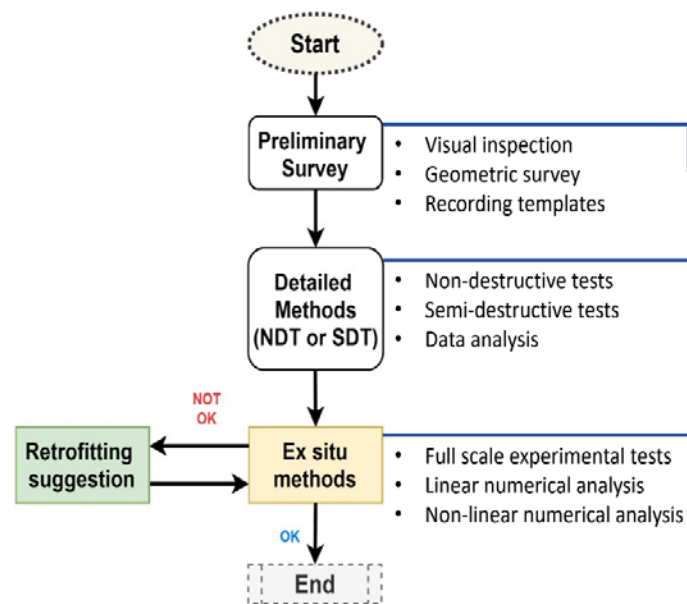
Figure 11. HYPERION methodology for vulnerability assessment and conservation of heritage timber buildings.

In order to improve the COST action guidelines flowchart, a new methodology for the conservation of heritage building is proposed in this study, which can be seen in Figure 11. This flowchart will be used for the structural vulnerability assessment of heritage buildings in the HYPERION project.

The preliminary survey, including desk survey, visual inspection and geometrical survey, is the first step of the vulnerability assessment, which is included in both flowcharts. Detailed in situ methods, including NDT or SDT, comprise the next step to investigate the general defects in the structure and mechanical properties of the timber material. Afterwards, simulation is necessary to assess the current condition (subjected to gravity loads) or predict the behavior of the buildings subjected to different risks scenarios (earthquake, wind, etc.).

For the structural analysis of the models, two approaches are employed in order to accelerate the analysis procedure. For buildings that are in very high or high seismicity zones or in locations with high speed winds, sophisticated nonlinear models are recommended. Seismicity or wind risks can be taken into account based on code provisions [133–135]. For buildings subjected to snow loads or located in low-risk areas, linear simulation will usually sufficient.
