# Durability of pretensioned concrete girders in coastal climate bridges: Basis for better maintenance and future design

Magdalena J. Osmolska<sup>1,2</sup>

bridges, coastal climate, corrosion, durability design, durability status, pretensioned girders

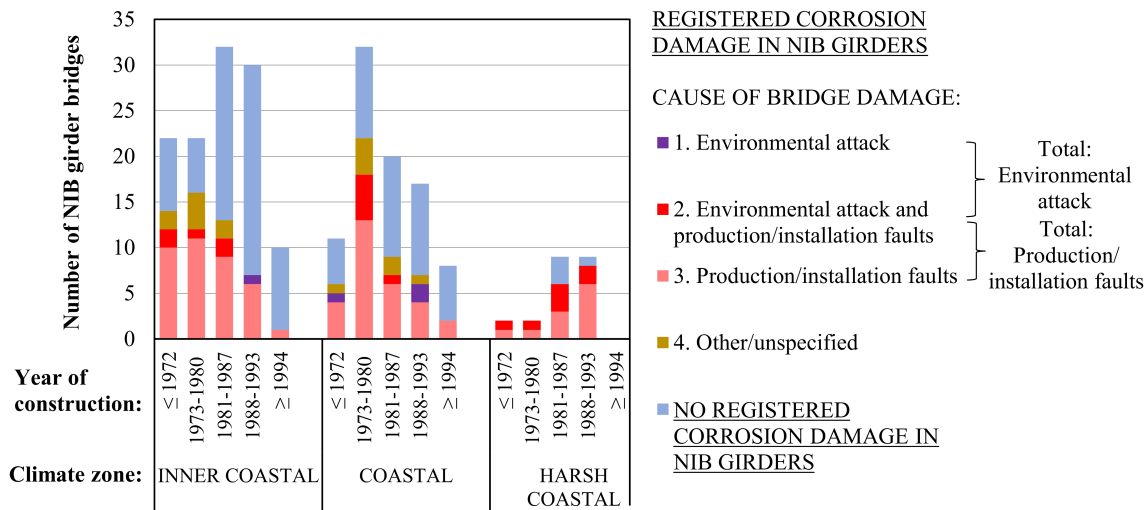
**FIGURE 6** Durability status of the NIB girder bridges in Norwegian coastal climate zones. Causes of corrosion damage versus time of construction

The number of NIB girder bridges in the harsh coastal zone is significantly lower than in the other coastal zones (see Figure 6), but the percentage of bridges with registered corrosion damage is much higher here (82%) than in the coastal and inner coastal zones (51% and 44%, respectively).

Overall, most of the corrosion damage in NIB girders was related to production or installation faults (see Figure 6).

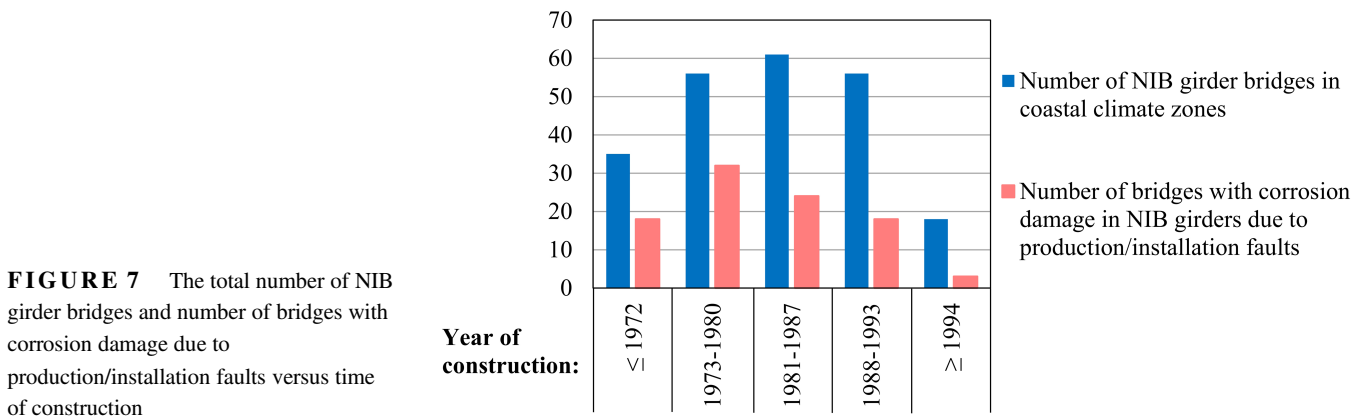
**FIGURE 7** The total number of NIB girder bridges and number of bridges with corrosion damage due to production/installation faults versus time of construction

We found that 51% of the bridges investigated have registered corrosion damage in the NIB girders, which includes damage since repaired. The percentage of bridges with corroded NIB girders decreases the more recent the year of construction. This trend is observed for both the coastal and inner coastal zones (see Figure 6). For the above zones, we found that the highest percentage of corrosion-damaged bridges were built in the years 1973–1980, when the concrete cover thickness required was lowest (see Figure 3). It should be mentioned that the number of NIB girder bridges built in this period in coastal zones was about 60% higher than in the previous period. Such an increase in the production volume of NIB girders could have affected production quality, leading to increased bridge corrosion due to production/installation faults (see Figure 7).

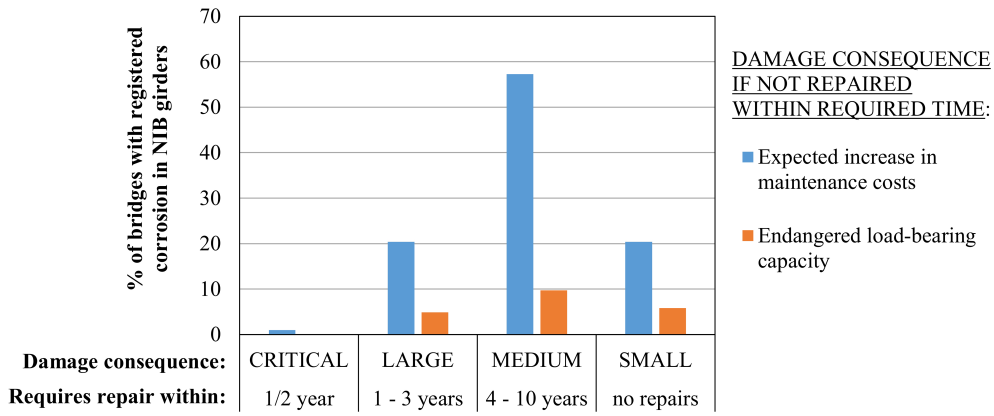
**FIGURE 8** Consequences of corrosion damage in pretensioned NIB girder bridges

maintenance registered in BRUTUS<sup>1</sup> was assessed in accordance with the NPRA Handbook for the Inspection of Bridges<sup>2</sup> (see Figure 8). The majority of bridges with damage impacting maintenance costs required repairs within 4–10 years, and about 20% of the corroded NIB girder

bridges have little damage and, according to the NPRA handbook,<sup>2</sup> do not require repairs. It should be mentioned that no flexural cracks were reported in BRUTUS<sup>1</sup> for any of the bridges, and only one shear crack was found (in the NIB girder of a bridge located in inner coastal zone).

Corroded areas in NIB girders are usually repaired mechanically with sprayed mortar (patch repairs). Nevertheless, the BRUTUS data<sup>1</sup> show that many NIB girders have corrosion cracking in places previously repaired, which suggests this type of treatment is ineffective. Moreover, in pretensioned girders, removal of the concrete cover irreversibly reduces the bond between strands and concrete and can lead to a reduction in the girder's pretensioning.

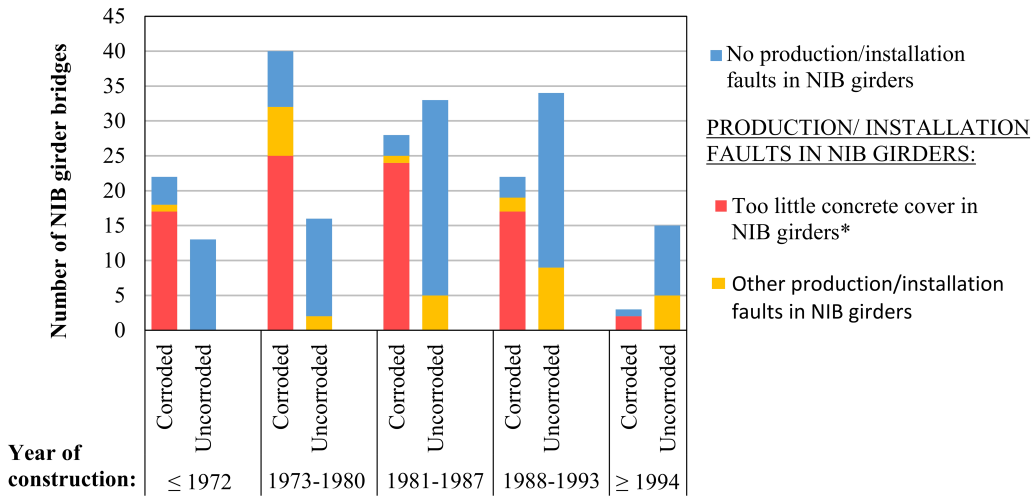
**FIGURE 9** Bridges with NIB girders damaged due to production/installation faults

In corroded NIB girder bridges, the percentage of bridges damaged due to production/installation faults is rather constant over the years (see Figure 9). In uncorroded bridges, it increases the more recent the year of construction. This

suggests poor quality production and/or installation of NIB girders and potential damage increase in the coming years.

In each construction period, some 63–86% of the corroded bridges have corrosion damage caused by having less concrete cover in the NIB girders than the minimum required (see Figure 9). This is associated mainly with incorrectly placed reinforcement.<sup>2</sup> In several bridges, the registered local thickness of the concrete cover was less than 10 mm.

The installation faults in Figure 9 are linked to damage specified in BRUTUS<sup>1</sup> as spalling, which occurs due to impacts during the transportation, lifting, or installation of the NIB girders. Typically, spalling damages the concrete cover, which could lead to reinforcement corrosion.

The other production faults in Figure 9 generally relate to poor quality concrete cover. Poor concrete compaction and/or curing conditions led to the formation of rock pockets, honeycombs, porous, and/or cracked concrete cover.<sup>2</sup> Poor compaction might be due to workability

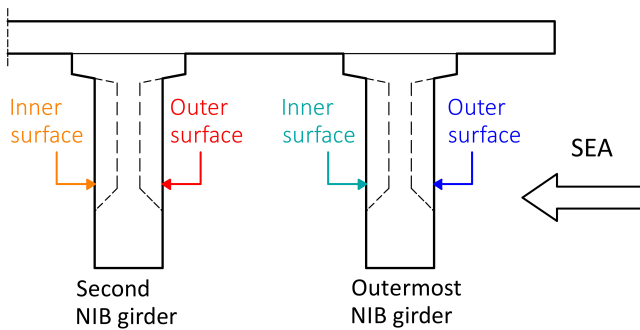
**FIGURE 15** Location of chloride samples for the Hulvåg Bridge

For instance, chloride surface concentrations are well-documented on bridges and quays located in Norway's coastal climate, and they show that chloride concentrations decrease with increasing height above sea level.<sup>31–33</sup> Figure 14 shows an example of a difference in chloride content in NIB girders for bridges in the harsh coastal zone but at different heights above sea level (comparing chloride contents between parts a and b). At Hulvåg Bridge, concrete powder samples for chloride analysis were taken from webs of the outermost and second NIB girder facing the sea, but close to an abutment (see Figure 15). The results were compared with chloride profiles based on data collected by the NPRA from similar locations next to a supporting pillar at Hafrsfjord Bridge.<sup>28</sup> The bridges were of similar age at the time of sampling: Hulvåg with 30 and Hafrsfjord with 29 years of exposure. However, the NIB girders in the Hulvåg Bridge had been coated with hydrophobic paste for the first 13 years, and protect later with wooden panels. Because the hydrophobic surface treatment has proven to have a good effect in slowing chloride ingress, it can be assumed that chloride ingress in Hulvåg Bridge had been considerably reduced over those years. Nevertheless, the chloride content was significantly greater in the Hulvåg Bridge than in Hafrsfjord Bridge (see Figure 14), despite the treatment. This shows that corrosion in NIB girders with the same cover thickness is more likely in bridges less elevated above the sea level, supporting earlier findings on the impact of height above sea level on chloride ingress.
