Master's Degree in
Structural Engineering and Building Technology
Department of Civil Engineering and Energy Technology

MASTER THESIS

<p>THESIS TITLE</p> <p>Hygrothermal performance of thermally upgraded log walls of an in-use cultural heritage building from the 17th century based on current and future climate scenario</p>	<p>DATE</p> <p>09.06.2021</p>
	<p>NUMBER OF PAGES</p> <p>110 + 32</p>
<p>AUTHOR(S)</p> <p>Sindre Didrichsen Kris Anders Flaskerud</p>	<p>SUPERVISOR(S)</p> <p>Dimitrios Kraniotis</p>

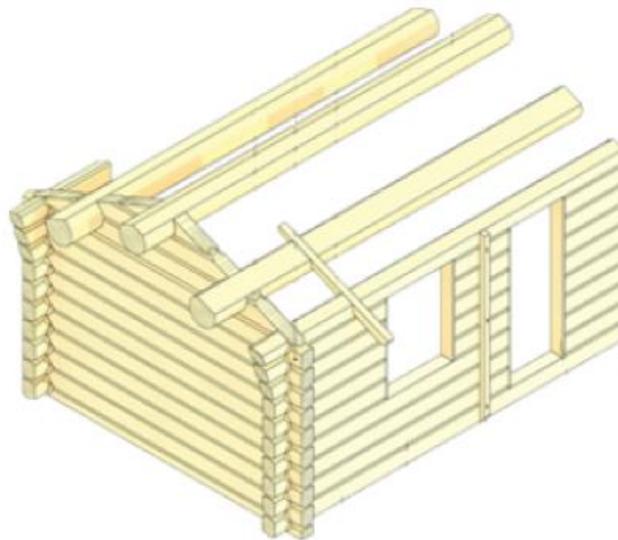
In short, the basic structural principle of log buildings is the horizontal logs which are mounted on top of each other and interlocked at the corners to form the walls of the building. Furthermore, purlins are mounted to form the structural part of the roof. These basic principles are illustrated in Figure 2.1. (SINTEF Byggforsk, 2019b)

Figure 2.1 Typical structure of a log building. Text from the figure has been removed. Included with permission from SINTEF.

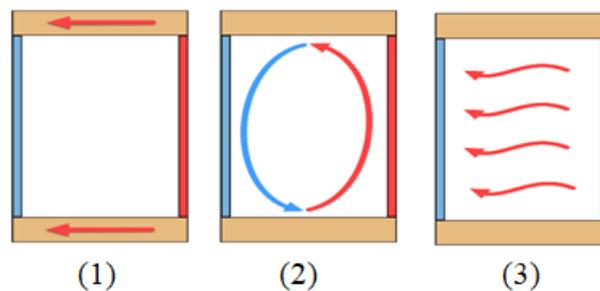
Whenever there is a temperature difference in a system, heat transport will occur from the warmer to the colder area by conduction (1), convection (2) or radiation (3) as illustrated in Figure 2.2. In construction materials, these three forms of heat transport are combined to form the total heat transport (Edvardsen & Ramstad, 2014).

Figure 2.2 Heat transport mechanisms

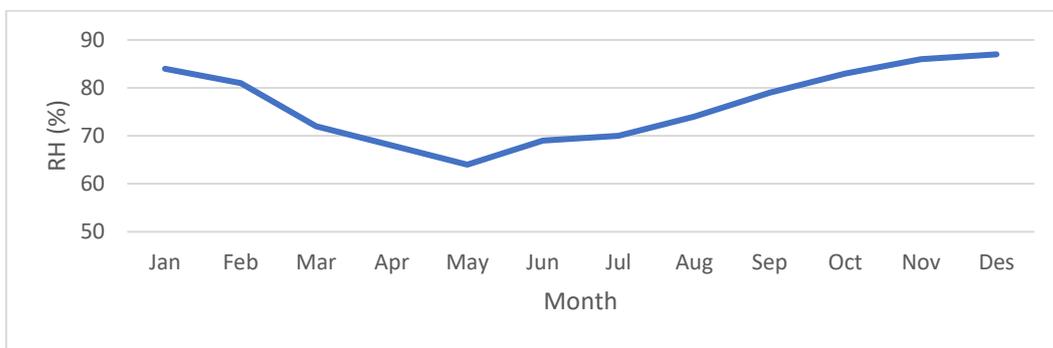
The water vapour content in outdoor air is affected by geographical location and time of the year. The mean relative humidity outdoors in Norway is usually between 50 and 90 %, but close to 100 % in foggy and rainy weather (Edvardsen & Ramstad, 2014). Figure 2.3 illustrates the relative humidity for each month of a typical year in Oslo with data gathered from (SINTEF Byggforsk, 1999).

Figure 2.3 Relative humidity of a typical year in Oslo climate

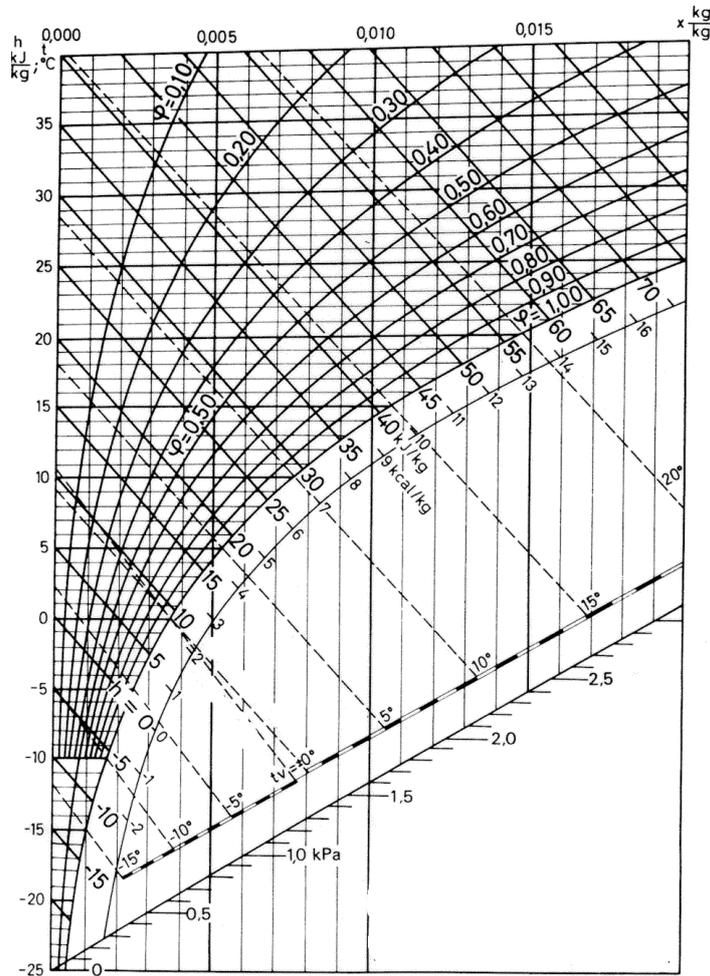
The mollier diagram, Figure 2.4, is an engineering tool that illustrates the relationship between temperature, relative humidity, water vapour pressure and moisture content in the air graphically.

Figure 2.4 Molliers diagram (Engineering ToolBox, 2003)

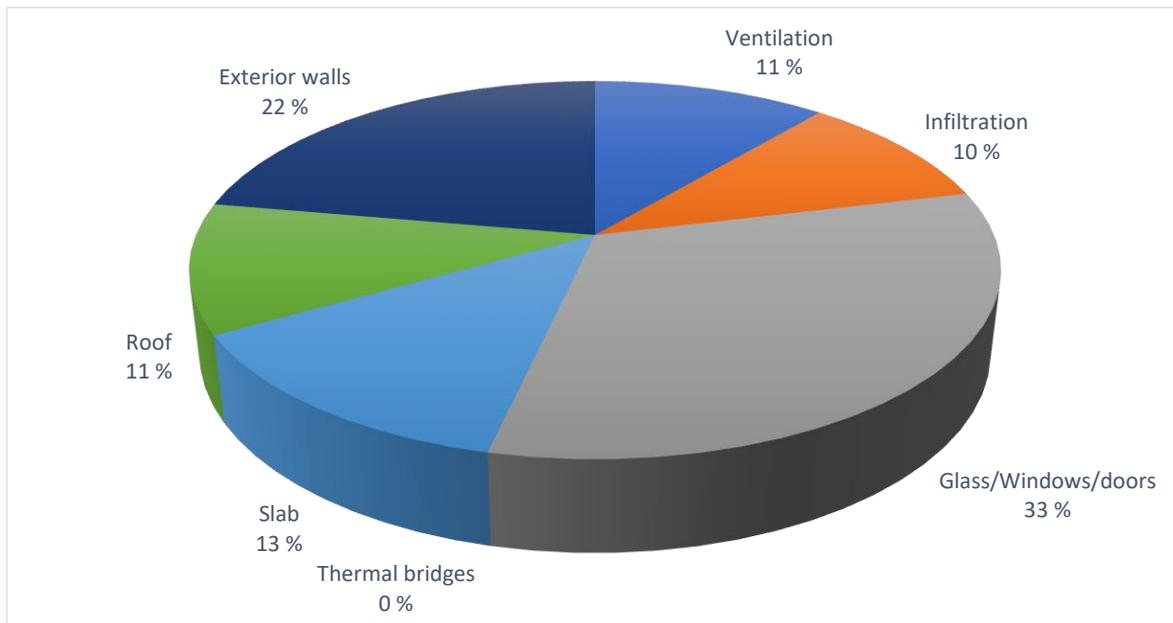
Figure 2.5 illustrates a distribution of heat loss in a typical non-insulated log building in Oslo climate (Svensson et al., 2012). Although these values may vary from case to case, it gives a clear indication of what to expect in this type of building. The absolute largest heat losses are from the windows and the outer walls, while the least is from the thermal bridges. According to Svensson et al. (2012), heat loss from thermal bridges in log buildings is neglectable unless the building is insulated, especially on the interior side.

Figure 2.5 Distribution of heat loss. The graph is reproduced based on the data from (Svensson et al., 2012).

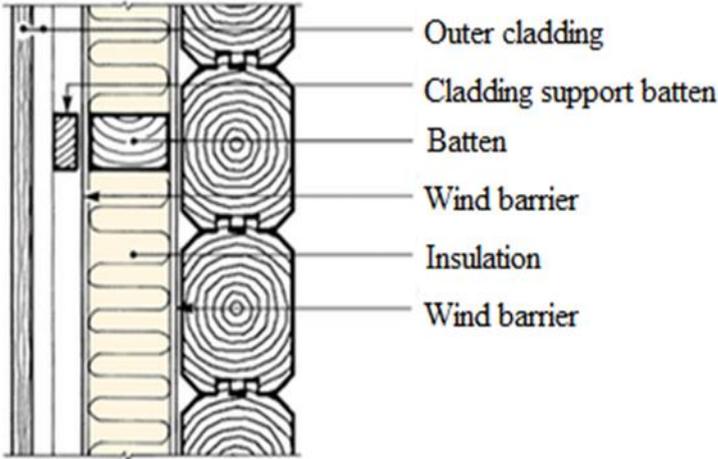
SINTEF Byggforsk (2004) describes two different methods regarding log house with exterior insulation. The first method, Figure 2.6, is described by installing a wind barrier to the logs to make it airtight, followed by a layer of mineral wool and another layer of wind barrier. After the new layer of wind barrier, a ventilation layer and the outer cladding is installed.

Figure 2.6 - Insulation on interior side of logs, alternative 1. Translated from (SINTEF Byggforsk, 2004). Included with permission from SINTEF.

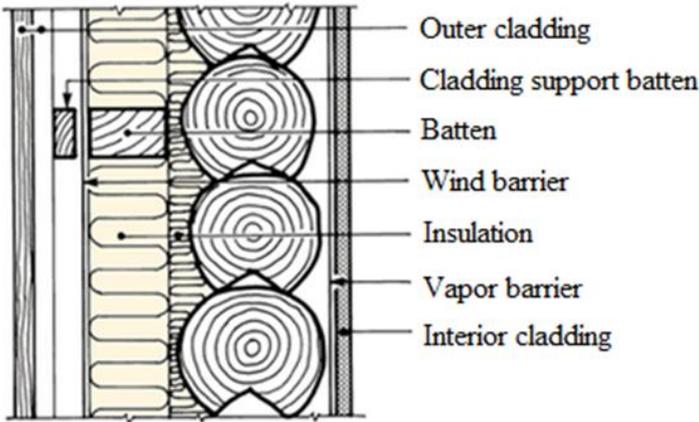
The second method, Figure 2.7, is regarding walls with an existing interior vapour barrier and interior cladding. The mineral wool layer can be installed directly to the logs provided that the outer wind barrier is mounted with tight seals and transitions to the existing wall.

Figure 2.7 - Insulation on interior side of logs, alternative 2. Translated from (SINTEF Byggforsk, 2004). Included with permission from SINTEF.

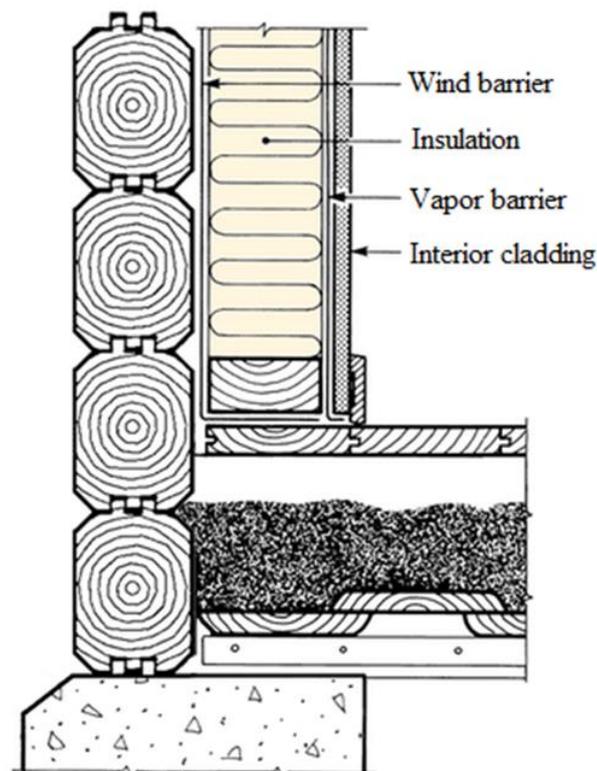
SINTEF Byggforsk (2004) describes a method regarding the installation of interior insulation in log buildings as illustrated in Figure 2.8. It is recommended to install a wind barrier against the logs if the wall isn't airtight, which they usually aren't. The inside of the insulation is then covered with a sealed vapour barrier before the interior cladding.

Figure 2.8 - Insulation on interior side of logs. Translated from (SINTEF Byggforsk, 2004). Included with permission from SINTEF.

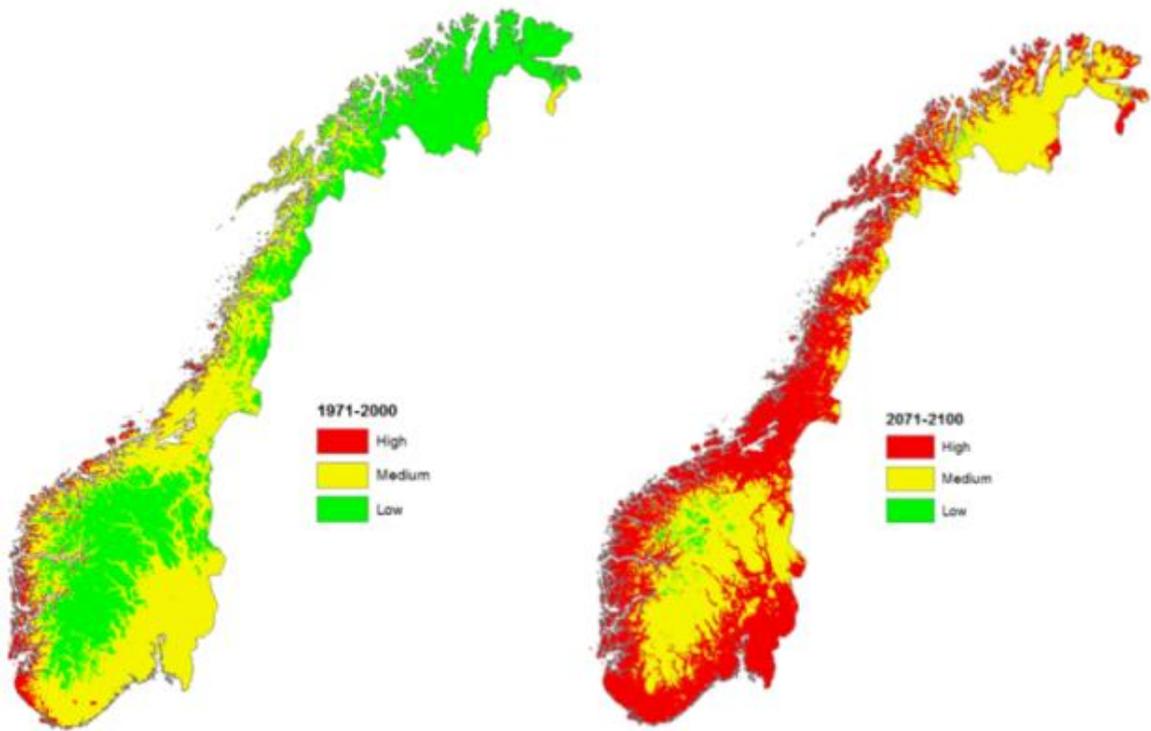
Figure 2.9 illustrates the risk of rot-decay across Norway with the figure to the left from 1971 to 2000 and figure to the right from 2071 to 2100.

Figure 2.9 Risk of rot-decay in Norway. Translated from The Norwegian Meteorological Institute

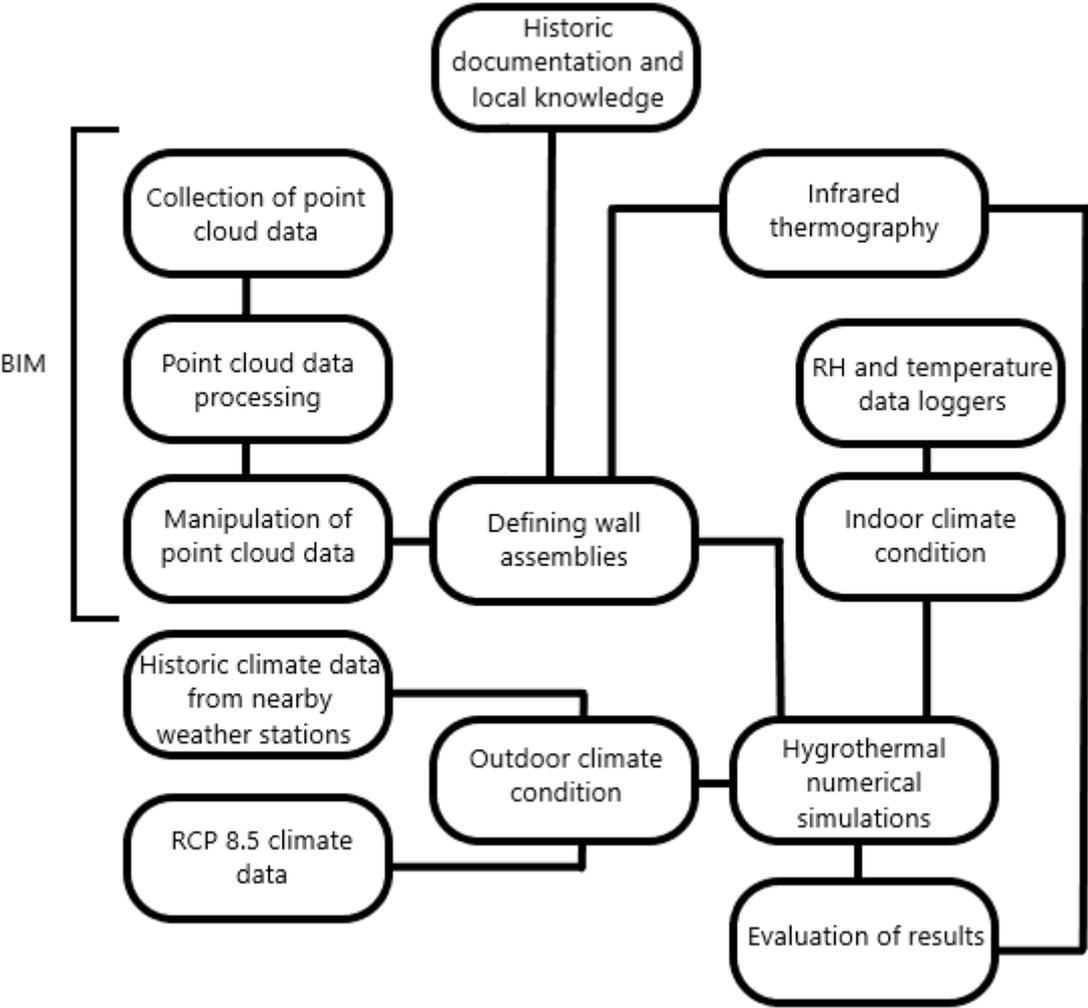
Answering the research question of this master thesis has been done using quantitative research including primary and secondary data to ultimately evaluate the hygrothermal performance of Bentegården with current and future climate. A 3D scanning has been performed to create a digital model of the building. Supplied by historical documentation, local knowledge and infrared thermography, this has created a basis for determining the hidden elements within the building envelope. Numerical simulations have been conducted for the different wall assemblies with current and future climate data primarily based on observed data from weather stations and scenario RC8.5. Figure 3.1 displays an overview of key elements included.

Figure 3.1 Overview of key elements

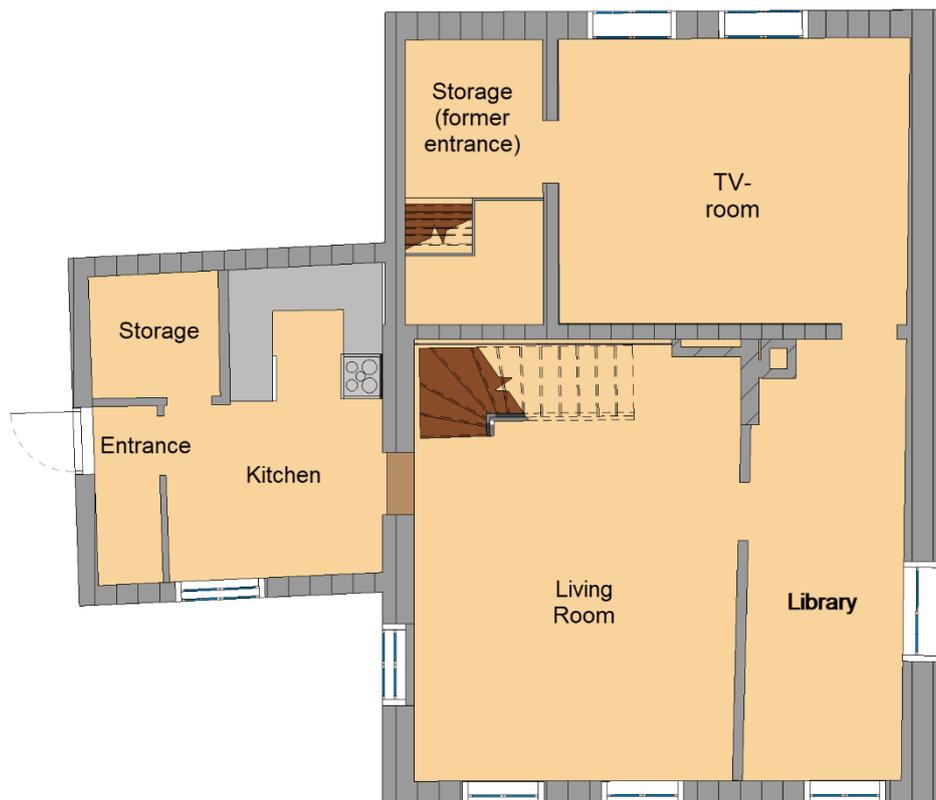
The entrance to the building is located in the extension observed in Figure 3.5, leading into a small entrance hall. The plan drawing of the 1st floor is presented in Figure 3.6. The first floor of the extension includes a storage room and kitchen. The original section of this floor further consists of a living room, library, TV-room and the former entrance, now used as a storage room.

Figure 3.6 – 1st floor plan drawing

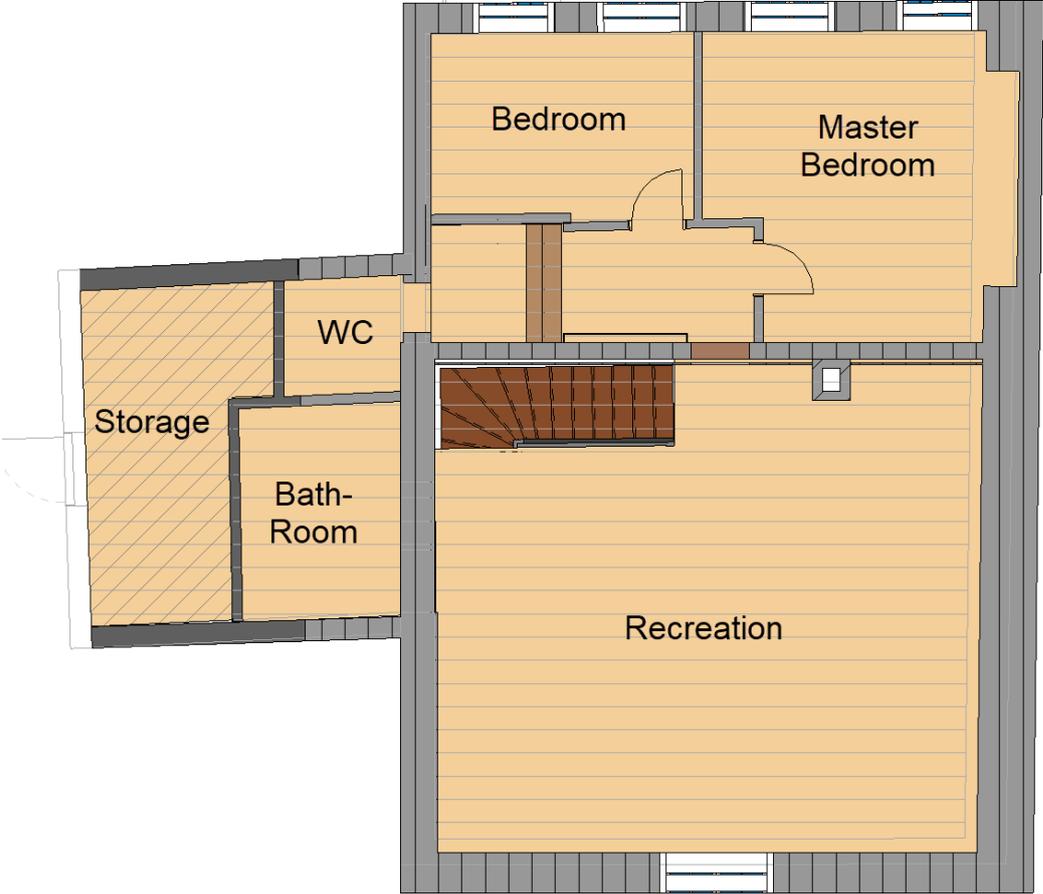
The original section of the second floor, Figure 3.7, consists of a recreational room and two bedrooms. A bathroom, WC and a cold storage room make up the area for the extension.

Figure 3.7 - 2nd floor plan drawing

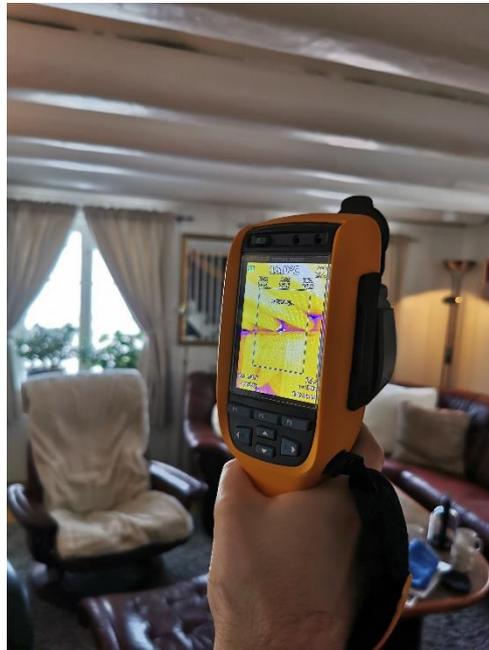
The infrared thermography was performed using an IR-camera called Fluke Ti105. This device got a 3,5-inch LCD screen with a resolution of 160x120 and is able to capture infrared images with a thermal sensitivity of 80 mK within a temperature range of -20 to +250 °C. Figure 3.8 shows the device in question being operated during the fieldwork at Bentegården.

Figure 3.8 IR-camera Fluke Ti105. Photo by Kris A. Flaskerud

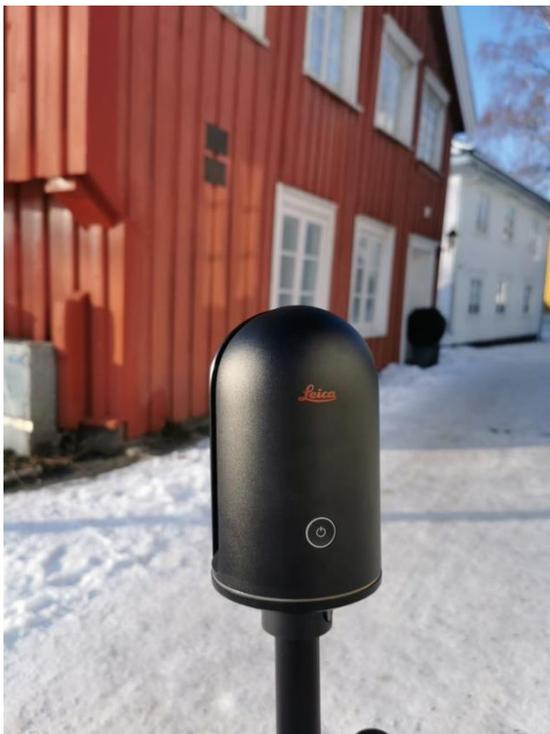
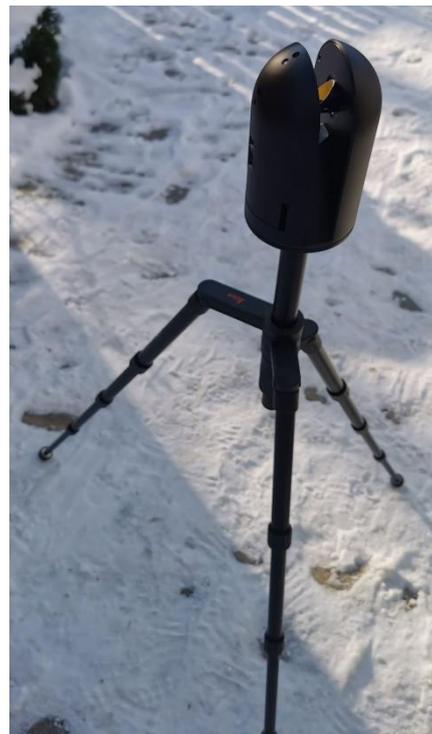
3D point clouds were collected using a Leica BLK360 Imaging Laser Scanner, which is a portable tool that can be placed on adjustable legs. This scanner is capable of generating point clouds at a point measurement rate up to 360 000 points per second with a ranging accuracy of 4 mm at 10 m distance and 8 mm at 20 m distance. According to the producer it weighs 1 kg, got a height of 165 mm, a diameter of 100 mm and is equipped with a camera system capable of capturing images at a 360° horizontal and 300° vertical field of view. Figure 3.9 and Figure 3.10 illustrates the scanner during the fieldwork.

Figure 3.9 - Leica BLK360 #1. Photo by Kris A. Flaskerud

Figure 3.10 - Leica BLK360 #2. Photo by Kris A. Flaskerud

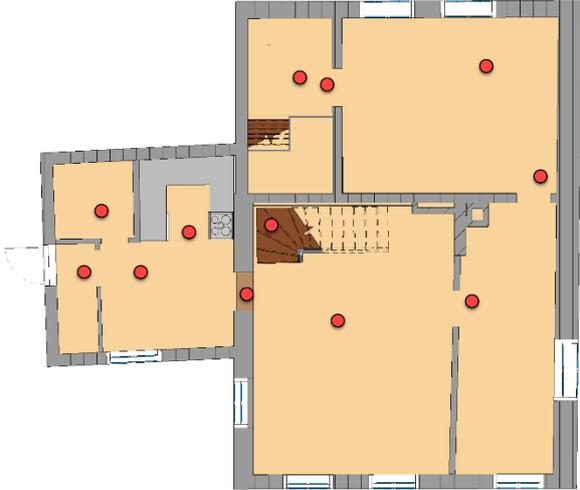
Figure 3.11 - 1st floor, position of each scan

As the aim was to make the finalized model of Bentegården as identical as possible to the real building, a great deal of focus was on making sure that all areas were included and that the connection between the individual scans was sufficient. As Cyclone FIELD 360 was used during the work, scans that did not fulfil these criteria could easily be replaced. In some areas, it was necessary to make several scans due to complex geometry. The location of the scanner position for all individual scans is illustrated below. Figure 3.11 presents the different positions at 1st floor, Figure 3.12 the positions at 2nd floor, while Figure 3.13 presents the positions of each scan of the exterior. The process is documented in APPENDIX E.

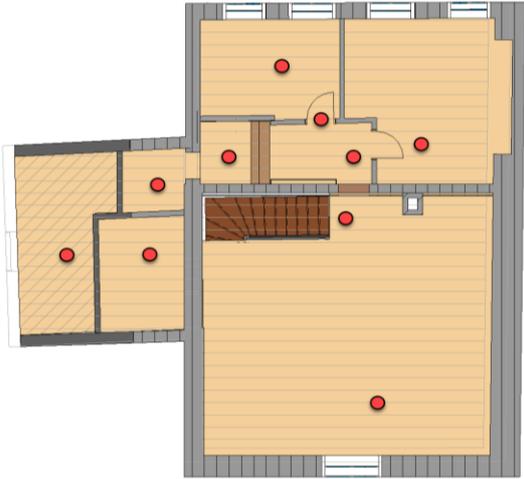
Figure 3.12 - 2nd floor, position of each scan

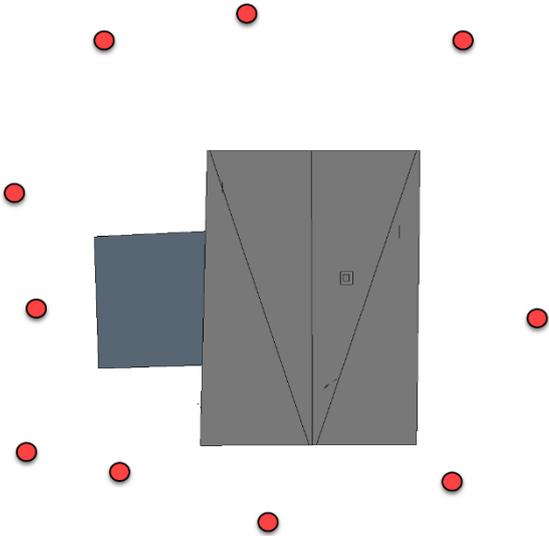
Figure 3.13 - Exterior side, position of each scan

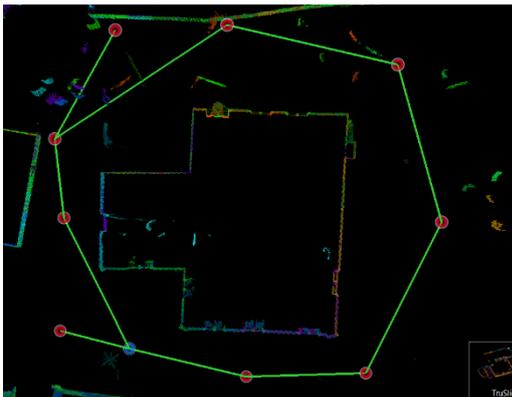
The individual scans got connected to form three sets of point cloud bundles, including the exterior section, first floor and second floor. Figure 3.14 and Figure 3.15 illustrates the bundle from the exterior side of Bentegården. The red points indicate the positions of each scan, while the green line indicates the connection between each scan. The figures on the left side also display the exterior walls registered by the laser, while the figures on the right-side display objects registered by the camera. Figure 3.16 and Figure 3.17 represents the cloud bundle of the interior side of the 1st floor. Figure 3.18 and Figure 3.19 represents the cloud bundle of interior side of the 2nd floor.

Figure 3.14 Point cloud bundle of exterior scans

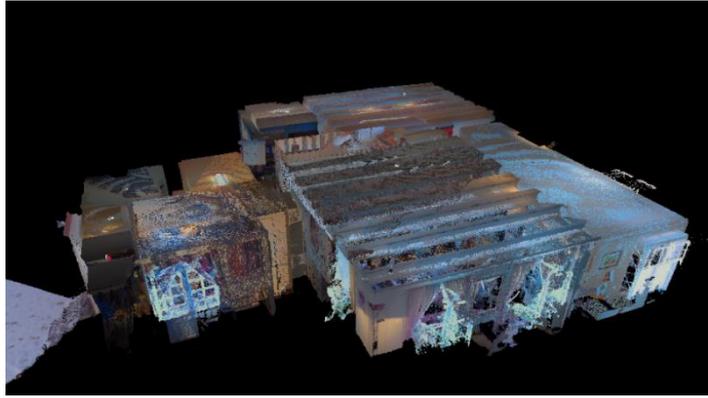
Figure 3.16 Point cloud bundle of interior scans 1st floor

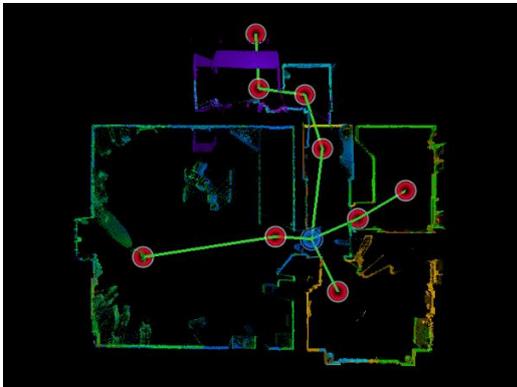
Figure 3.17 Point cloud bundle of interior scans 1st floor

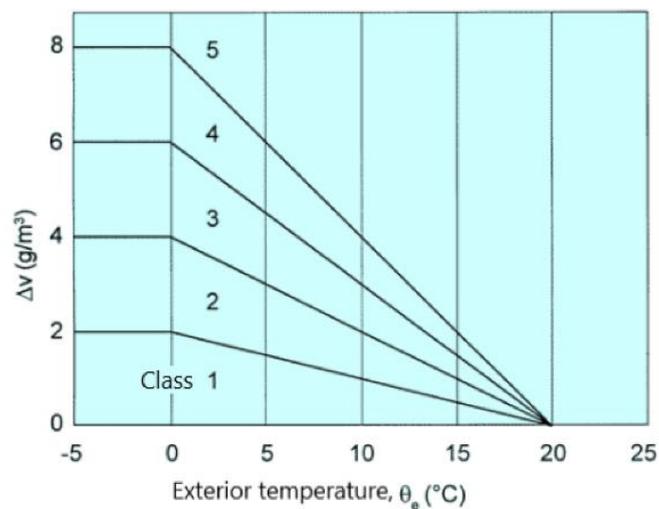
For all humidity classes, the moisture excess is considered with a constant maximum value, ΔV_{max} when the outdoor temperature is at 0 C° or lower. When the outdoor temperature increases ΔV reduces linearly until it reaches 20 C°. At this point, no moisture excess is included in the calculations. This reduction in ΔV is based on an assumption that occupants tend to use more natural ventilation with increasing temperatures e.g., opening windows. All of this is illustrated graphically in Figure 3.21.

Figure 3.21 Humidity classes, translated from (SINTEF Byggforsk, 1999). Added with permission from SINTEF

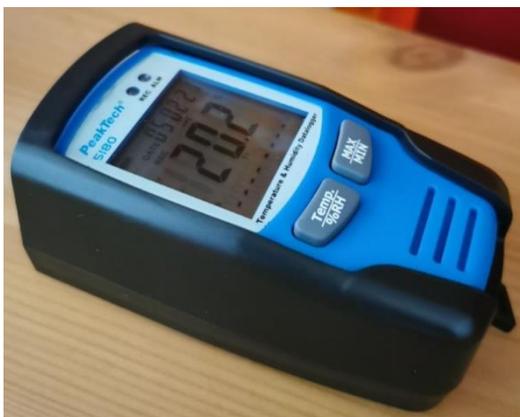
PeakTech 5180, Figure 3.22, can store up to 67 000 readings per measurements with a sampling rate that can be specified between 1 second and 12 hours. Its battery is dependent on the settings but is according to the producer capable of gathering data for 3 months with a sampling rate of five seconds.

Figure 3.22 - PeakTech 5180 logger. Photo by Kris A. Flaskerud

Both loggers operate with similar accuracy with respect to temperature of ± 2 °C for the intervals of -40 to -10 °C and 40 to 70 °C, and ± 1 °C for -10 to 40 °C. For the relative humidity, Extech RHT10 indicates an accuracy of ± 3 % for all values, while PeakTech 5180 differentiate with ± 3 % (40-60 %), ± 3.5 % (20-40 % and 60-80 %) and ± 5 % (0-20 % and 80-100 %).

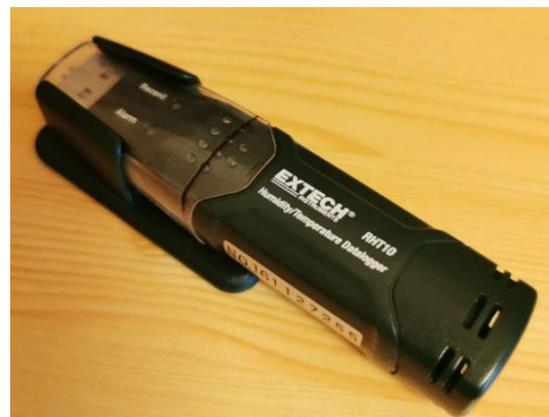
Extech RHT10, Figure 3.23, got a more limited memory compared with PeakTech 5180 but got longer battery life. More specifically it can store up to 16 000 readings over a period of approximately one year.

Figure 3.23 - Extech RHT10 logger. Photo by Kris A. Flaskerud

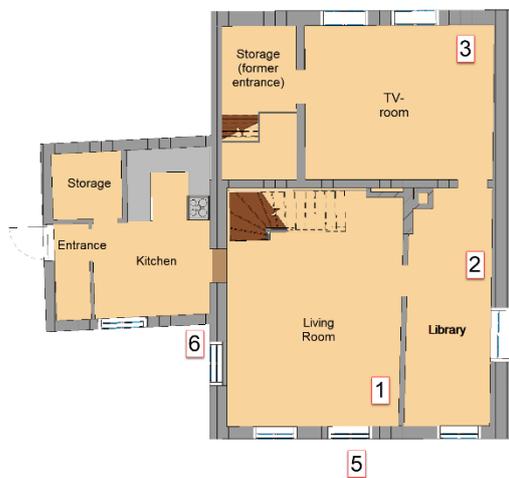
The position of all six loggers is illustrated in Table 3-2, Figure 3.24 and Figure 3.25. All of the loggers indoors are placed in a position where they are above medium height in their respective rooms, while the loggers outside are completely or partially shaded from direct sunlight. All loggers are specified with a sampling rate of 300 seconds (5 minutes).

Figure 3.24 - 1st floor, location of loggers

Nr.	Room
1	Living room
2	Library
3	TV-room
4	Recreational room
5	West façade
6	North façade

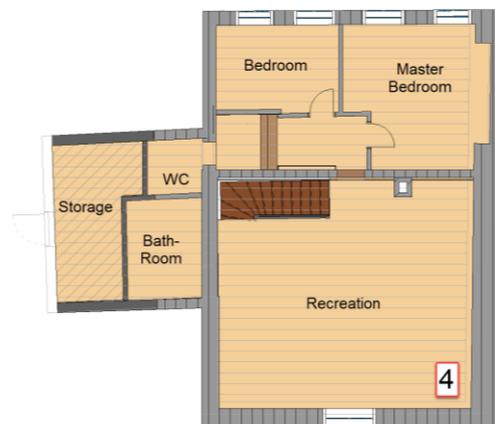
Figure 3.25 - 2nd floor, location of loggers

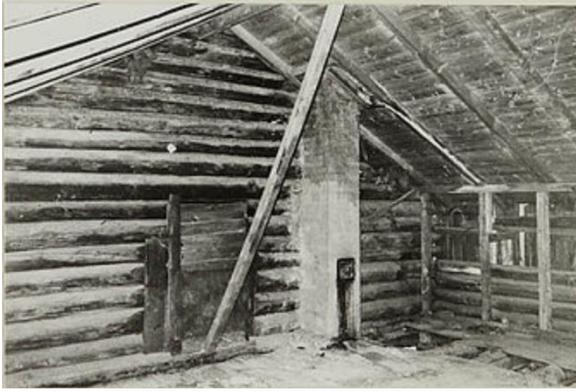
- The first photographs available in the archives is traced back to 1969. The condition of Bentegården seems to be poor observing Figure 4.3 and Figure 4.4.
- On both floors supports are mounted to the roof beams as some of the loadbearing seems to be in a very bad condition.
- The window on the south façade is sealed. Besides this, the rest of the windows seems to be the same as the ones present today.

Figure 4.3 - Interior side of the second floor. Date: 1969. Published with permission from Vestfold and Telemark County

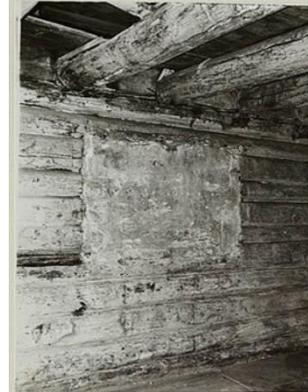
Figure 4.4 - Interior side of the south facade seen from the library. Date: 1969. Published with permission from Vestfold and Telemark County

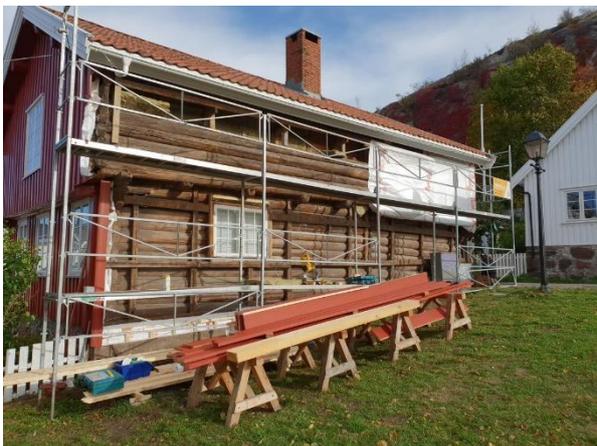
- The cladding on the west façade got replaced or repaired together with installation of exterior insulation in 2017.
- The cladding on the south façade got replaced or repaired together with installation of exterior insulation in 2018. Figure 4.7 is a photograph from the rehabilitation period, while Figure 4.8 presents the rehabilitation work finished.
- The wall's irregularities were not adjusted to keep the buildings originality.

*Figure 4.7 - During rehabilitation work. Date: 2018.
Published with permission from Vestfold and Telemark County*

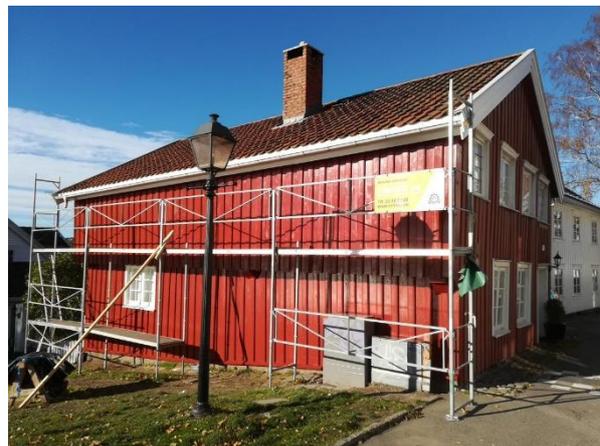
*Figure 4.8 - Rehabilitation work finished. Date: 2018.
Published with permission from Vestfold and Telemark County*

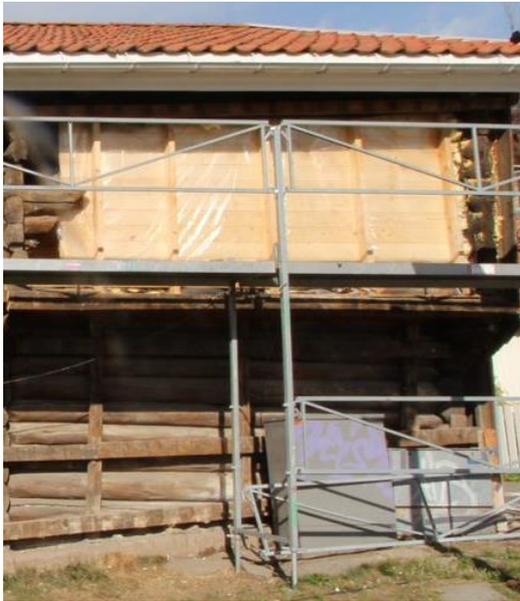
In addition to what has been mentioned in the above timeline, some measures are evident but not successfully traced to any documentations. Included in this is the removal of timber on the southern wall in the upstairs bedroom. It is not certain whether this is done to remove decayed timber or solely to make more room in the bedroom. Figure 4.9 and Figure 4.10 illustrate this area seen from the exterior and interior side.

Figure 4.9 Second floor on the south wall. Published with permission from Vestfold and Telemark County

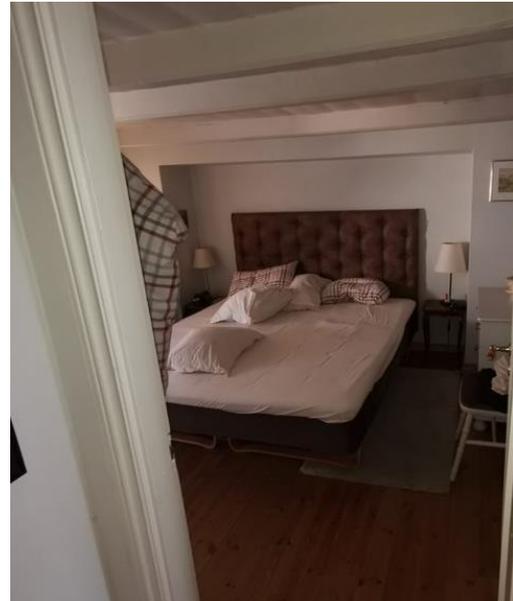
Figure 4.10 Main bedroom. Photo by Kris A. Flaskerud.

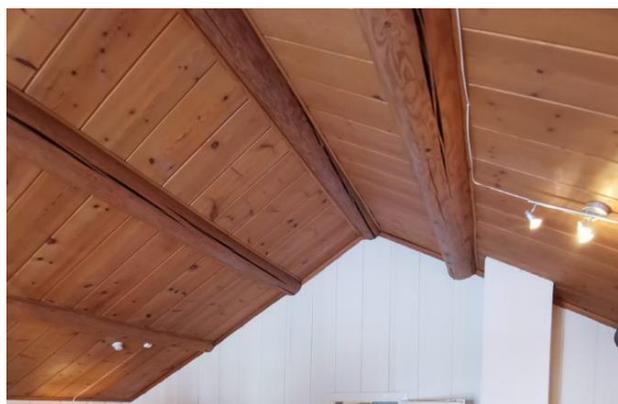
Another evident subject of renewal not documented in any known sources is the roof, illustrated in Figure 4.11. Although there are some visible cracks in the roof beams it can be characterized as being in relatively good shape based on visual observation.

Figure 4.11 Interior side of the roof. Photo by Kris A. Flaskerud

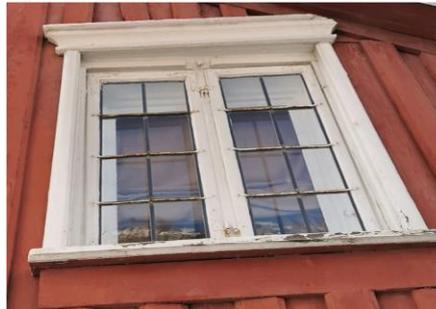
Figure 4.12 illustrates one of the windows on the east façade with its leaded window frame.

Figure 4.12 Second floor window on the east façade. Photo by Kris A. Flaskerud

The interior section of the windows however an additional layer of glass installed to improve the insulating properties without significantly altering the architectural features. This is the case for all windows in the building envelope.

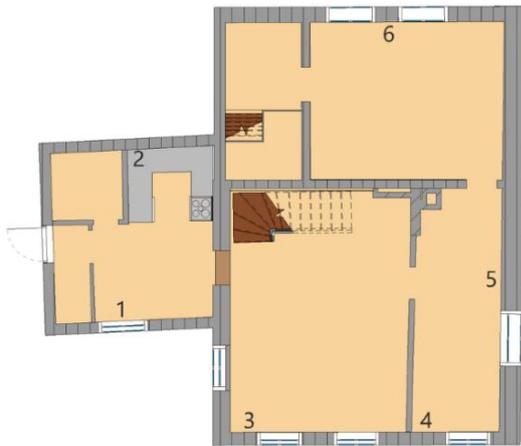
Table 4-1 and Table 4-2 shows the surface temperature measured for the walls marked with numbers according to Figure 4.13 and Figure 4.14.

Figure 4.13 Location of measurements 1st floor

Location	Surface temperature [°C]
1	13,2
2	12,2
3	18,4
4	17,5
5	21,2
6	16,0

Although naturally being affected by the heating within the living room, there are significantly higher measured surface temperatures on the walls where installation of exterior insulation is known to have been mounted (location 3-5 in Figure 4.13 and location 1 in Figure 4.14). The lowest surface temperatures are found in the extension based on the IR images in the kitchen area, referred to in Figure 4.13 as location 1 and 2.

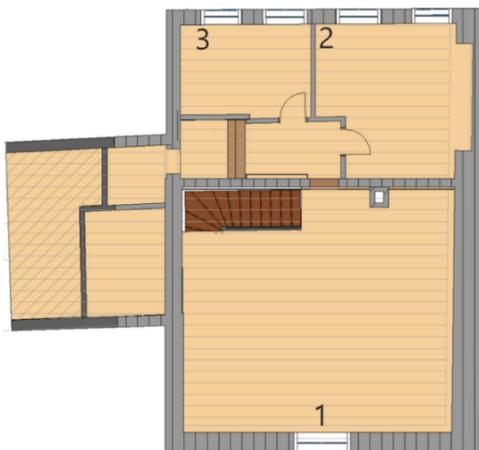
Figure 4.14 Location of measurements 2nd floor

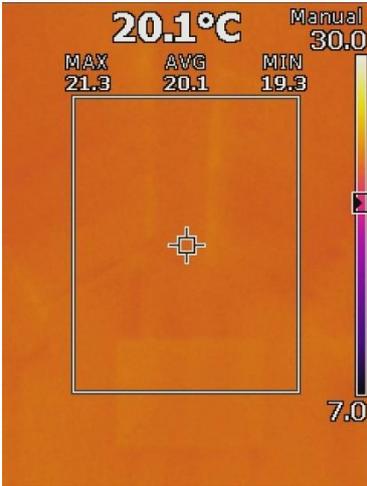
Other areas of the building envelope, including the roof illustrated in Figure 4.15 and the floor, here exemplified with a selection including IR-images from TV-room, library and living room is shown in Figure 4.16, Figure 4.17 and Figure 4.18.

Figure 4.15 Thermographic image, roof 2nd floor

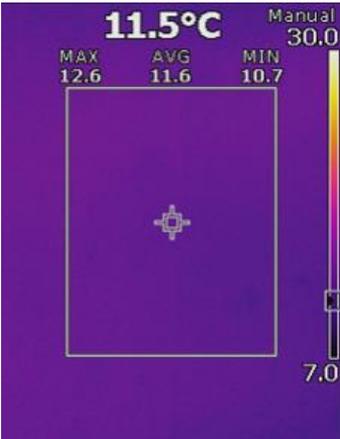
Figure 4.16 Thermography image floor, TV-room

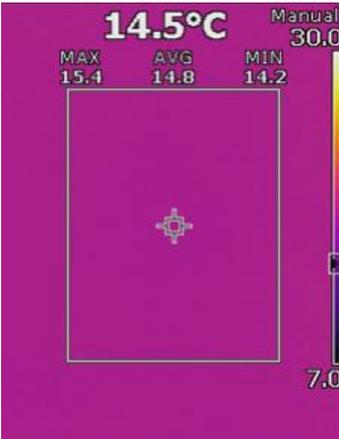
Figure 4.17 Thermography image floor, library

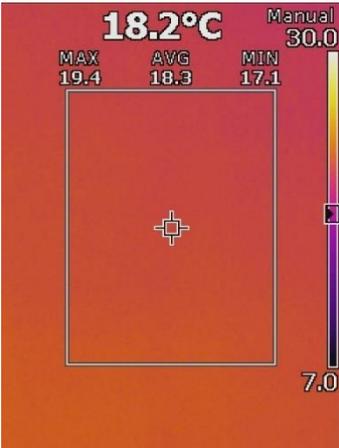
Figure 4.18 Thermography image floor, living room

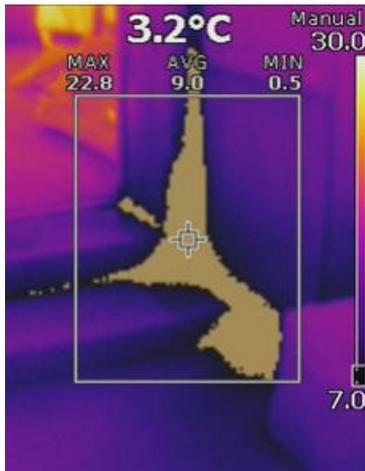
Evidently, large heat losses are occurring through the windows, especially in the kitchen and the east façade. This is exemplified in Figure 4.19, Figure 4.20 and Figure 4.21, which are captured in the kitchen, TV-room and bedroom, respectively.

Figure 4.19 Thermography image window, kitchen

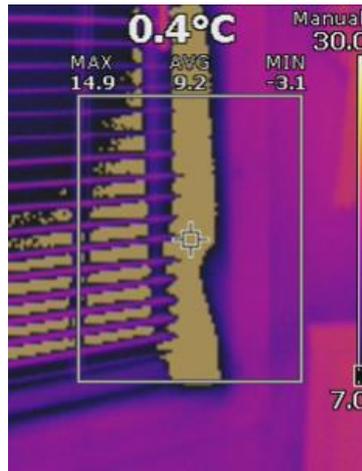
Figure 4.20 Thermography image window, TV-room

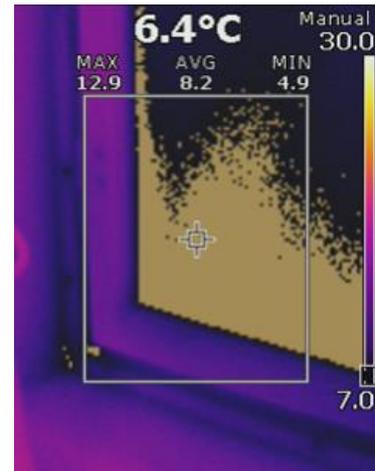
Figure 4.21 Thermography image window, bedroom

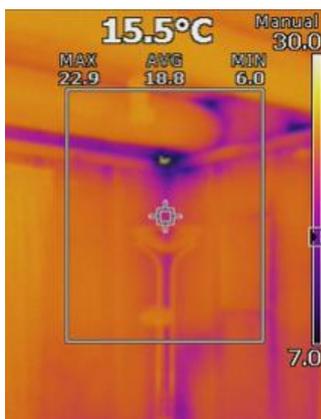
The most notable thermal bridges are located in the living room, library and the recreational room. Additionally, there are major occurrences in the rooms within the extension. This is exemplified by the thermal images illustrating the thermal bridges. Figure 4.22, Figure 4.23 and Figure 4.24 present the north-western corner of the living room, the southwestern corner of the library and the south-west corner of the recreational room, respectively.

Figure 4.22 Thermal bridges captured in the north-west corner of living room

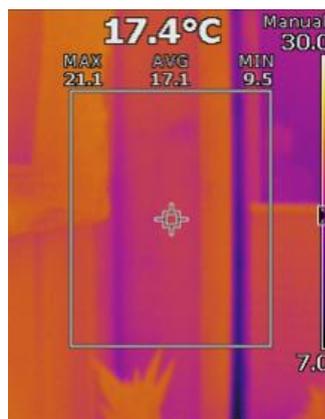
Figure 4.23 Thermal bridges captured in the south-west corner of the library

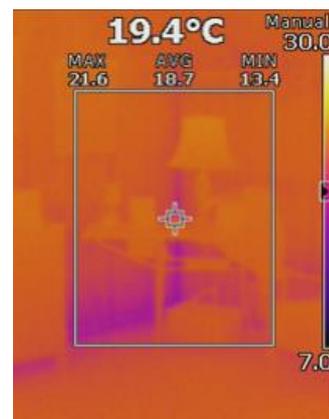
Figure 4.24 Thermal bridges captured in the south-west corner of the recreational room

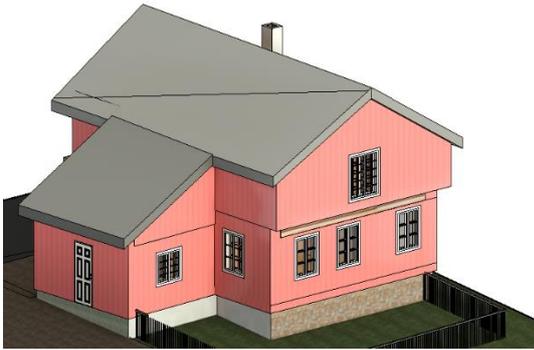
The point cloud data has been utilized according to the description in chapter 3.4, resulting in a Revit model with accurate dimensions. Figure 4.25 shows the building in Revit and Figure 4.26 shows the building after rendering, while Figure 4.27 and Figure 4.28 illustrates the first and second floor.

Figure 4.25 Revit model - 3D view

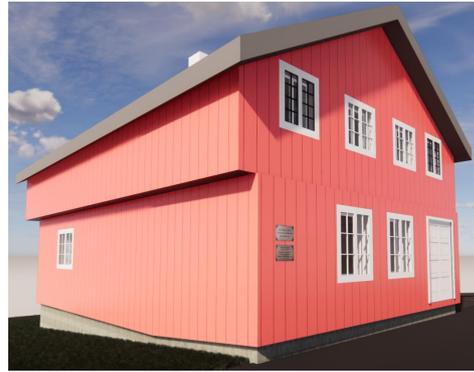
Figure 4.26 Rendered model - 3D view

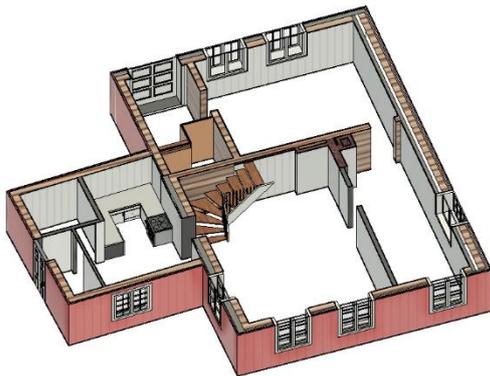
Figure 4.27 Section view of the first floor

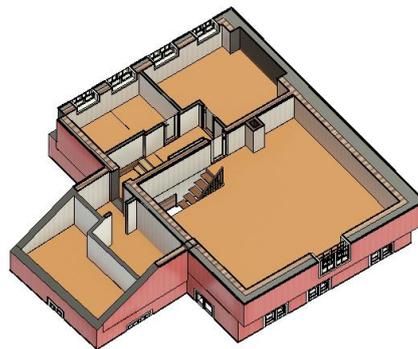
Figure 4.28 Section view of the second floor

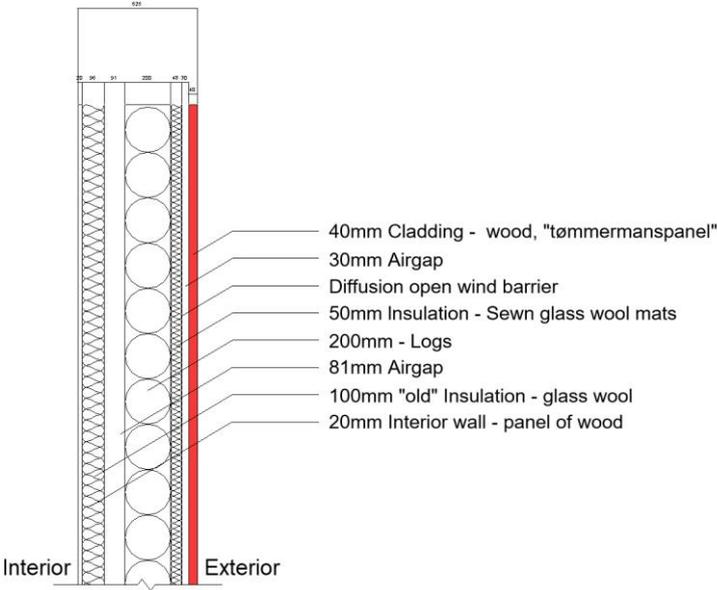
Figure 4.29 has been included to show a more detailed drawing, presented with the south wall of the first floor. The wall assembly illustrates the exterior wall from the right side towards the interior side on the left side. The cladding is marked with a red colour, while the air layers have no pattern. The exterior insulation with sewn mats is illustrated with a small cross-grid and the interior insulation have a larger cross-grid. The vertically positioned circles identify the logs and the panel on the left side is the interior surface.

Figure 4.29 Detail drawing of the south wall

The thickness from interior panels to exterior claddings varies between the different walls and floors. It is also evident that some walls are sloping both vertically and horizontally. This has not been included in the model. Another neglect is the polar foam described in the TIMBER report, as it is expected to not have any significance today.

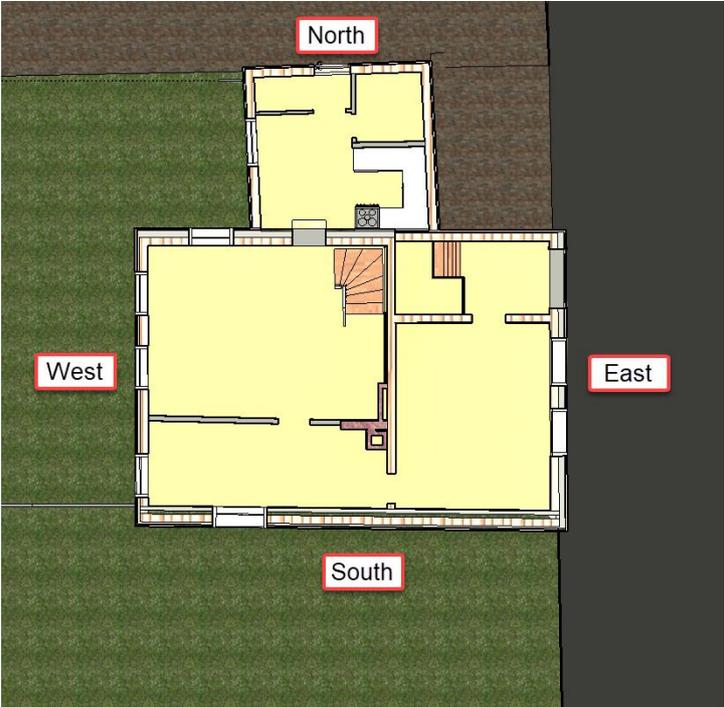
Figure 4.30 presents a capture from the digital model of Bentegården seen from above marked with the orientation of the facades. To clarify, this image is only for illustrative purposes, meaning that it is not orientated with true north.

Figure 4.30 Bentegården from above. This illustration is not oriented towards true north.

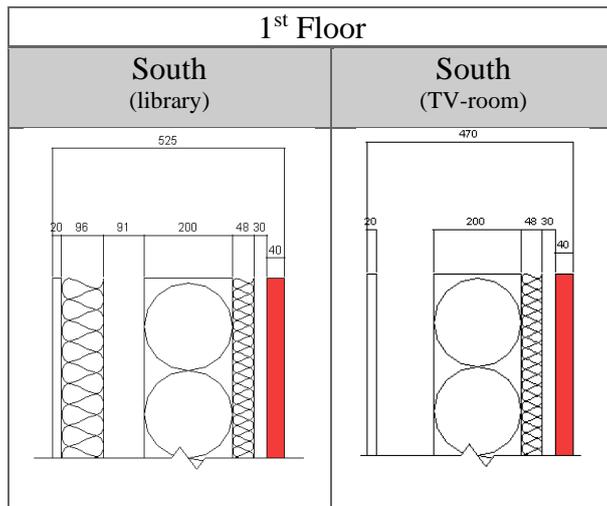
Table 4-4 1st floor wall assemblies Table II

Table 4-3 and Table 4-4 represents the wall assemblies of the first floor of Bentegården. The second-floor wall assemblies are illustrated in Table 4-5 and Table 4-6. While the extended part of Bentegården is presented with figure Table 4-7. All the assemblies are illustrated with the interior surface to the left and the exterior surface to the right.

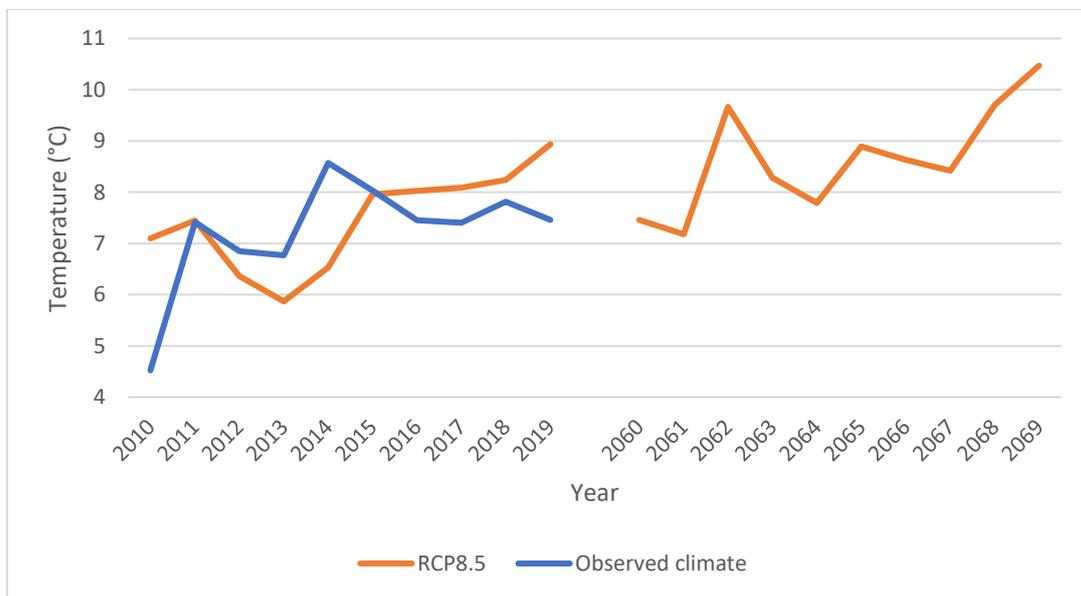
The following representation illustrates the climate parameters of temperature (Figure 4.31), relative humidity (Figure 4.32) and precipitation (Figure 4.33) for the current and future climate, where blue is the RCP8.5-model and red represent the data gathered from weather stations.

Figure 4.31 Annual temperature, observed climate data and RCP8.5
