Master's Degree in
Structural Engineering and Building Technology
Department of Civil Engineering and Energy Technology

MASTER THESIS

<p>THESIS TITLE</p> <p>Hygrothermal performance of thermally upgraded log walls of an in-use cultural heritage building from the 17th century based on current and future climate scenario</p>	<p>DATE</p> <p>09.06.2021</p>
	<p>NUMBER OF PAGES</p> <p>110 + 32</p>
<p>AUTHOR(S)</p> <p>Sindre Didrichsen Kris Anders Flaskerud</p>	<p>SUPERVISOR(S)</p> <p>Dimitrios Kraniotis</p>

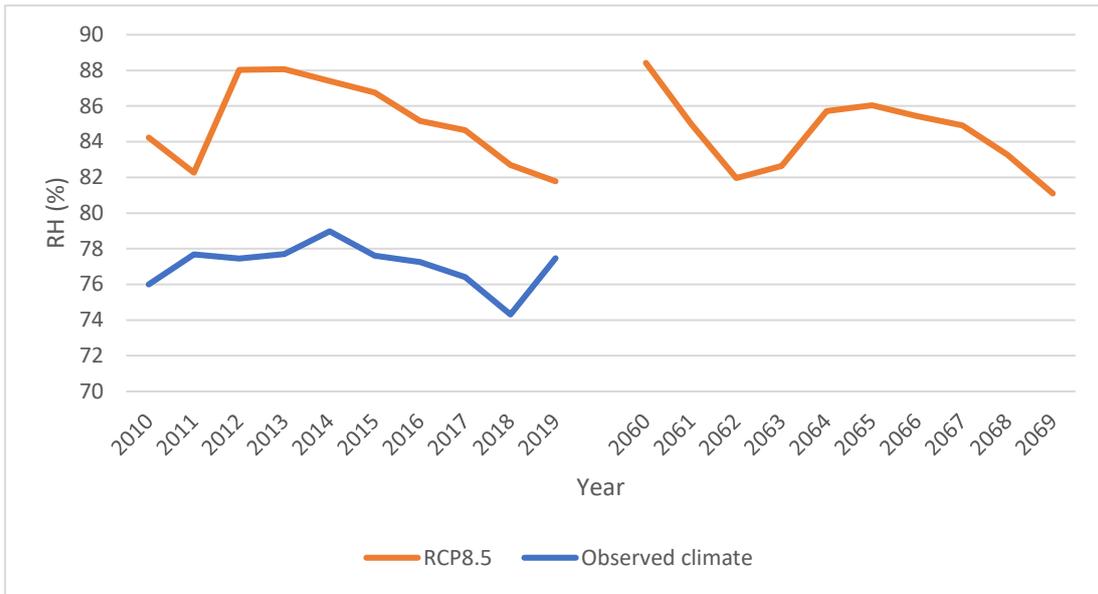
The following representation illustrates the climate parameters of temperature (Figure 4.31), relative humidity (Figure 4.32) and precipitation (Figure 4.33) for the current and future climate, where blue is the RCP8.5-model and red represent the data gathered from weather stations.

Figure 4.32 Annual RH, observed climate data and RCP8.5

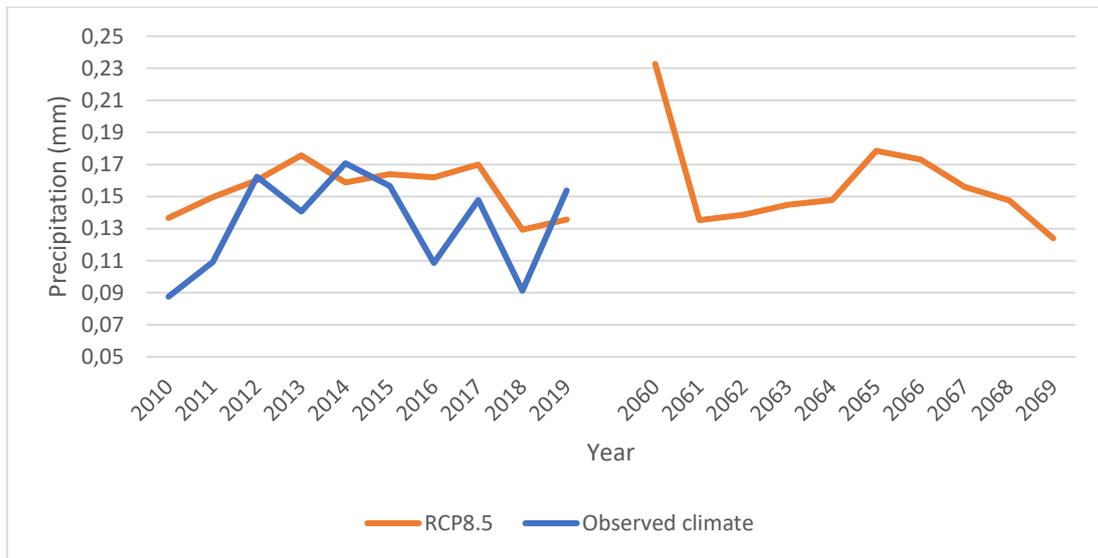
Figure 4.33 Annual precipitation, observed climate data and RCP8.5

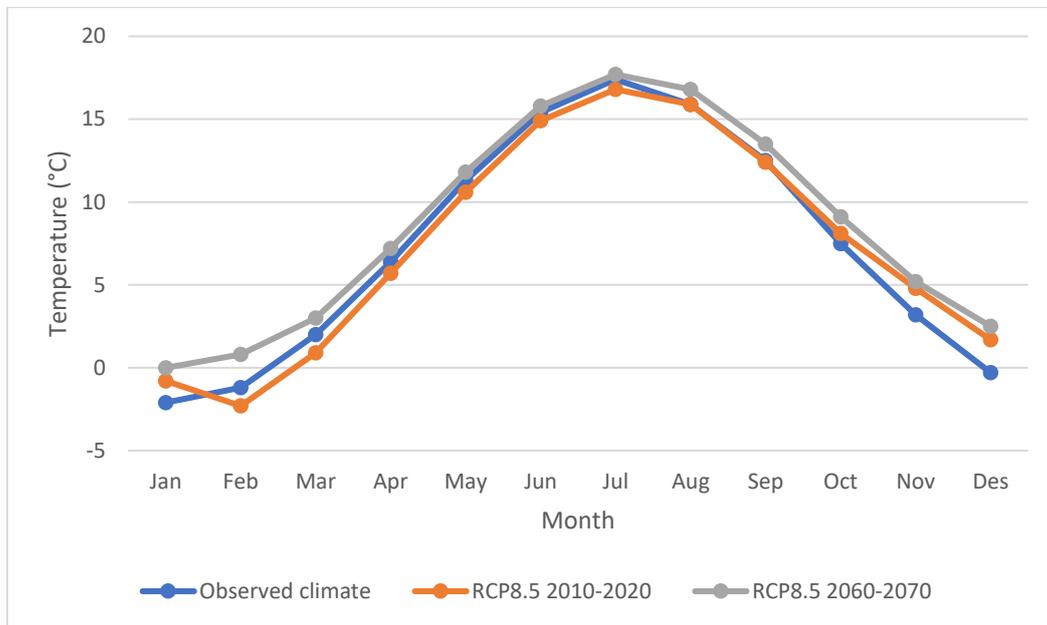
Figure 4.34 illustrates the monthly average temperature for the three individual sets of climate data. When comparing the future climate according to RCP8.5 with the two sets of climate data from 2010-2020 the greatest temperature increase is present during the winter and the lowest during the summer.

Figure 4.34 Monthly average temperature, observed data and RCP8.5

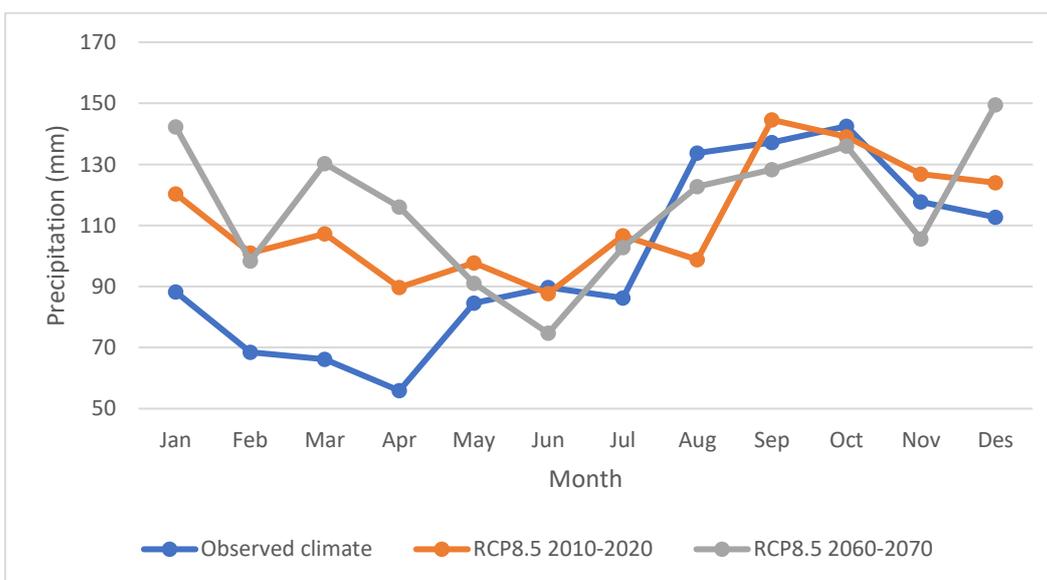
Figure 4.35 represents the average monthly precipitation for the different climate models. The graphs below suggest a drastic increase during the winter and spring when comparing current and future situation, especially for the measured climate data. The following seasons shows a more even or slightly reduced sum.

Figure 4.35 Monthly average precipitation, observed data and RCP8.5

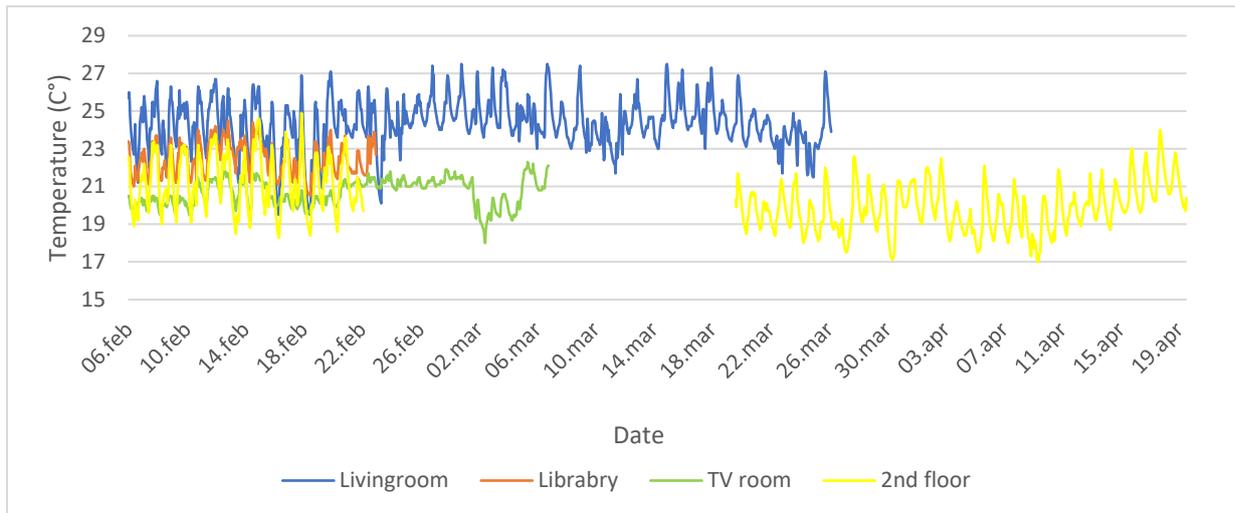
The graphical illustration in this chapter shows the data of which has been collected from the interior and exterior loggers mounted at Bentegården. To avoid the extreme values within the first hours of logging, the included values is set from midnight (00:00) on the following day (06.02). Figure 4.36 and Figure 4.37 shows the temperature and relative humidity from the four interior loggers, while Figure 4.38 and Figure 4.39 shows these values for the two exteriorly placed loggers.

Figure 4.36 Data from loggers inside, temperature

For the period of measuring, the indoor temperature can be considered rather high, especially in the living room which is caused by a lot of wood-burning from the residents. What is particularly worth noticing is the low values measured for the interior relative humidity.

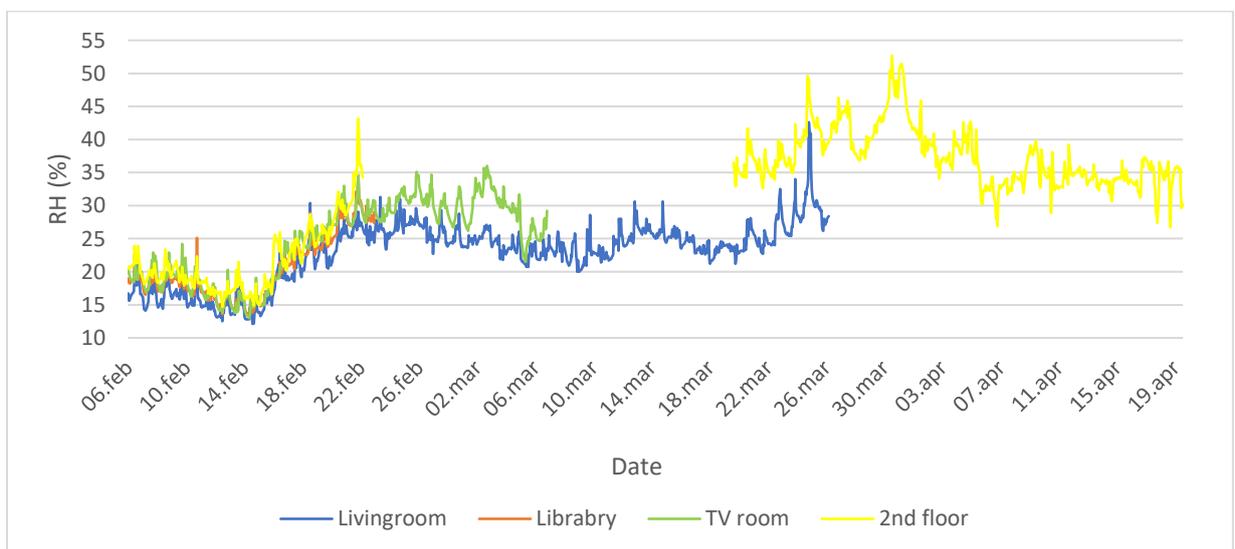
Figure 4.37 Data from loggers inside, relative humidity

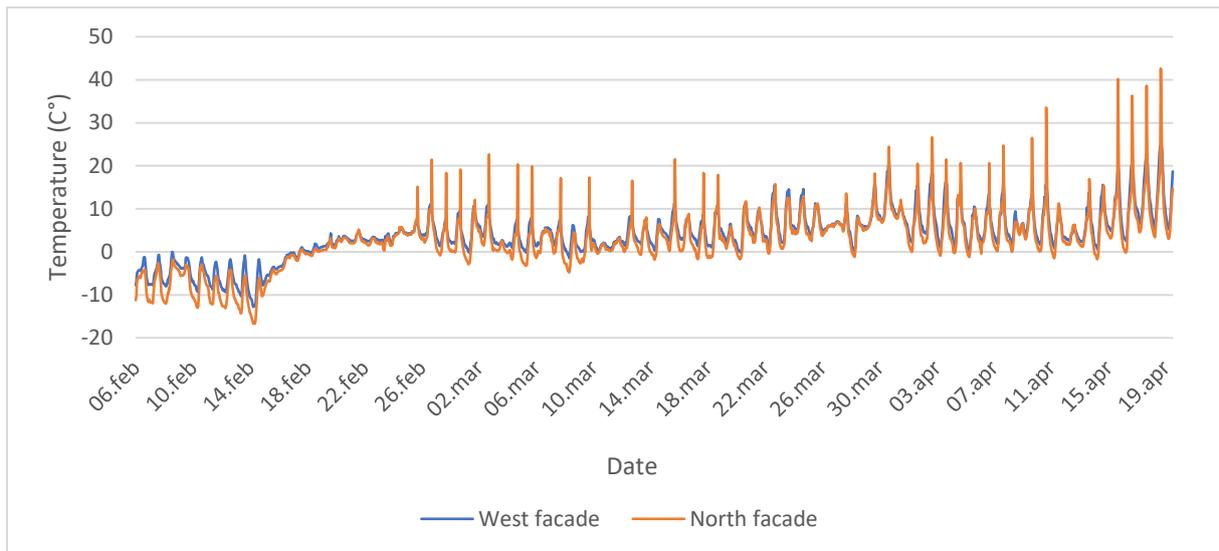
Figure 4.38 Data from loggers outside, temperature

The exterior logger mounted on the north façade is clearly affected by direct sunlight, causing very high temperatures for certain periods. The logger on the west façade however, represent the air temperature without any major peaks caused by direct sunlight and has been compared against data from Tønsberg gjestebrygge.

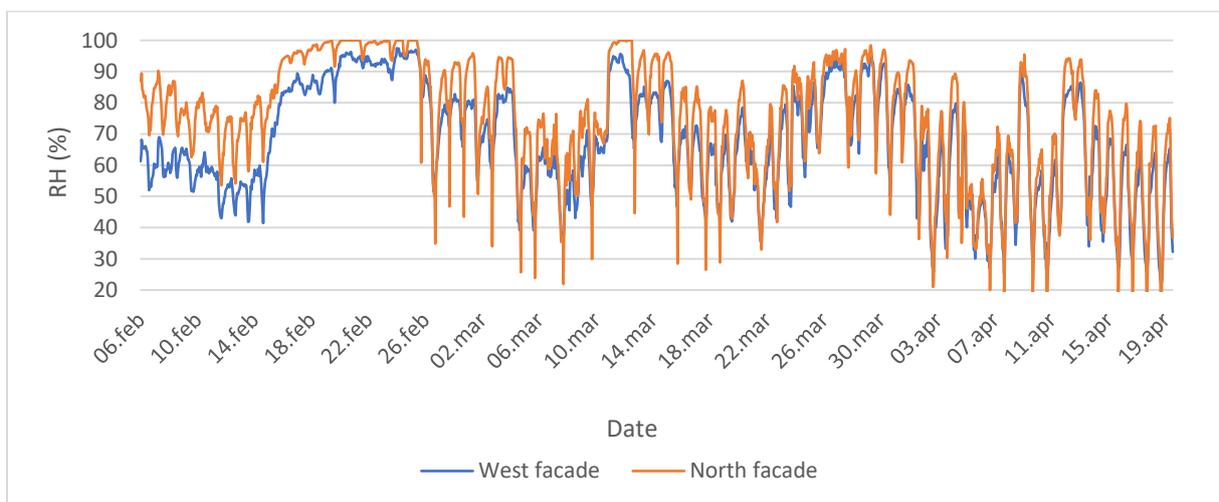
Figure 4.39 Data from loggers outside, relative humidity

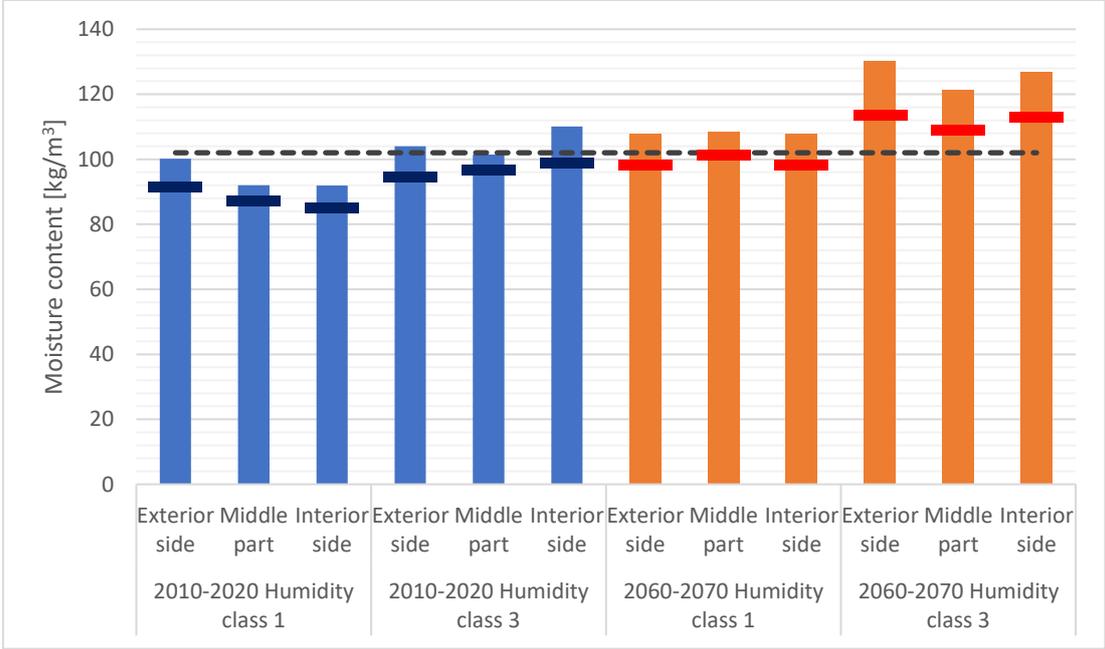
Figure 4.40 presents the moisture content of wall assembly 1. Wall assembly 1 in current climate using humidity class 1 have a moisture content below 20 %. The median illustrates a typical moisture content of about 16-17 % with a downward trend towards the interior side. While investigating the same climate with humidity class 3 an upward trend is observed with a median of around 18-19 %.

The future climate with humidity class 1 illustrates a higher amount of moisture with all max values above 20 % moisture content and a median of 19-20 %. Humidity class 3 increase the median moisture content up to 21-22 %.

Figure 4.40 - Assembly 1 - moisture content

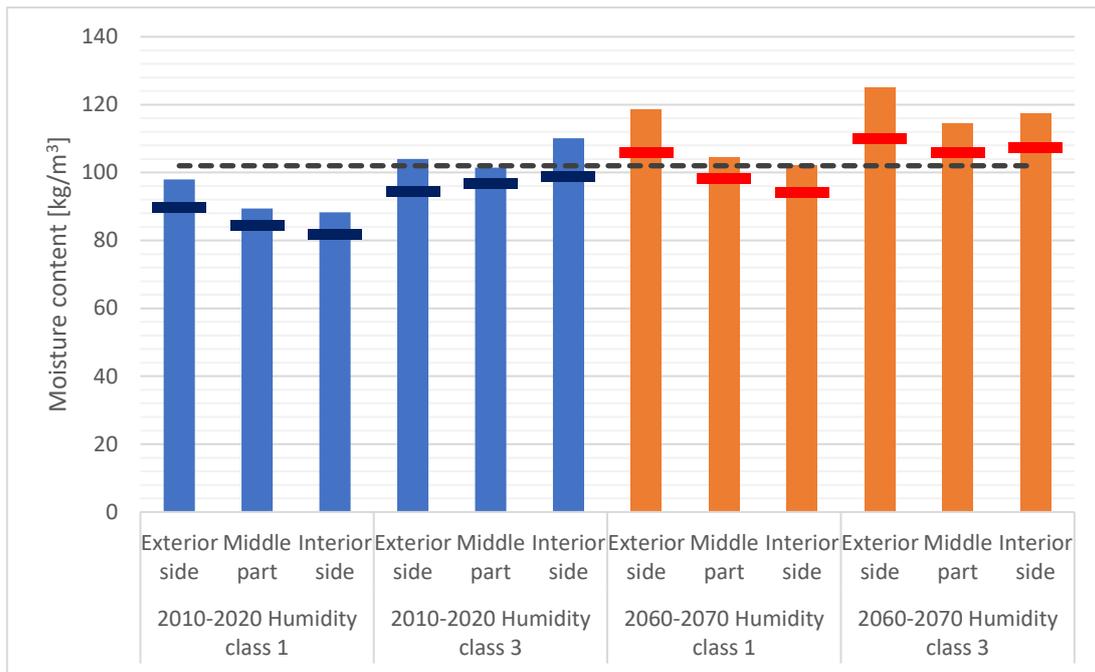
Figure 4.41 presents the moisture content of wall assembly 2. Wall assembly 2 with current climate and humidity class 1 have a maximum moisture content below 20%. The median illustrates a typical moisture content of 16-17 %, while humidity class 3 have a median of around 18-19 %.

Future climate and humidity class 1 shows higher values than observed climate and humidity class 1. The median moisture content of the exterior side is slightly above the critical limit with a median of 21 %. The middle and interior side, however, is lower. Furthermore, humidity class 3 have some higher values with a median between 21-22 % for all layers.

Figure 4.41 Wall assembly 2 - moisture content

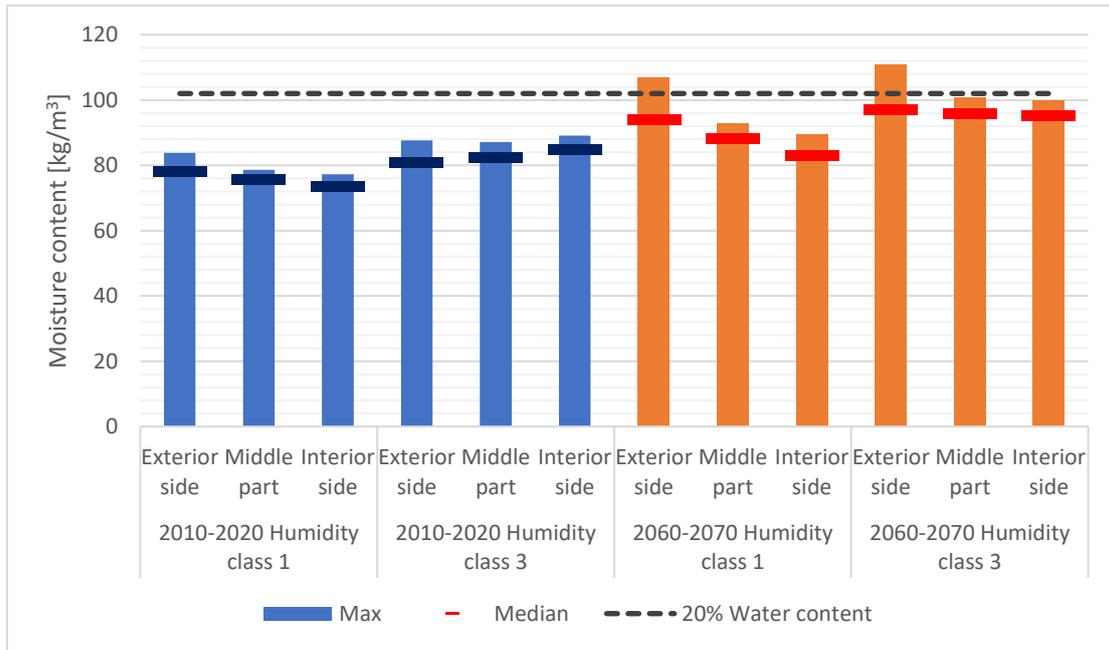
Figure 4.42 presents the moisture content of wall assembly 3. Wall assembly 3 with observed climate, simulated with both humidity class 1 and 3 have a moisture content well below 20 %. The median illustrates a typical moisture content of 14-15 %, while humidity class 3 have a median of around 16 %.

Future climate and humidity class 1 and 3 shows higher values than current climate. Humidity class 1 have a median moisture content of 16-18 % and humidity class 3 of 19 %.

Figure 4.42 Wall assembly 3 - moisture content

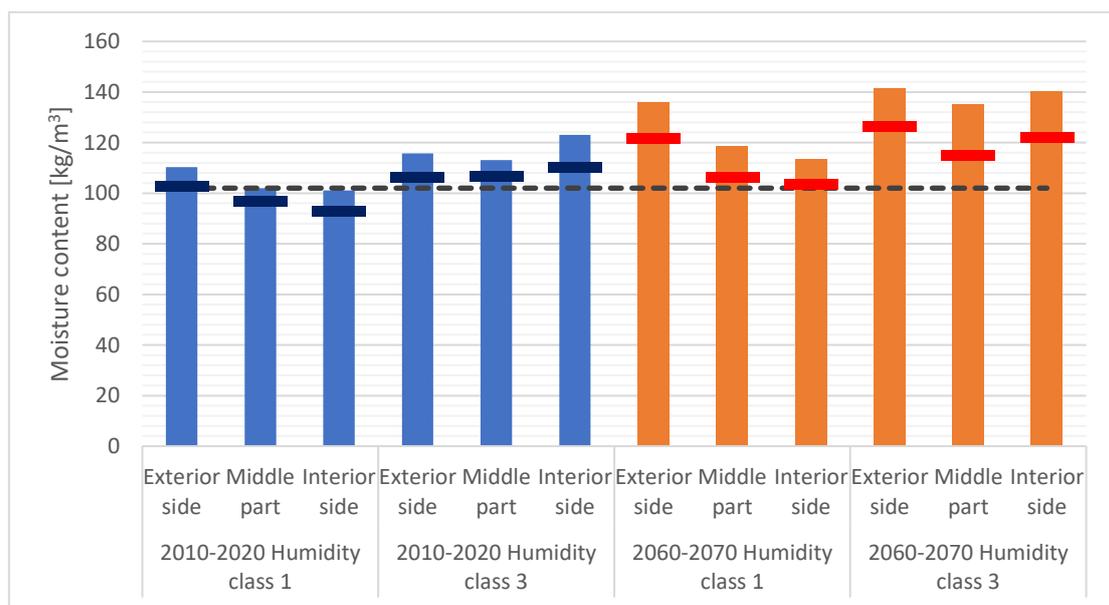
Figure 4.43 presents the moisture content of wall assembly 4. Wall assembly 4 with current climate and humidity class 1 got a median ranging from 19-20 %, while humidity class 3 results slightly above the critical value with a median of 21-22 %.

The future climate is above the critical value both with humidity class 1 and 3. Humidity class 1 have a median of 24 % on the exterior side and 20-21 % in the middle and interior side. Humidity class 3 have median values up to 24-25 % on the exterior and interior side.

Figure 4.43 Wall assembly 4 - moisture content

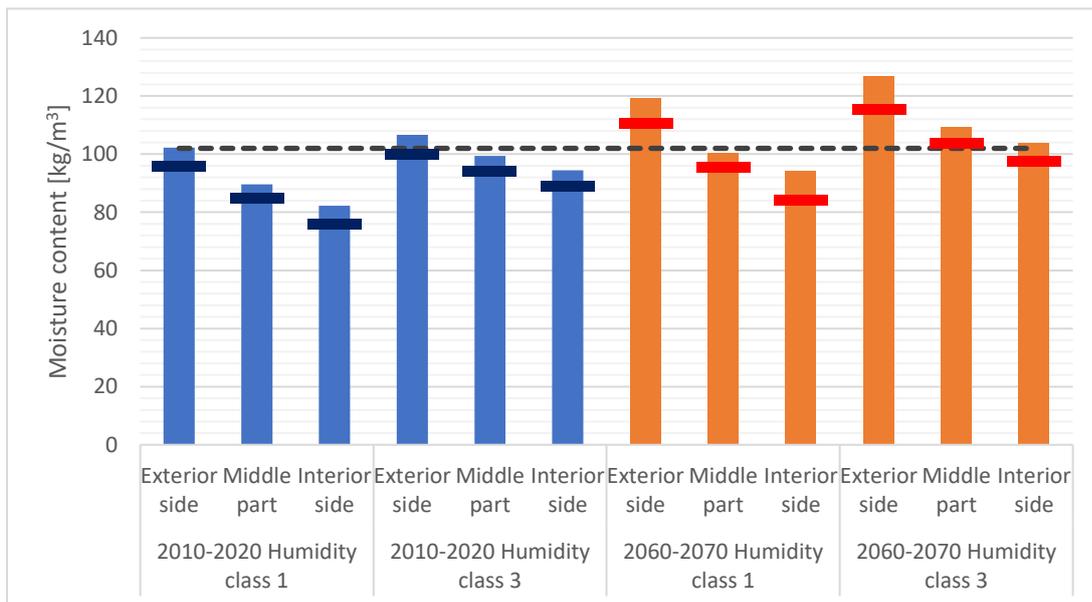
Figure 4.44 presents the moisture content of wall assembly 5. Wall assembly 5 with current climate and humidity class 1 and 3 have a moisture content below 20 % with a median value between 15 and 19 %.

The moisture content with future climate has higher values, where humidity class 1 have a median value on the exterior side of 21 %, while the middle part and the interior side is lower. The moisture content with humidity class 3 has a median value of 23 % on the exterior side, 20% in the middle part and slightly below 20 % on the interior side.

Figure 4.44 Wall assembly 5 - moisture content

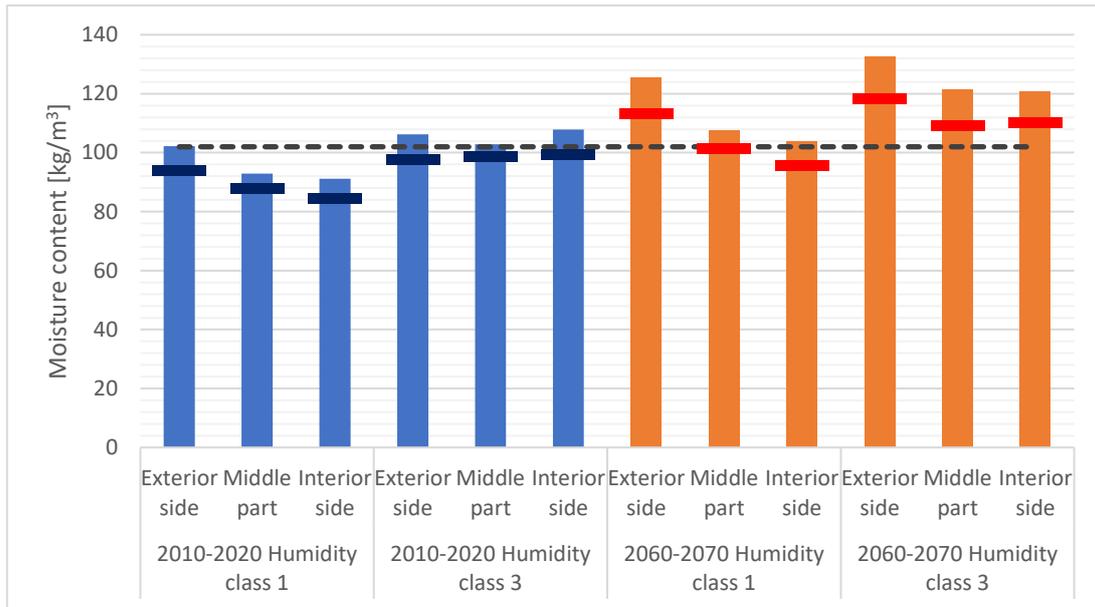
Figure 4.45 presents the moisture content of wall assembly 6. Wall assembly 6 with current climate have a median value of moisture content below the critical value. Humidity class 1 have a median value of 16-18 % while humidity class 3 is around 19 %.

The future climate and humidity class 1 has a median value of 22 % on the exterior side and 18-19 % on the middle part and interior side. Humidity class 3 have all values higher than the critical value and varies from 21-23 % with the highest value on the exterior side.

Figure 4.45 Wall assembly 6 - moisture content

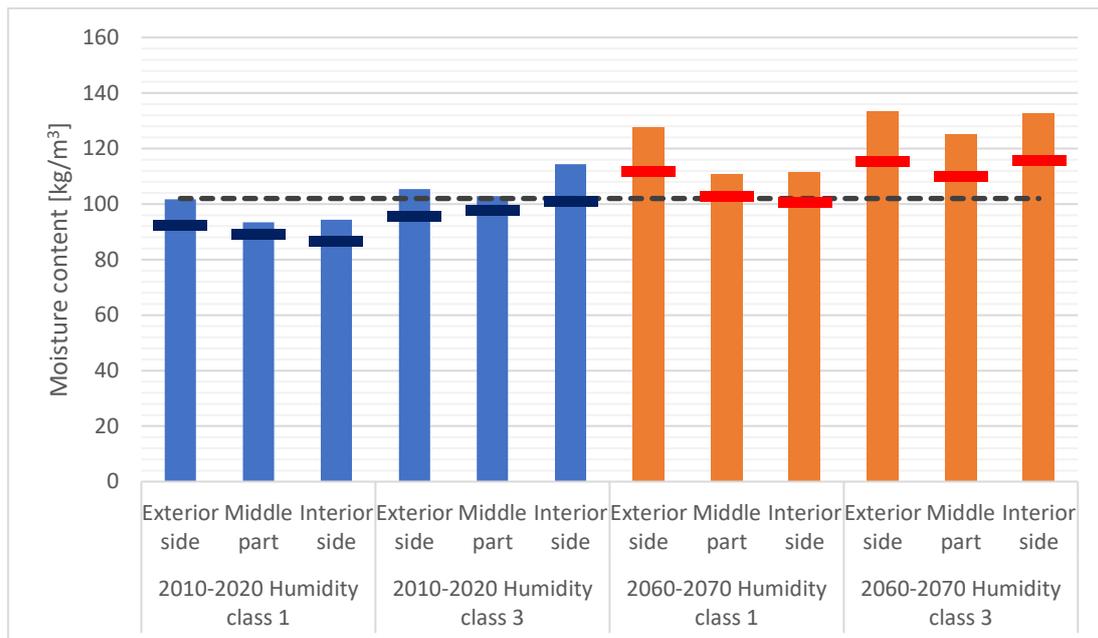
Figure 4.46 presents the moisture content of wall assembly 7. The moisture content in the wall assembly 7 with current climate, humidity class 1 has a median value of 17-18 %, while humidity class 3 have a median value of 19-20 %.

The moisture content with future climate has a median value of 20-22 % with the highest value on the exterior side of the logs. Humidity class 3 is fairly higher with a median value of 21-23 % and the highest values on the exterior and interior side of the logs.

Figure 4.46 Wall assembly 7 - moisture content

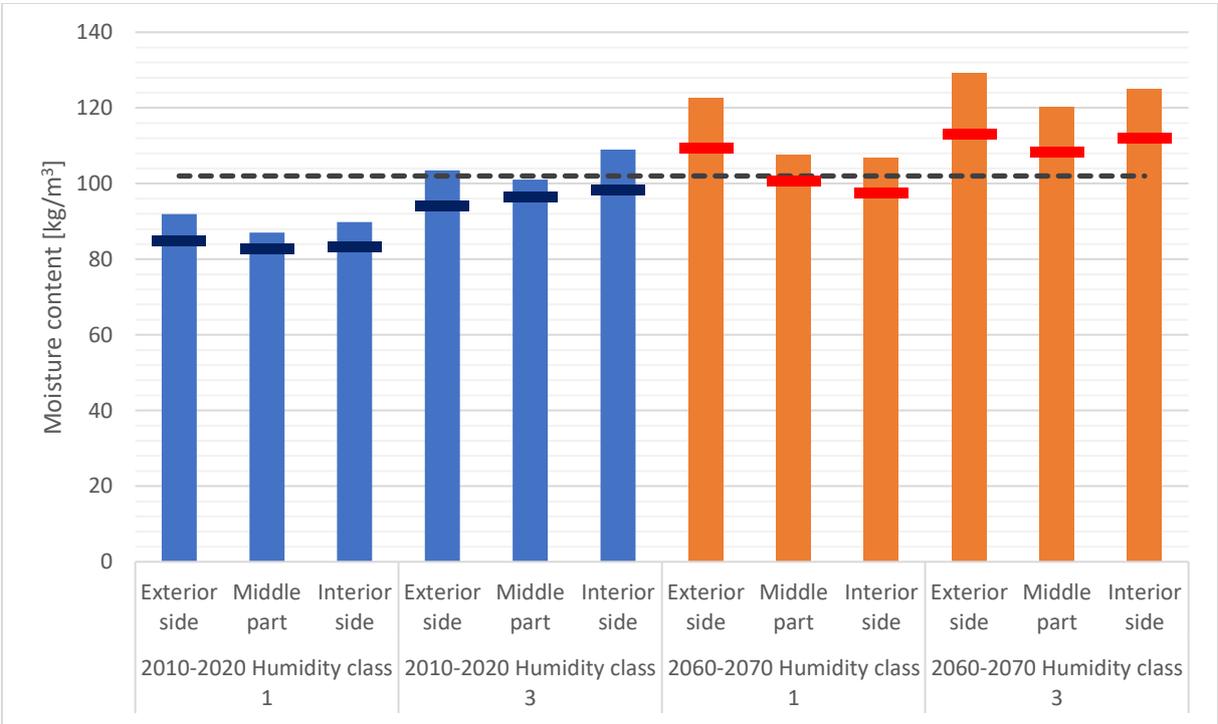
Figure 4.47 presents the moisture content of wall assembly 9. The moisture content of wall assembly 9 with current climate, humidity class 1 and 3 is below the critical value of 20 %. Humidity class 1 have a median value of 16 % while humidity class 3 have a value of 18-19 %.

The moisture content with future climate, humidity class 1 has a median value of 21 % on the exterior side and 19-20 % in the middle part and on the interior side of the logs. Humidity class 3 have a median value of 22 % on the exterior and interior side of the logs, where the middle part has a value of 21 %.

Figure 4.47 Wall assembly 9 - moisture content

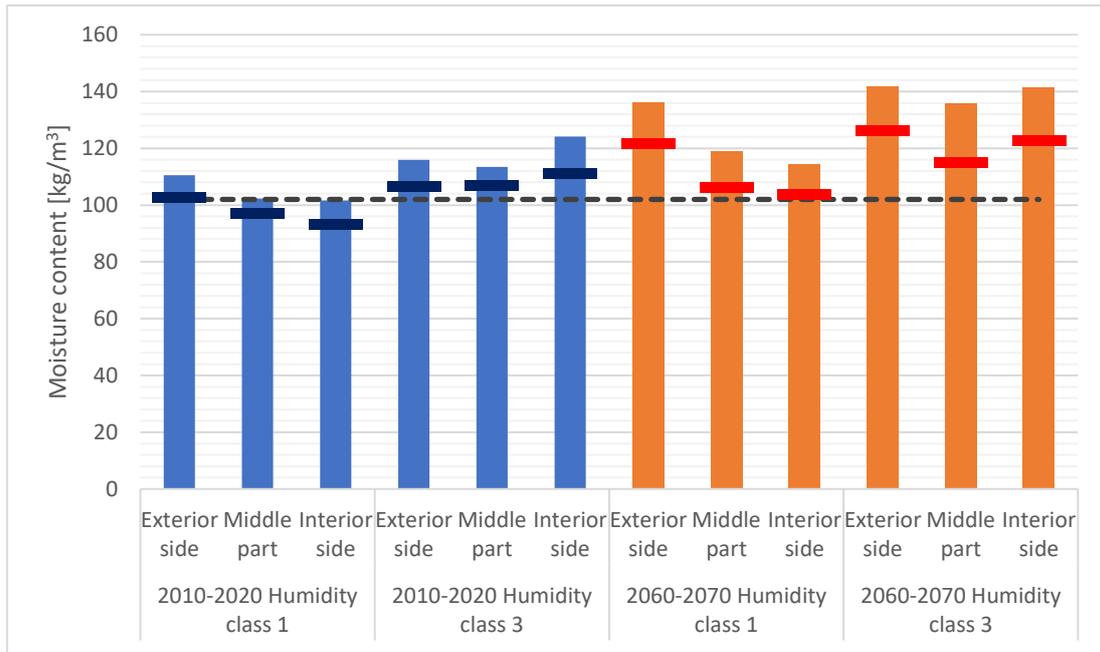
Figure 4.48 presents the moisture content of wall assembly 10. The current climate with humidity class 1 has a moisture content of up to 20 % on the exterior side, while the middle part and the interior side is slightly below.

The future climate with humidity class 1 has a moisture content up to a median value of 24 %, while the exterior side and the interior side is fairly lower. Humidity class 3 have a moisture content up to a median value of 25 %, where also the exterior side and interior side is a little lower.

Figure 4.48 Wall assembly 10 - moisture content

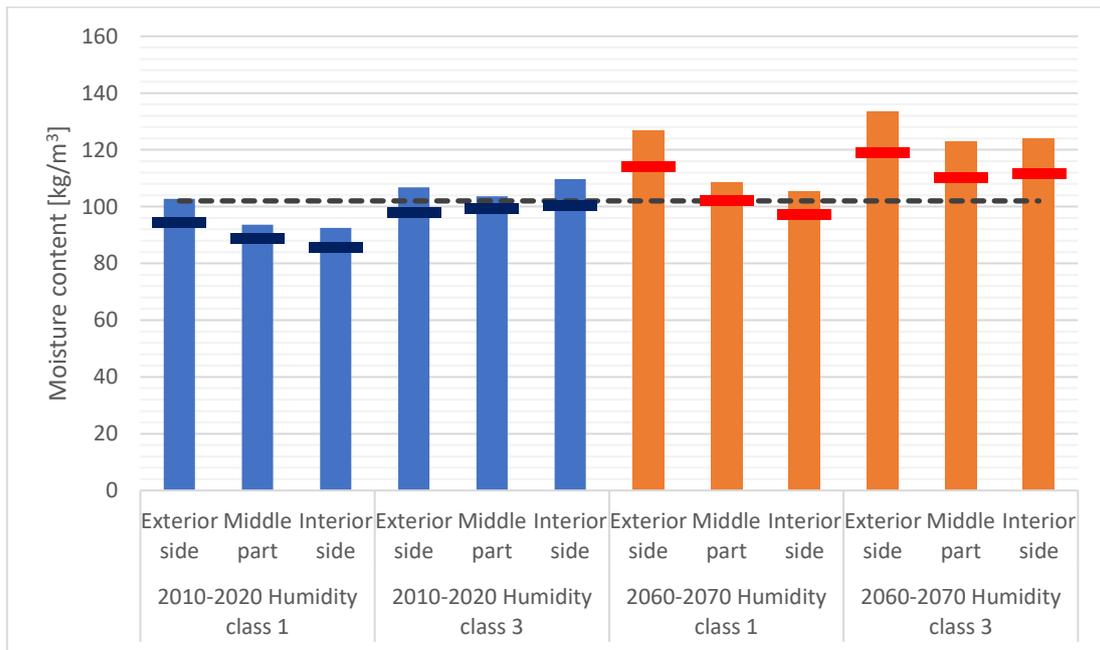
Figure 4.49 presents the moisture content of wall assembly 11. The current climate gives a moisture content below 20 % for both humidity class 1 and 3.

The future climate has a median value of up to 22 % in the middle layer of humidity class 1, while the middle layer of humidity class 3 is around 23 %.

Figure 4.49 Wall assembly 11 - moisture content

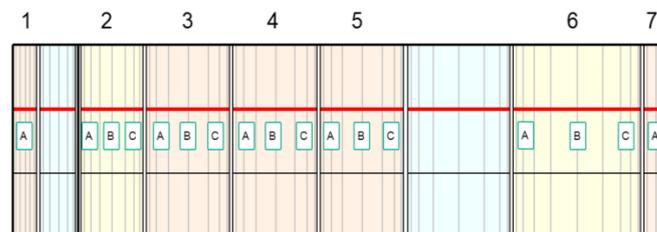
Figure 4.50 presents wall assembly 1 and its respective monitor positions. Figure 4.51 is the graph with humidity class 1, while Figure 4.52 is humidity class 3.

Figure 4.50 Wall assembly 1, monitor position

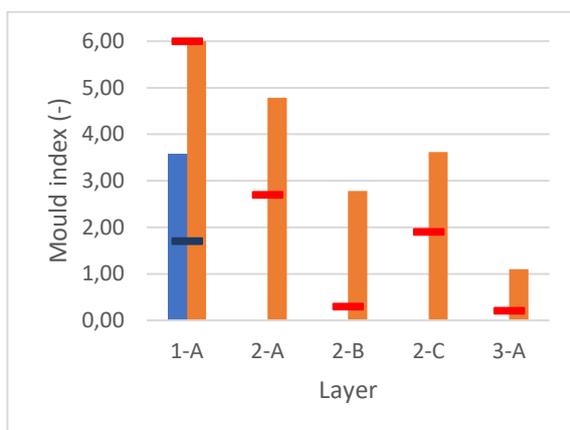
There is a minor difference between humidity class 1 and 3, where humidity class 3 have slightly higher values. The difference from year 2010 to 2020 and 2060 to 2070 is significant with critical values within several layers. The exterior side of the log structure is at yellow colour according to the traffic light indicator with future climate.

Figure 4.51 Mould index, humidity class 1, assembly 1

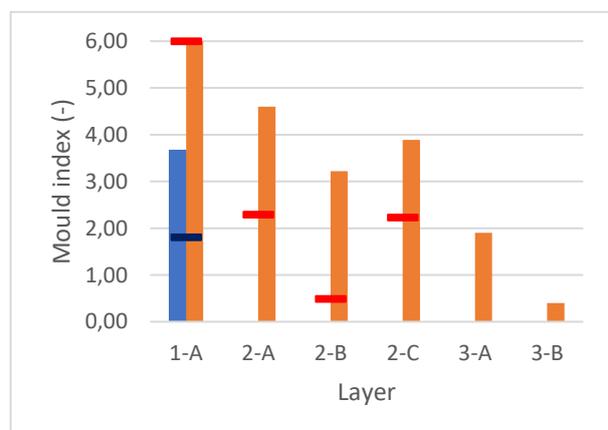
Figure 4.52 Mould index, humidity class 3, assembly 1

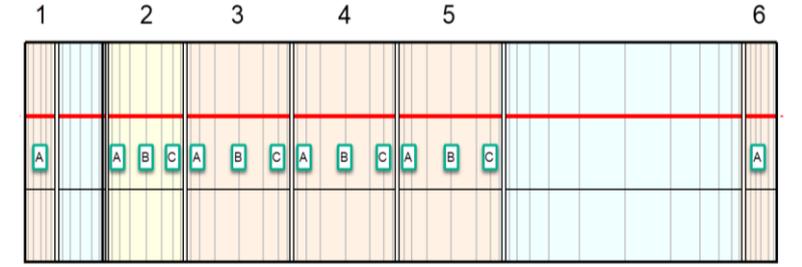
Figure 4.53 presents wall assembly 2 and its respective monitor positions. Figure 4.54 is the graph with humidity class 1, while Figure 4.55 is humidity class 3.

Figure 4.53 Wall assembly 2, monitor position

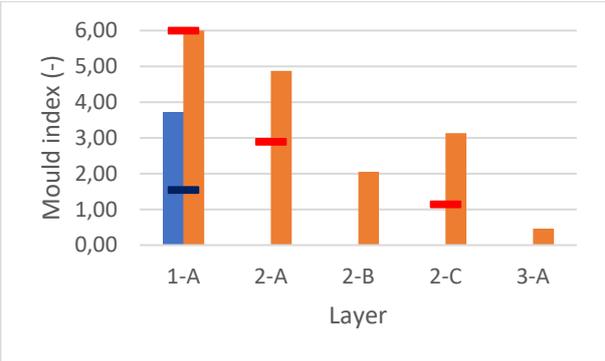
The first period from 2010 to 2020 for both humidity class 1 and 3 do not indicate any problems expect for the cladding. Future climate presents higher values and red traffic light indicator. The layer of logs is within the green indication.

Figure 4.54 Mould index, humidity class 1, assembly 2

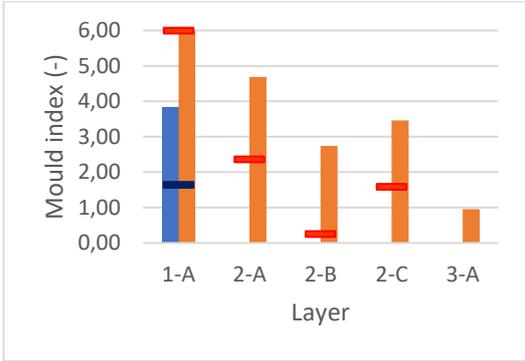
Figure 4.55 Mould index, humidity class 3, assembly 2

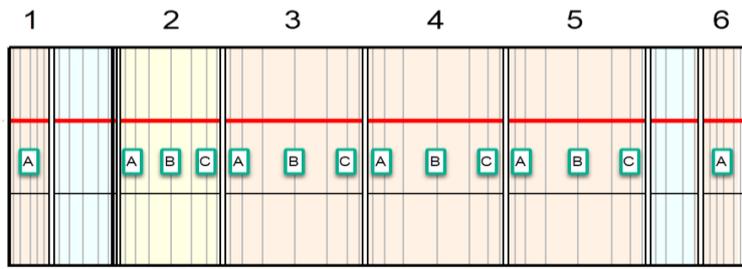
Figure 4.56 presents wall assembly 3 and its respective monitor positions. Figure 4.57 is the graph with humidity class 1, while Figure 4.58 is humidity class 3.

Figure 4.56 Wall assembly 3, monitor position

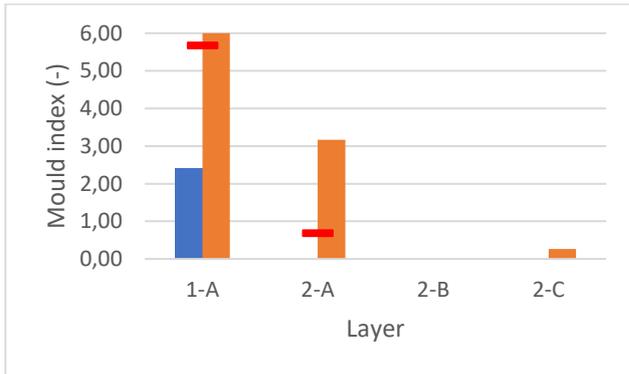
The traffic light indicator indicates no trouble within wall assembly 3 from 2010 to 2020, while values are higher with future climate. The exterior side of the insulation and cladding is within red indication, but not any other layer. Humidity class 3 shows fairly higher values than humidity class 1.

Figure 4.57 Mould index, humidity class 1, assembly 3

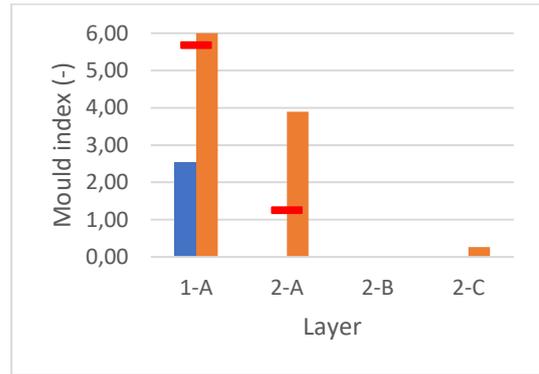
Figure 4.58 Mould index, humidity class 3, assembly 3

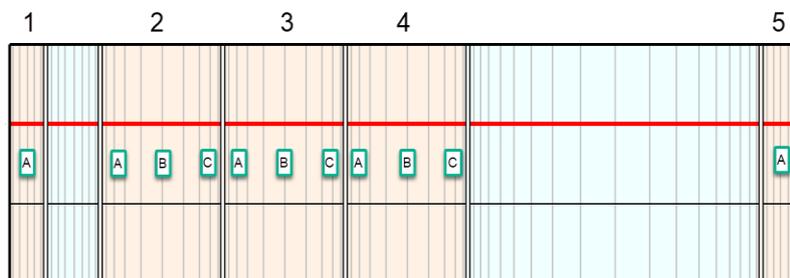
Figure 4.59 presents wall assembly 4 and its respective monitor positions. Figure 4.60 is the graph with humidity class 1, while Figure 4.61 is humidity class 3.

Figure 4.59 Wall assembly 4, monitor position

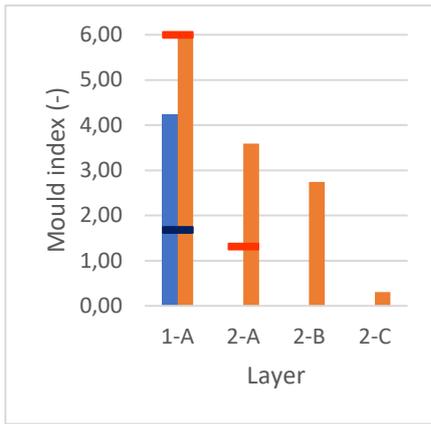
With climate from year 2010 to 2020 there is no problems within any layer expect for the cladding. However, year 2060-2070 and humidity class 1 show some trouble in the exterior part of the logs. Within the same year but with humidity class 3, it is at red or close to red traffic light indication in all layers.

Figure 4.60 Mould index, humidity class 1, assembly 4

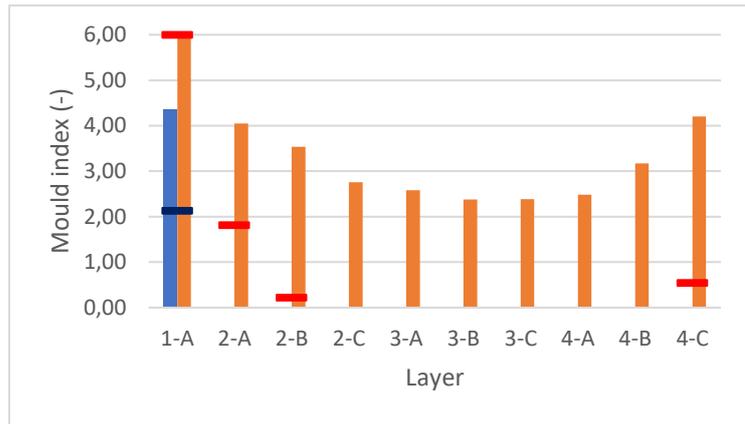
Figure 4.61 Mould index, humidity class 3, assembly 4

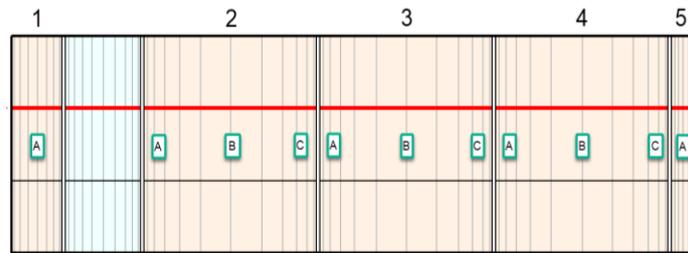
Figure 4.62 presents wall assembly 5 and its respective monitor positions. Figure 4.63 is the graph with humidity class 1, while Figure 4.64 is humidity class 3.

Figure 4.62 Wall assembly 5, monitor position

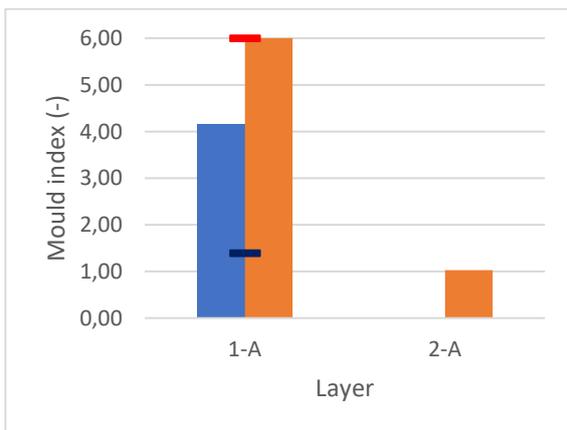
Wall assembly 5 is within green indication for both current and future climate within all layers except for the cladding.

Figure 4.63 Mould index, humidity class 1, assembly 5

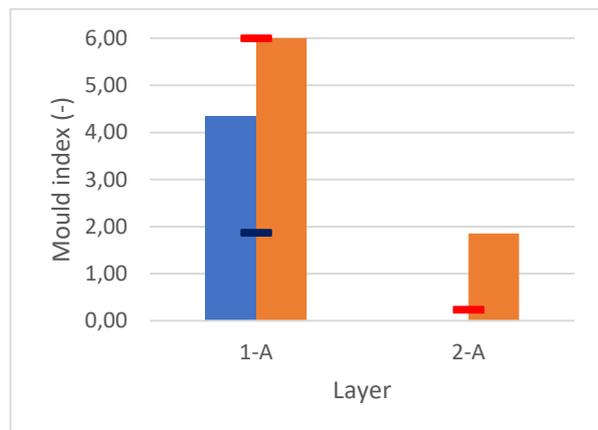
Figure 4.64 Mould index, humidity class 3, assembly 5

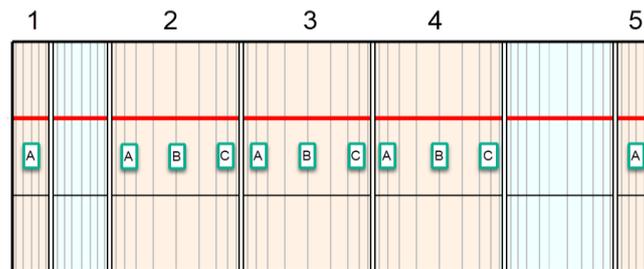
Wall assembly 6 results are similar to wall assembly 5 with all layers within green indication expect for the cladding.

Figure 4.65 Wall assembly 6, monitor position

Figure 4.65 presents wall assembly 1 and its respective monitor positions. Figure 4.66 is the graph with humidity class 1, while Figure 4.67 is humidity class 3.

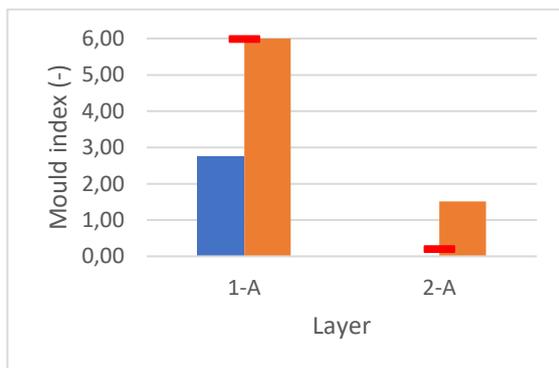
Figure 4.66 Mould index, humidity class 1, assembly 6

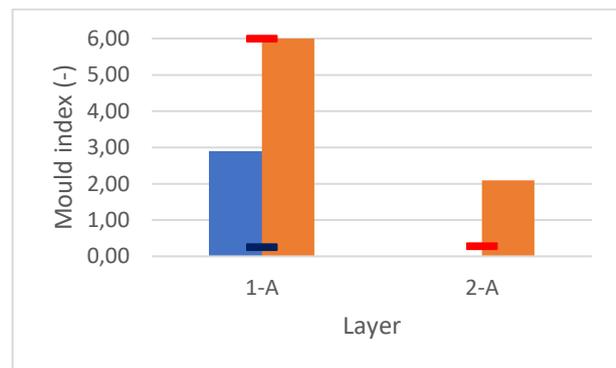
Figure 4.67 Mould index, humidity class 3, assembly 6

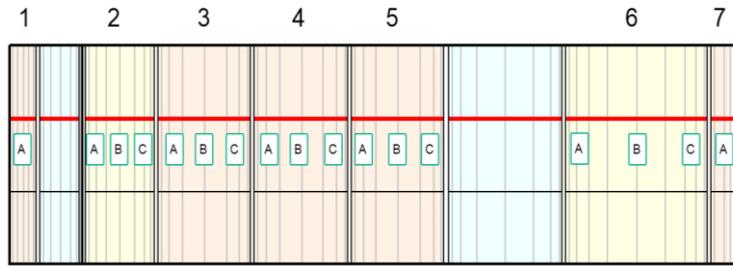
Figure 4.68 Wall assembly 7, monitor position

Figure 4.68 presents wall assembly 7 and its respective monitor positions. Figure 4.69 is the graph with humidity class 1, while Figure 4.70 is humidity class 3.

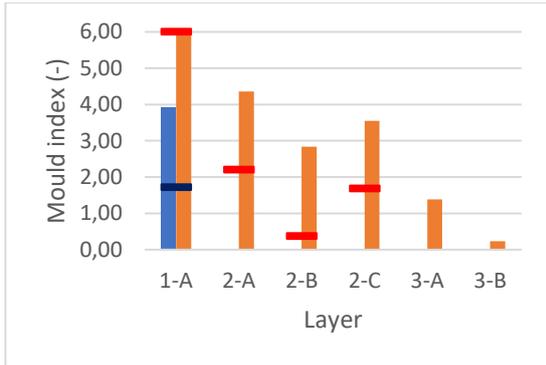
Assembly 7 show no problems within the layers from year 2010 to 2020 except the cladding while year 2060-2070 illustrates a higher risk. The insulation layer is at red indication and the exterior side of the logs mostly within green indication.

Figure 4.69 Mould index, humidity class 1, assembly 7

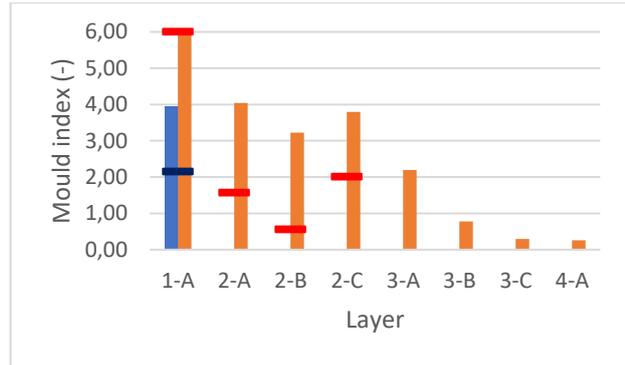
Figure 4.70 Mould index, humidity class 3, assembly 7

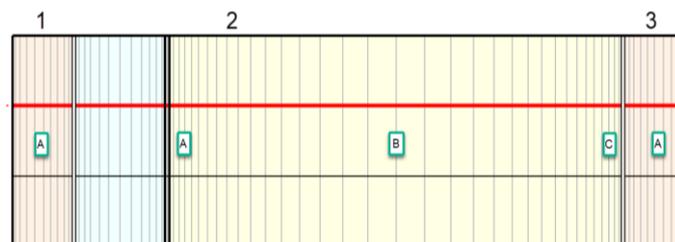
Figure 4.71 Wall assembly 8, monitor position

Figure 4.71 presents wall assembly 8 and its respective monitor positions. Figure 4.72 is the graph with humidity class 1, while Figure 4.73 is humidity class 3.

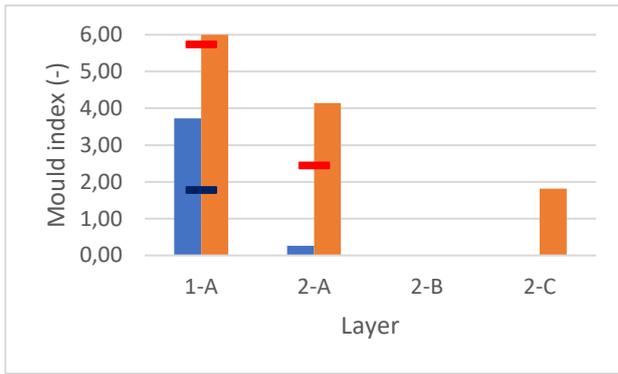
Assembly 8 with current climate and humidity class 1 only indicates problems with the cladding, while humidity class 3 potentially has problems with exterior side of the insulation. Simulations with future climate and humidity class 1 indicates potential problems with the cladding and exterior side of the insulation. Humidity class 3 indicates problems with cladding, exterior part of the insulation and potentially interior side of the insulation.

Figure 4.72 Mould index, humidity class 1, assembly 8

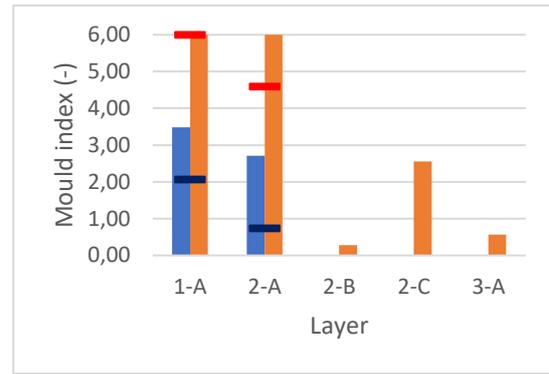
Figure 4.73 Mould index, humidity class 3, assembly 8

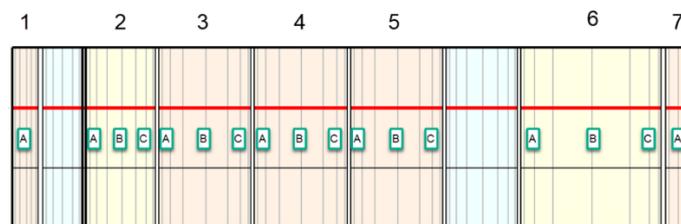
Figure 4.74 Wall assembly 9, monitor position

Figure 4.74 presents wall assembly 9 and its respective monitor positions. Figure 4.75 is the graph with humidity class 1, while Figure 4.76 is humidity class 3. Simulations with climate 2010-2020 humidity class 1 and 3 have no indication of problems with mould. Simulations with climate 2060-2070 humidity class 1 and 3 both indicates problems with the cladding and insulation layer.

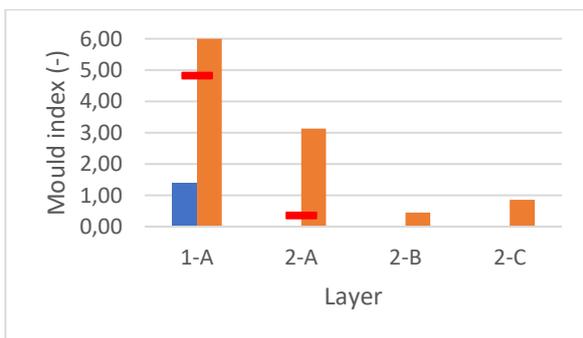
Figure 4.75 Mould index, humidity class 1, assembly 9

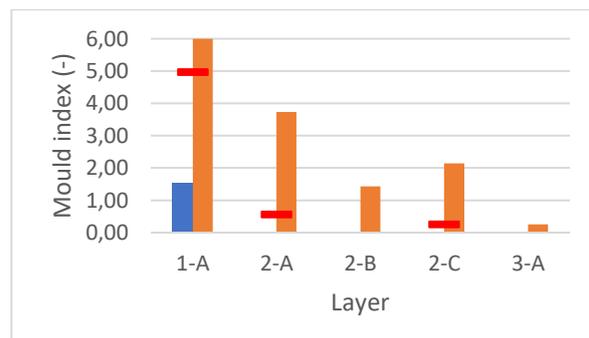
Figure 4.76 Mould index, humidity class 3, assembly 9

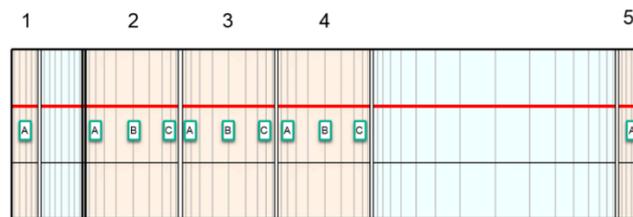
Figure 4.77 Wall assembly 10, monitor position

Figure 4.77 presents wall assembly 9 and its respective monitor positions. Figure 4.78 is the graph with humidity class 1, while Figure 4.79 is humidity class 3.

Wall assembly 4 and 10 are both oriented towards the north, together with wall assembly 5. However, the difference between wall assembly 4 and 10 compared to 5 is a large air layer on the interior side of the logs. This air layer results in a u-value significantly lower in assembly 4 and 10. The u-value of assembly 5 is 0,609 W/m²K, while assembly 4 and 10 is 0,253 W/m²K and 0,244 W/m²K, respectively. The low u-value decreases the heat transport through the wall and due to the orientation, the sun exposure is rather low. This combination might be the reason for higher moisture content and indications of problems with mould within the structure.

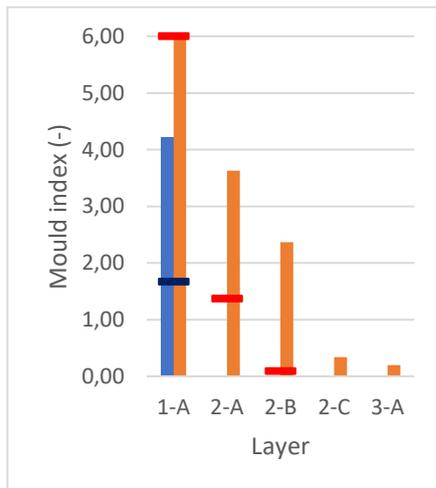
Simulations with current climate and humidity class 1 and 3 have no indication of problem with mould except for the cladding. While simulations with future climate presents higher values, especially humidity class 3. Humidity class 1 indicates problems with the exterior layer of the logs, while humidity class 3 indicates problems within all layers of the wall.

Figure 4.78 Mould index, humidity class 1, assembly 10
