Master's Degree in
Structural Engineering and Building Technology
Department of Civil Engineering and Energy Technology

MASTER THESIS

<p>THESIS TITLE</p> <p>Hygrothermal performance of thermally upgraded log walls of an in-use cultural heritage building from the 17th century based on current and future climate scenario</p>	<p>DATE</p> <p>09.06.2021</p>
	<p>NUMBER OF PAGES</p> <p>110 + 32</p>
<p>AUTHOR(S)</p> <p>Sindre Didrichsen Kris Anders Flaskerud</p>	<p>SUPERVISOR(S)</p> <p>Dimitrios Kraniotis</p>

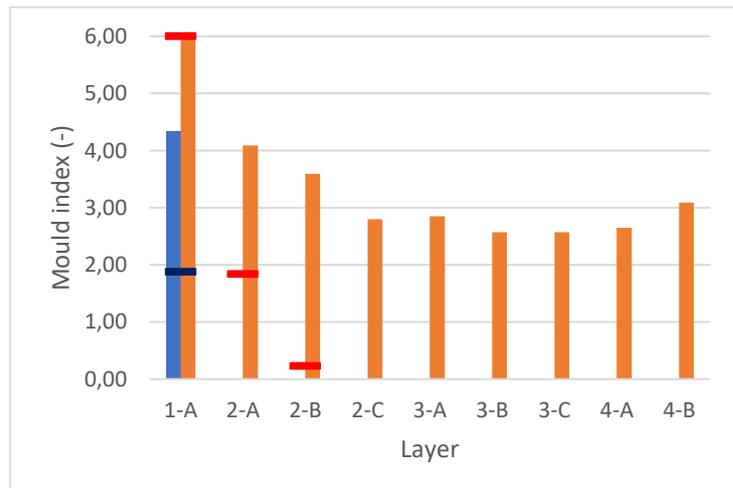
Simulations with current climate and humidity class 1 and 3 have no indication of problem with mould except for the cladding. While simulations with future climate presents higher values, especially humidity class 3. Humidity class 1 indicates problems with the exterior layer of the logs, while humidity class 3 indicates problems within all layers of the wall.

Figure 4.79 Mould index, humidity class 3, assembly 10

Figure 4.77 presents wall assembly 9 and its respective monitor positions. Figure 4.78 is the graph with humidity class 1, while Figure 4.79 is humidity class 3.

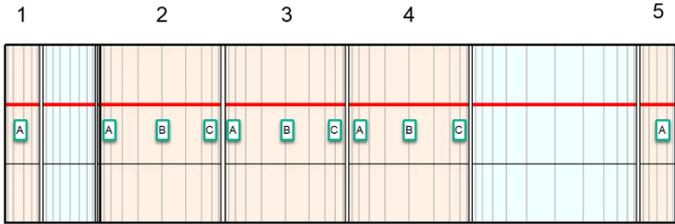
Figure 4.80 Wall assembly 11, monitor position

Figure 4.80 presents wall assembly 9 and its respective monitor positions. Figure 4.81 is the graph with humidity class 1, while Figure 4.82 is humidity class 3.

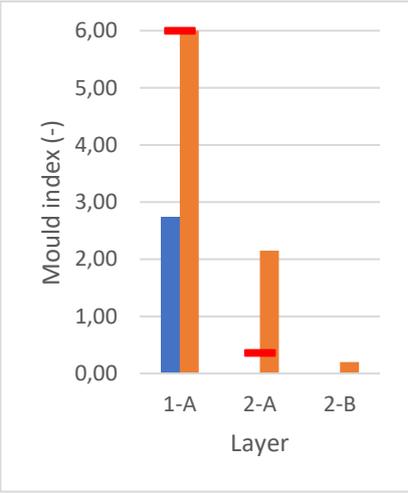
Simulations with current climate and humidity class 1 and 3 have no indication of problem with mould except for the cladding. Simulations with future climate humidity class 1 and 3 is both within yellow indication at exterior side of the logs and red indication at the cladding.

Figure 4.81 Humidity class 1, assembly 11

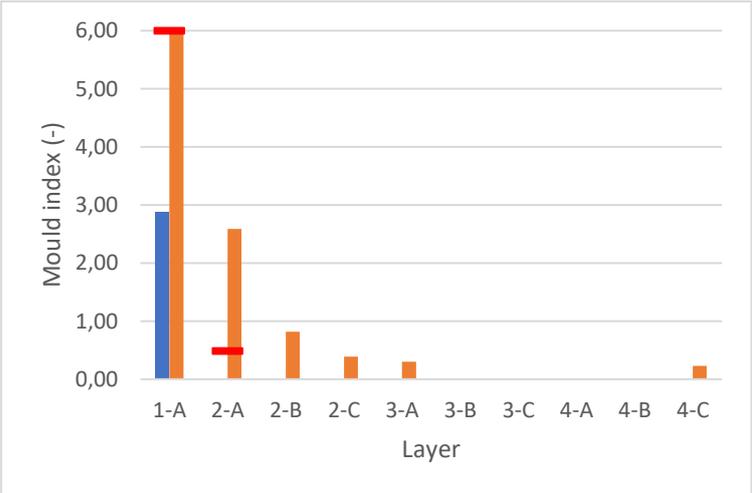
Figure 4.82 Humidity class 3, assembly 11

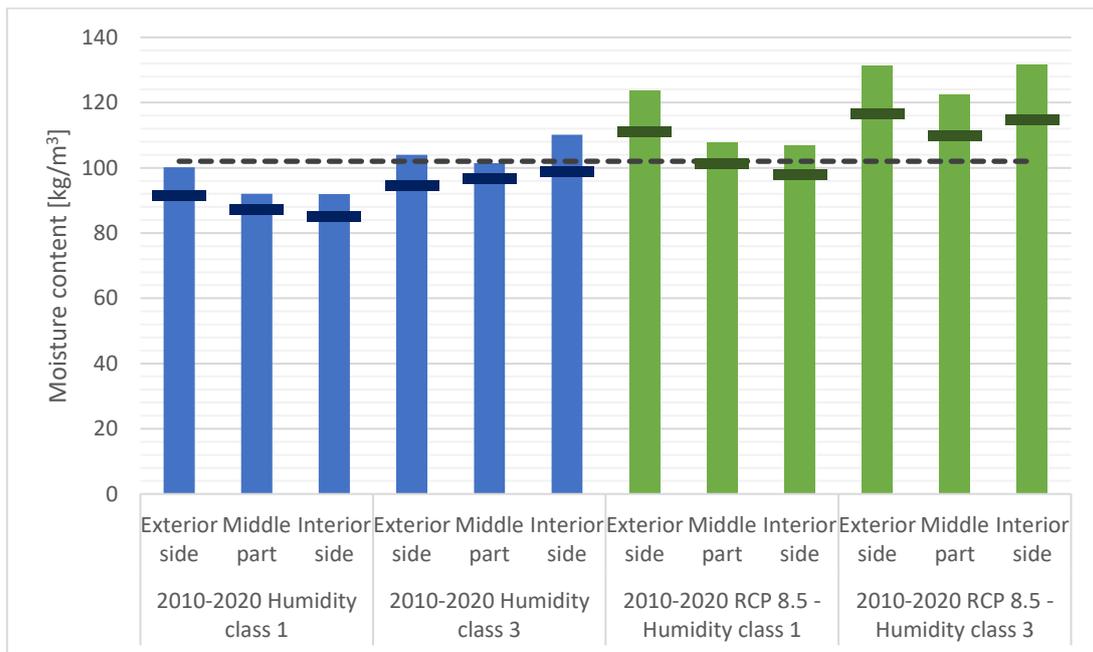
Figure 4.83 presents the moisture content of wall assembly 1. The blue bars represent the climate from 2010 to 2020 based on current climate, while the green bars indicate the climate from 2010 to 2020 based on RCP8.5. Observing the results with humidity class 1 the median values of exterior side, middle part and interior side increased by 6,5 %, 2,7 % and 2,7 % for RCP8.5, respectively. Furthermore, with humidity class 3 the increase from observed climate versus RCP8.5 for median values on exterior side, middle part and interior side was 4,3 %, 2,6 % and 3,1 %, respectively.

Figure 4.83 Wall assembly 1, RCP8.5 evaluation - moisture content

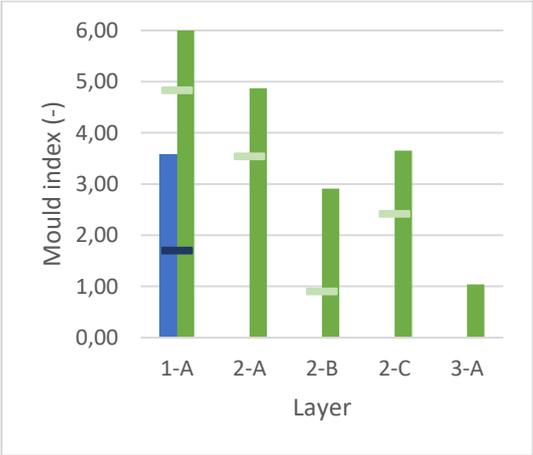
Figure 4.84 presents the mould index with humidity class 1, while Figure 4.85 presents humidity class 3. The mould index with climate 2010 to 2020 based on current weather indicates no trouble within the construction except for the cladding. Both humidity class 1 and 3 with climate 2010 to 2020 based on RCP8.5 show similar trends and indicates a high risk of mould in the exterior cladding and insulation layer. Humidity class 1 indicates no trouble with the layer of logs, while humidity class 3 are within a yellow indication.

Figure 4.84 Assembly 1 - Mould index, RCP8.5 evaluation, humidity class 1

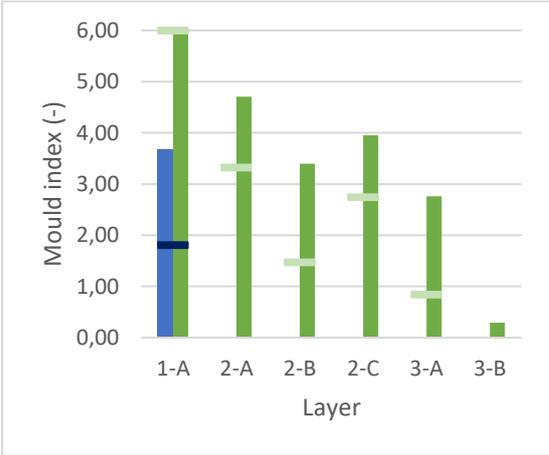
Figure 4.85 Assembly 1 - Mould index, RCP8.5 evaluation, humidity class 3

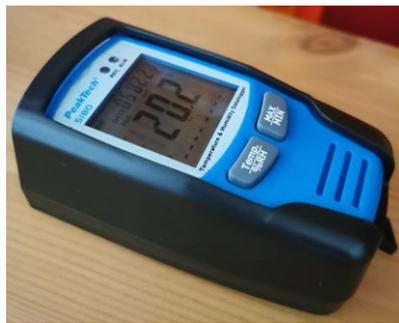
Inside: PeakTech 5180 – Temperature & Humidity Datalogger

Logger mounted inside (PeakTech 5180)

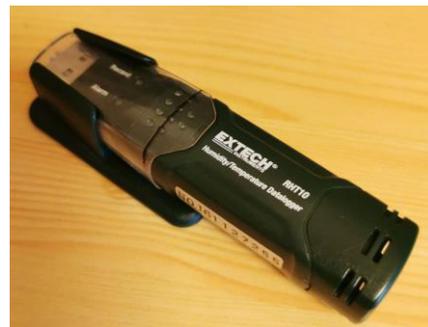
Outside: Extech RHT 10 - Temperature & Humidity Datalogger

Logger mounted outside (Extech RHT10)

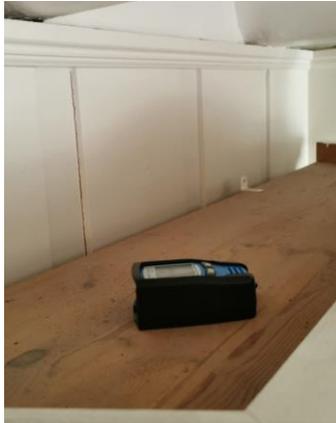
The first indoor logger was mounted in the living room of the house. This room is the main area of the house and is where the residents spend most of the time. A fireplace is also located in this room.

Logger positioned on top of a shelf towards the west wall in the living room

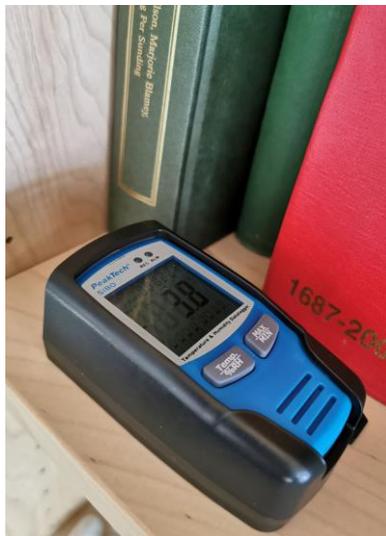
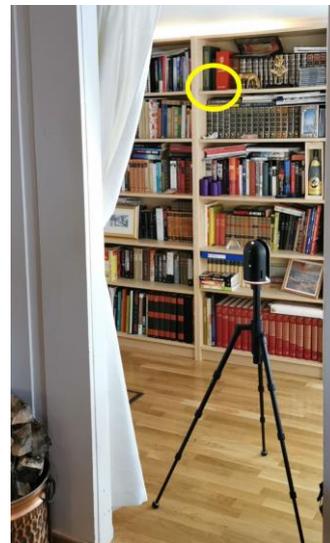
The second logger was mounted in a bookshelf at the library room. Yellow circle marks the position seen from the living room.

Second logger positioned in the library

Position seen from the living room

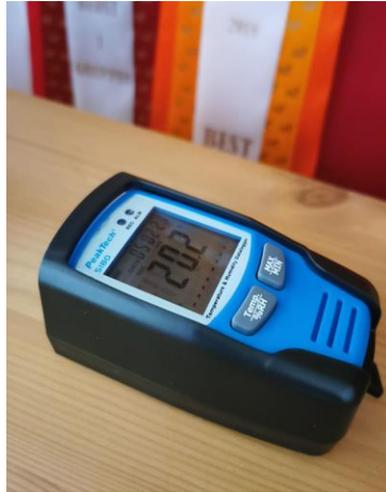
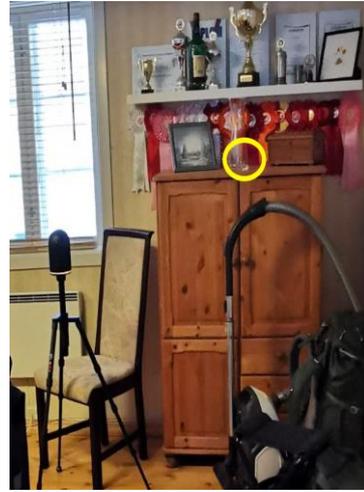
The third logger was mounted on top of a cabinet in the tv-room which is a less heated area with less human activity.

Third logger positioned in the tv-room

Position seen towards the east façade with south façade to the right.

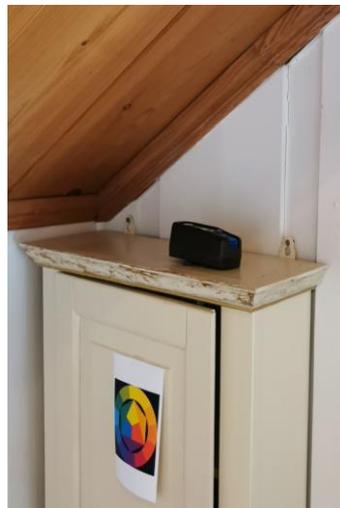
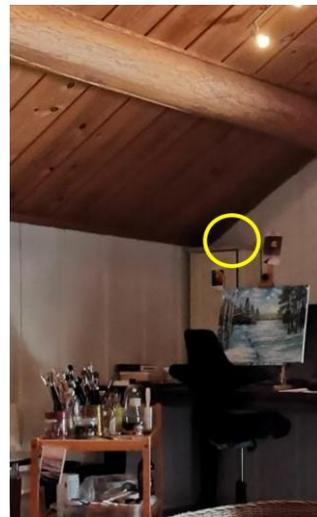
The fourth logger was mounted close to the corner of the large room in the second floor. This room works as a paint workshop and exercise area.

Fourth logger positioned in the recreational room

Position seen towards the corner of south-west façade

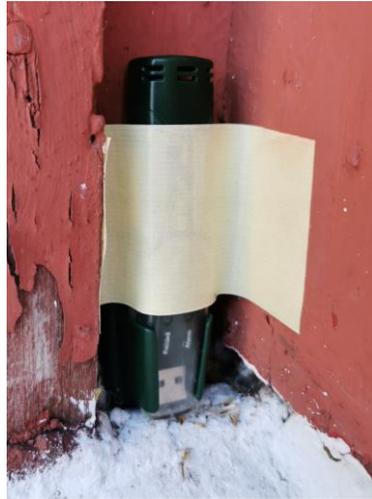
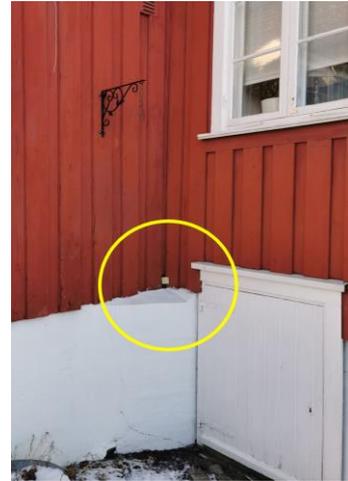
One of the loggers was mounted in the corner of the façade towards north to minimize the amount of sunlight accessing the logger.

Fifth logger positioned outside attached to the façade

Position seen towards outside in the corner between north façade and the extended part towards west

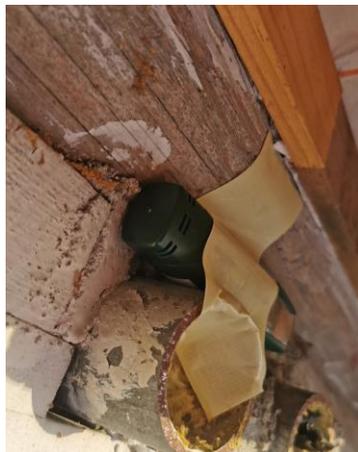
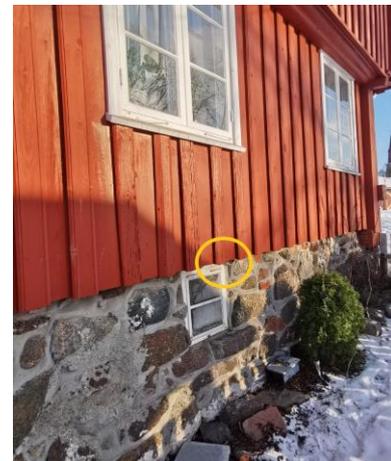
The sixth logger was mounted at the west façade and positioned behind the cladding to avoid sunlight.

Sixth logger positioned outside behind the cladding

Position seen towards the west facade

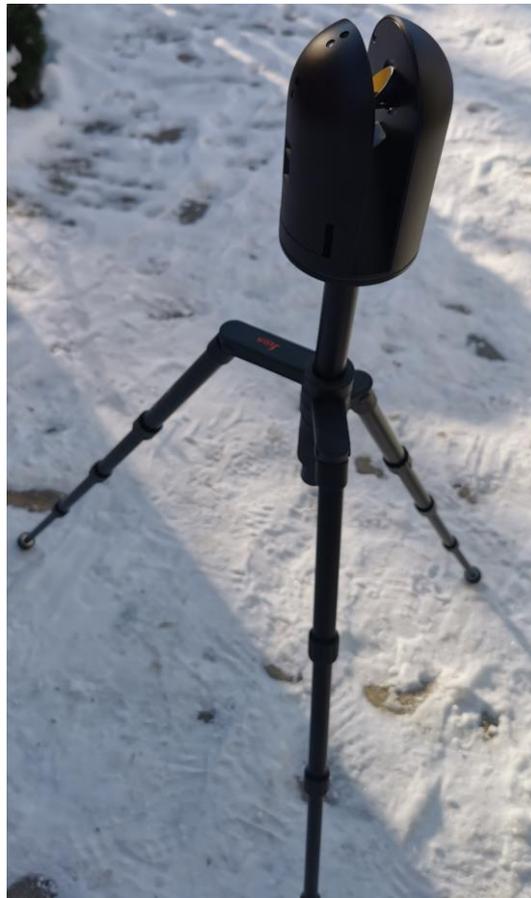
Figure 1 Leica BLK360

3D-laser scanner: Leica BLK360

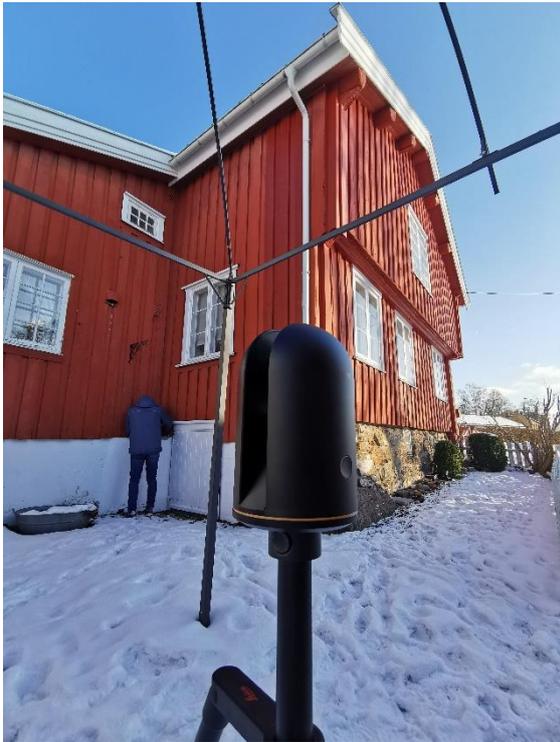
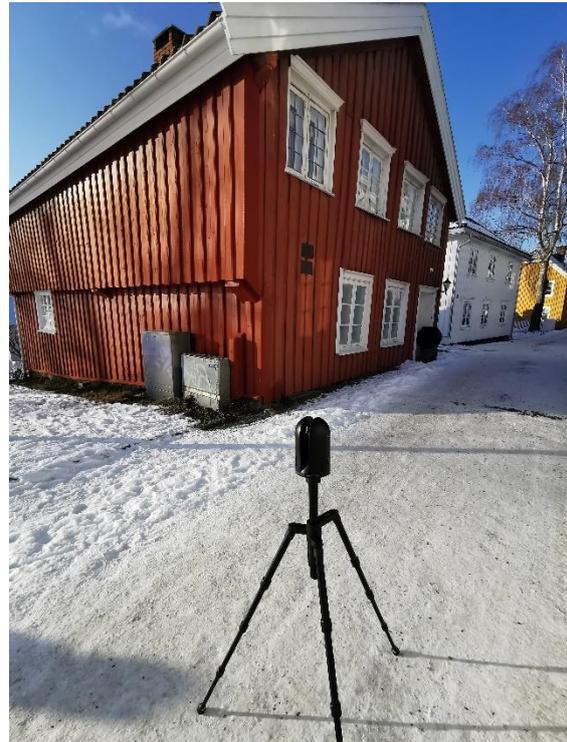
A laser scan was conducted for both interior and exterior of the building. All rooms inside the building were scanned and the specific location of the scanner was marked on a plan drawing of the house. *Figure 2* and *figure 3* illustrates the position of each scan conducted for each floor. Each scan was observed in Leica Cyclone FIELD 360 software on the phone to make sure the quality and connection between each scan was good.

Figure 2 Position #1

Figure 3 Position #2

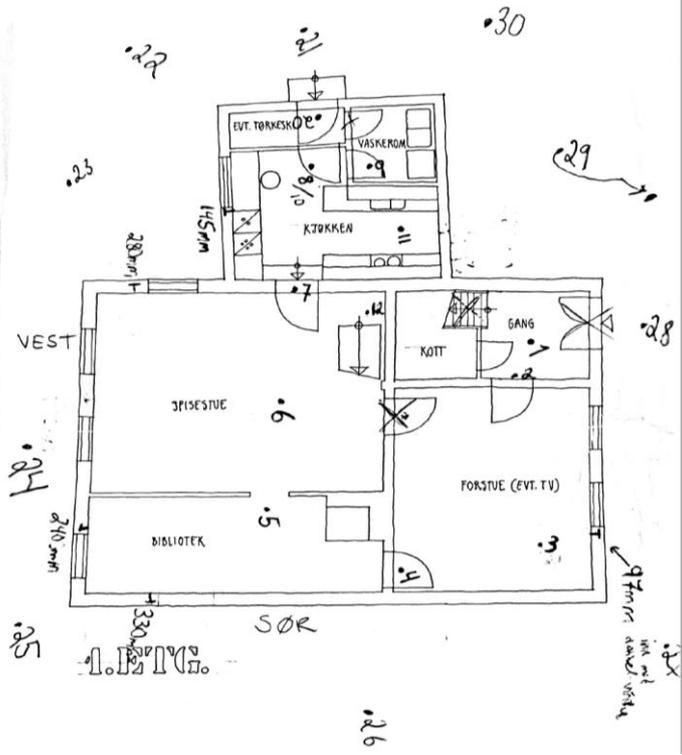
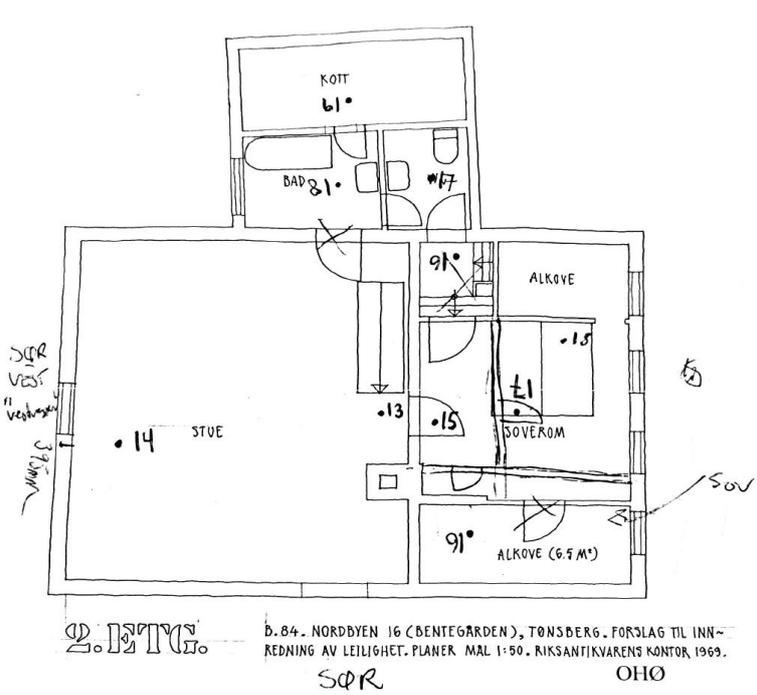
The following images illustrates the position of each scan performed. First image is a overview of first floor interior side and outside, while the second image is a overview of second floor.

Figure 4 Position of each scan 1th floor inside and outside

Figure 5 Position of each scan 2nd floor

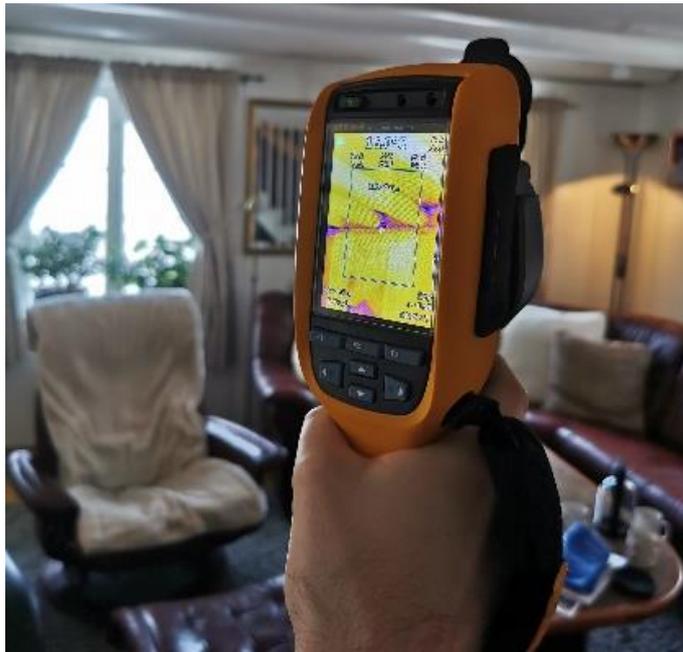
- Purpose:** A thermography of Bentegården to detect surface temperature and thermal bridges.
- Conducted by:** Dimitrios Kraniotis, Sindre Didrichsen and Kris A. Flaskerud
- Date:** 05.02.2020
- Equipment:** Fluke thermal imager Ti 125
- Method:** All interior surfaces were observed with the thermograph camera. Observations revealed many surfaces relatively cold and thermal bridges. Figure 1 displays the thermo camera pointing at a thermal bridge in the living room.

Figure 1 Fluke thermal imager Ti 125

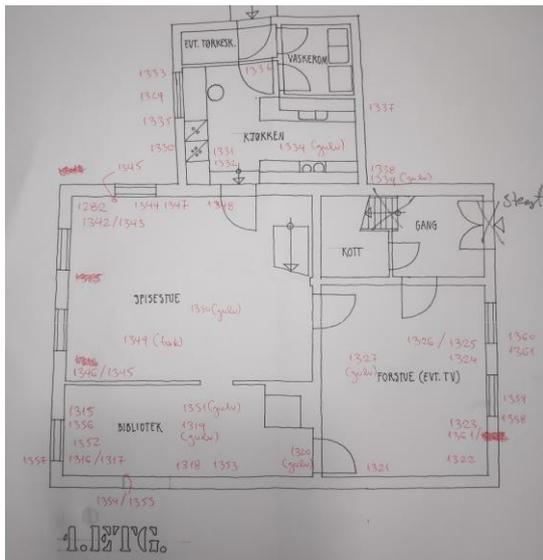
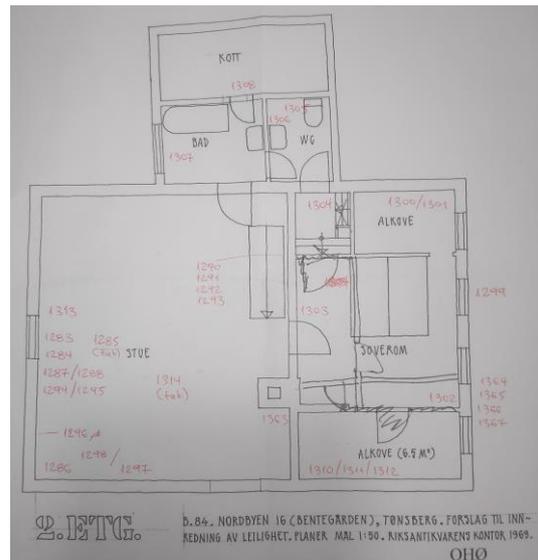
Location of each thermography picture:

Figure 2 Thermography 1th floor

Figure 3 Thermography 2nd floor

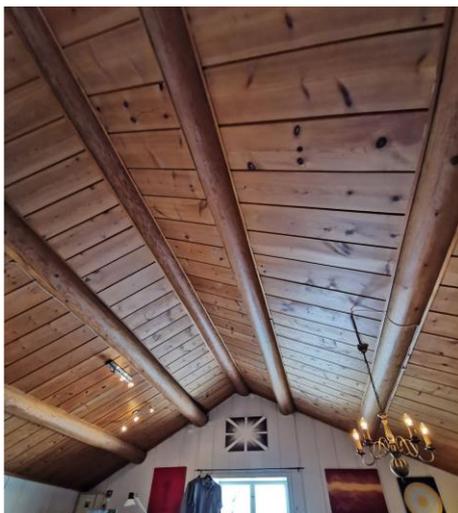
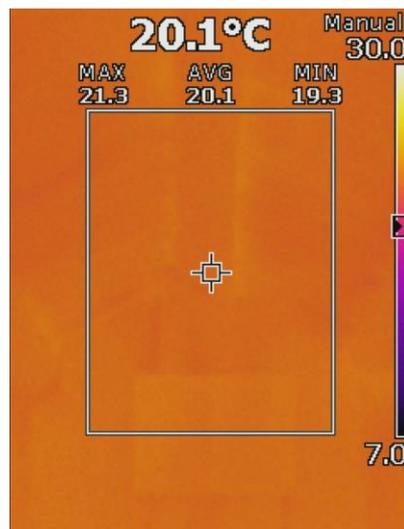
Figure 5 displays the surface temperature of the roof, which is close to the room temperature. No thermal bridges is observed across the roof.

Figure 4 Roof interior side

Figure 5 Thermal performance

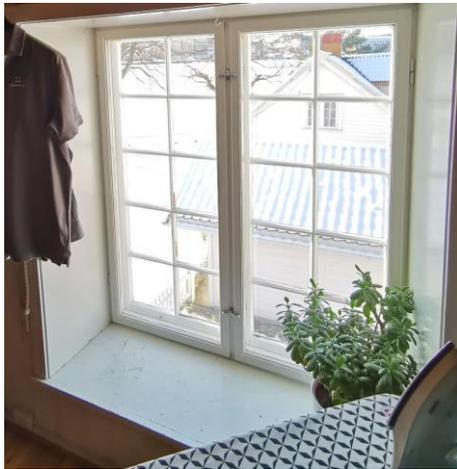
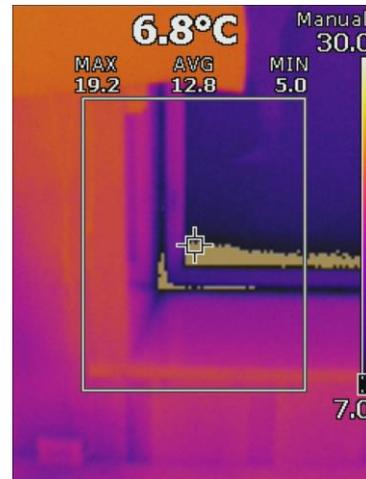
The windows at Bentegården are old and consist of a double wooden frame with one glass pane in each frame. The surface temperature of the windows was very low and figure 6 and 7 displays an example of a window in second floor.

Figure 6 Window 2nd floor

Figure 7 Thermal performance

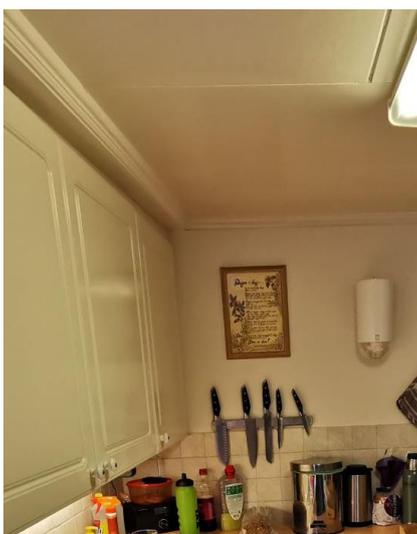
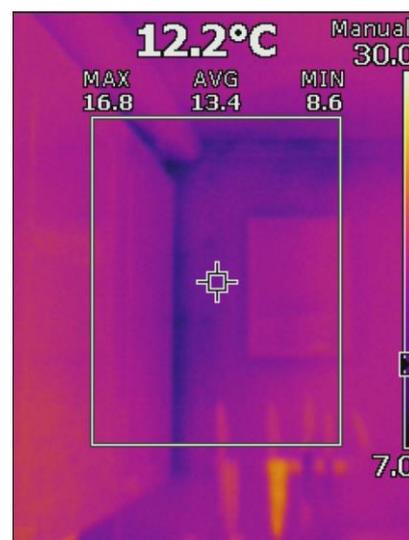
Figure 8 and 9 displays the exterior wall at the kitchen. A thermal bridge reveals in the corner of the kitchen and the temperature of the wall was rather low.

Figure 8 Kitchen wall

Figure 9 Thermal performance

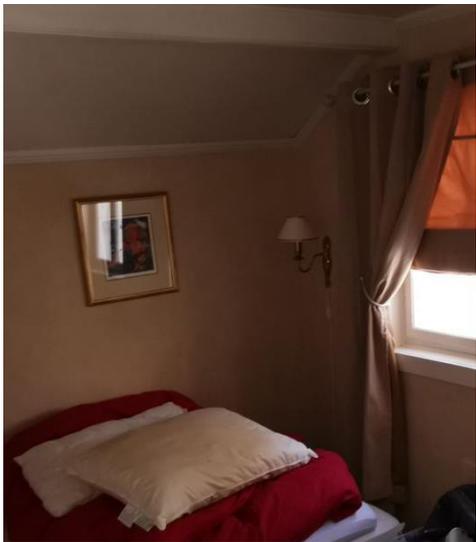
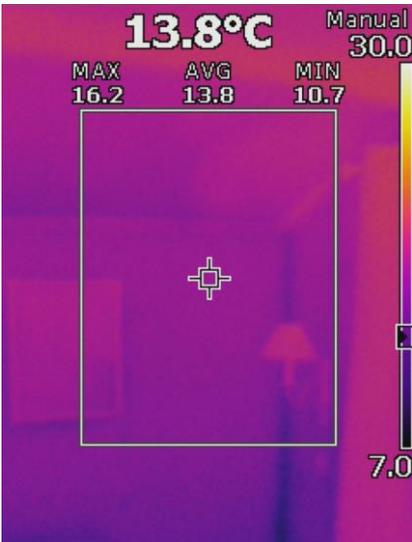
Figure 10 and 11 displays the exterior wall of a bedroom wall in the second floor which is oriented towards east. The picture reveals a thermal bridge marked with a blue colour in the corner of the bedroom.

Figure 10 Second bedroom

Figure 11 Thermal performance

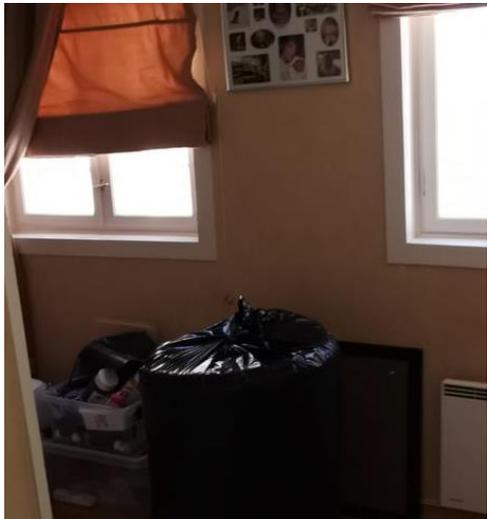
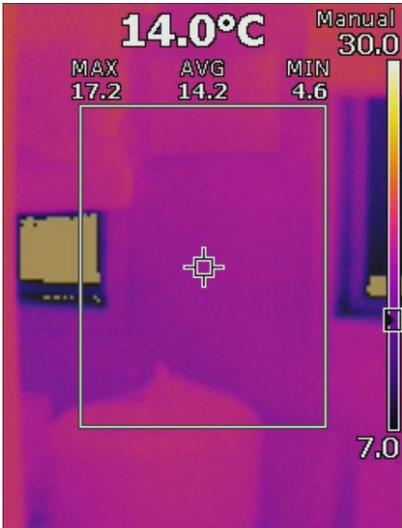
Figure 12 and 13 displays the exterior wall facing towards south.

Figure 12 Second bedroom

Figure 13 Thermal performance

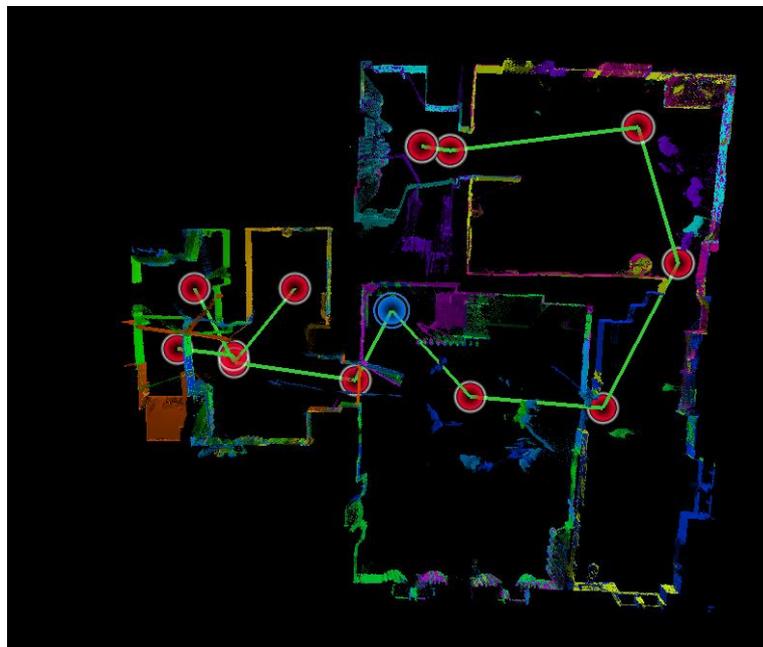
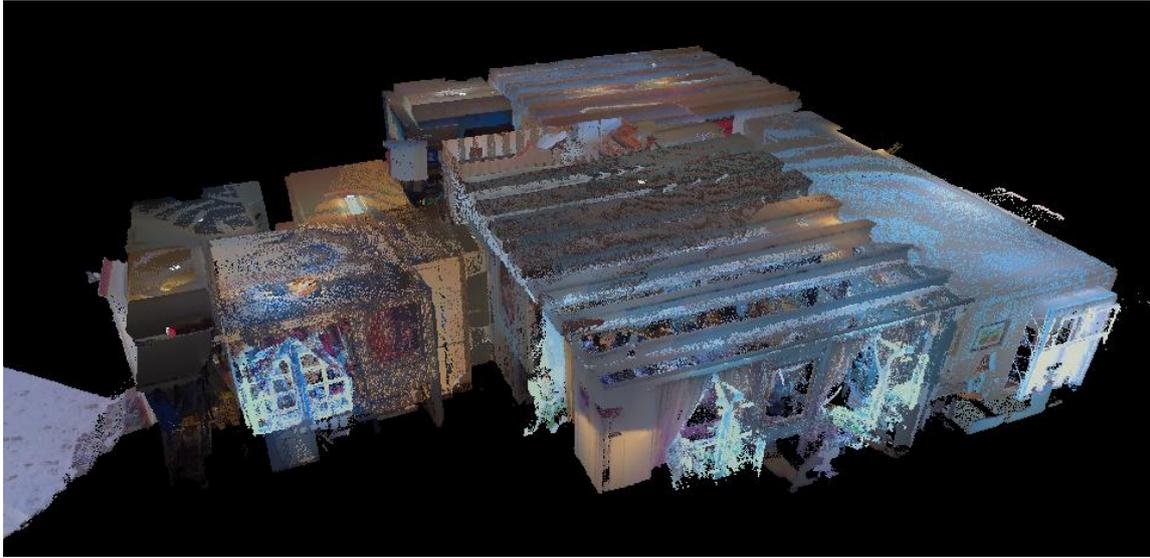
The point cloud bundle of first floor is captured from the software below. The red dots illustrate the position of each scan, while the green line illustrate the connection between each scan. The blue dot illustrates a scan which is also connected to the point cloud bundle on the second floor. All the other lines which follows the interior side of the wall illustrates the data from the laser scanner, while the 3D view illustrates the data from the camera on the scanner.

Point cloud bundle of the first floor, plan view

Point cloud bundle of the first floor, 3D view

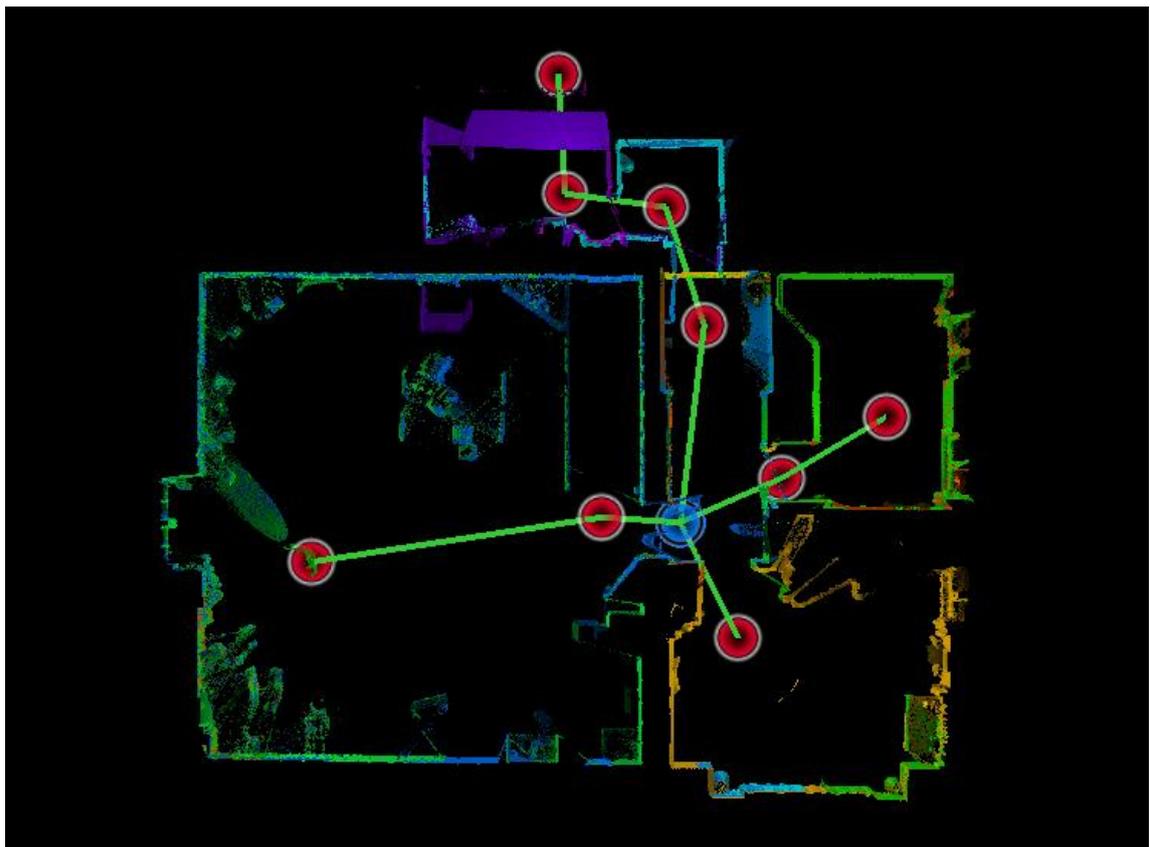
Point cloud bundle of the second floor, plan view

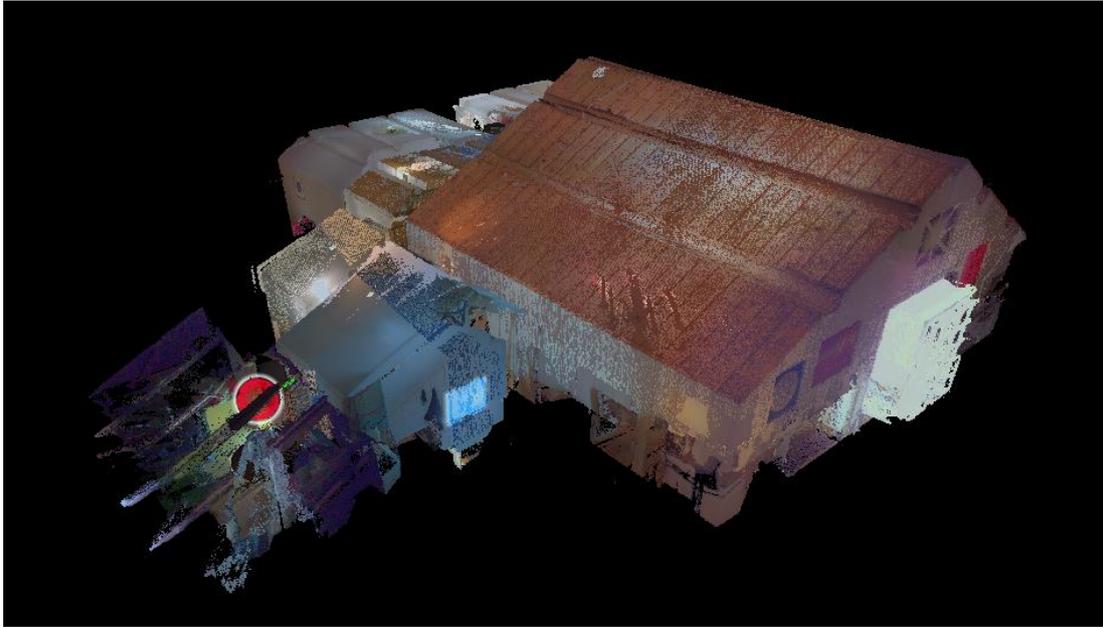
Point cloud bundle of the second floor, 3D view

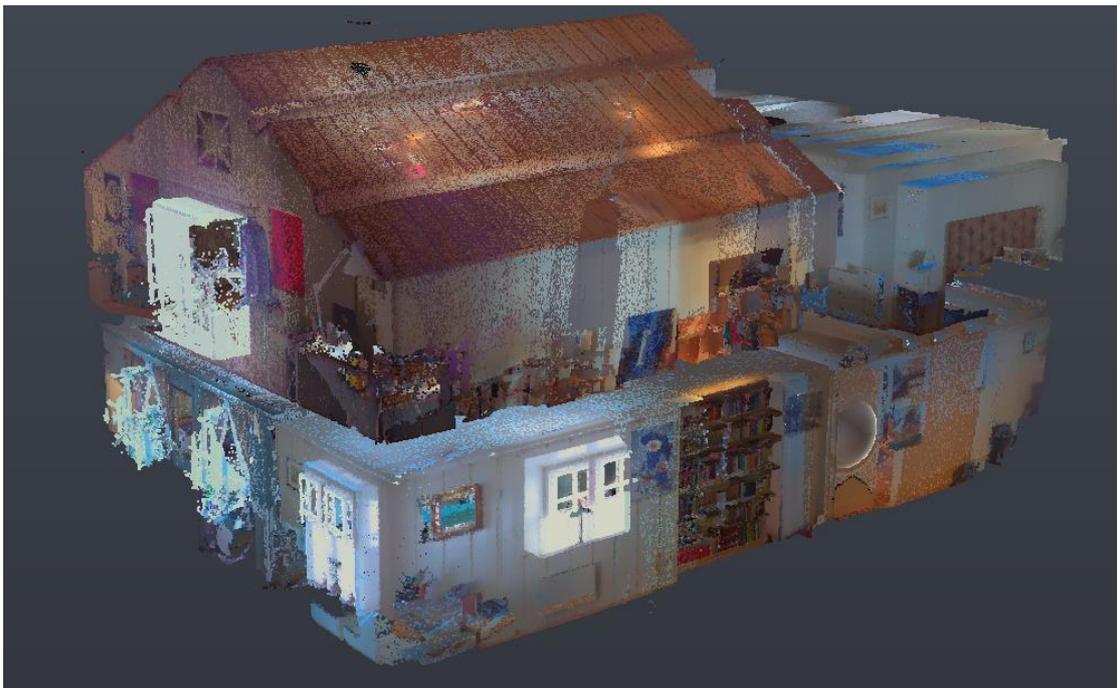
The first floor and second floor point cloud bundle were connected together as illustrated below.

Point cloud bundle of the first floor and second floor connected. The interior wall on left side is the west wall, while the south wall to the right.

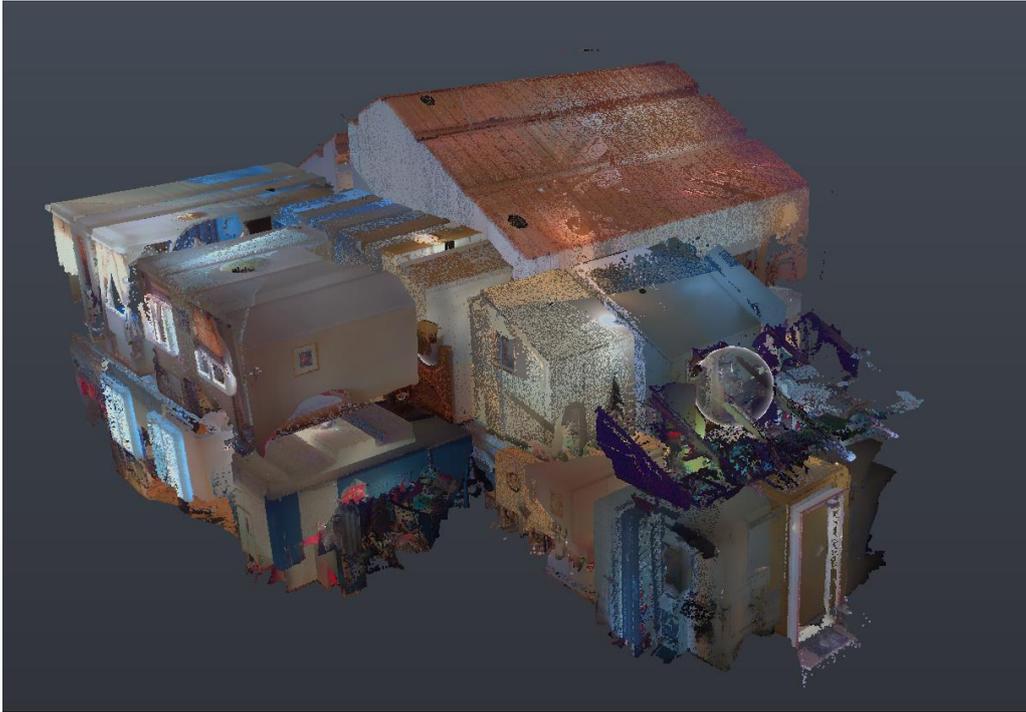
Point cloud bundle of the first floor and second floor connected. The interior wall of east wall with all the windows is on the left, while the extension is on the right side.

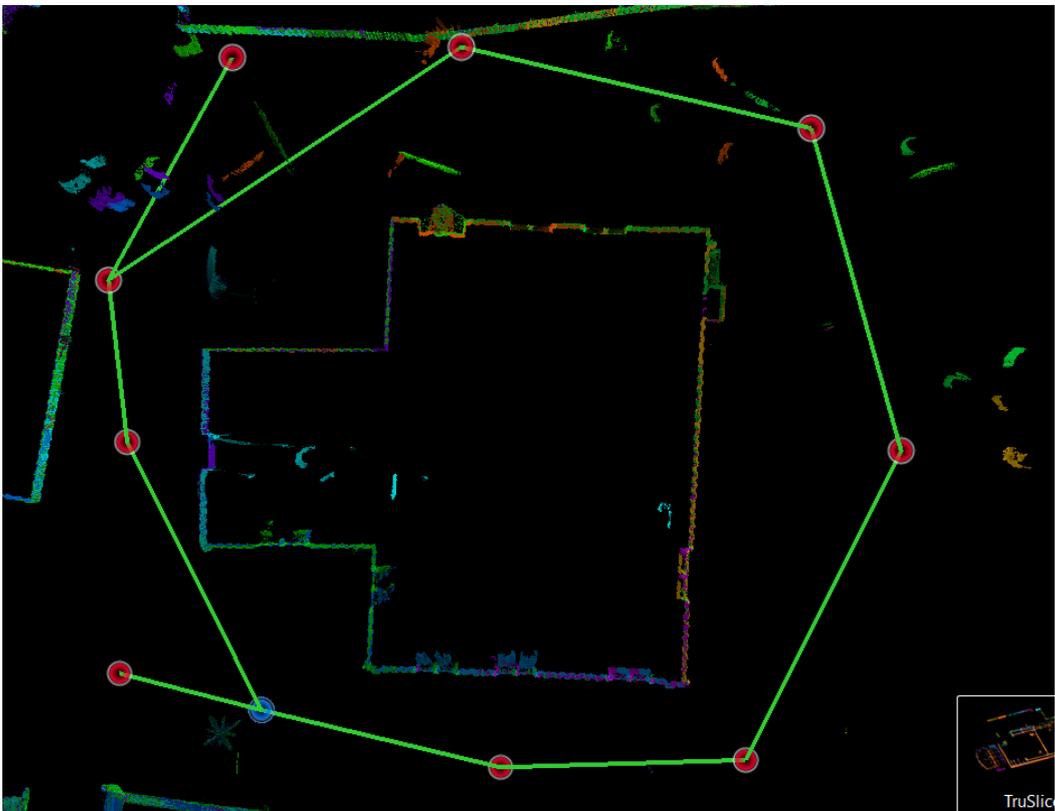
The images below illustrates the scans performed outside on exterior side of the walls.

Point cloud bundle of the exterior walls, plan view

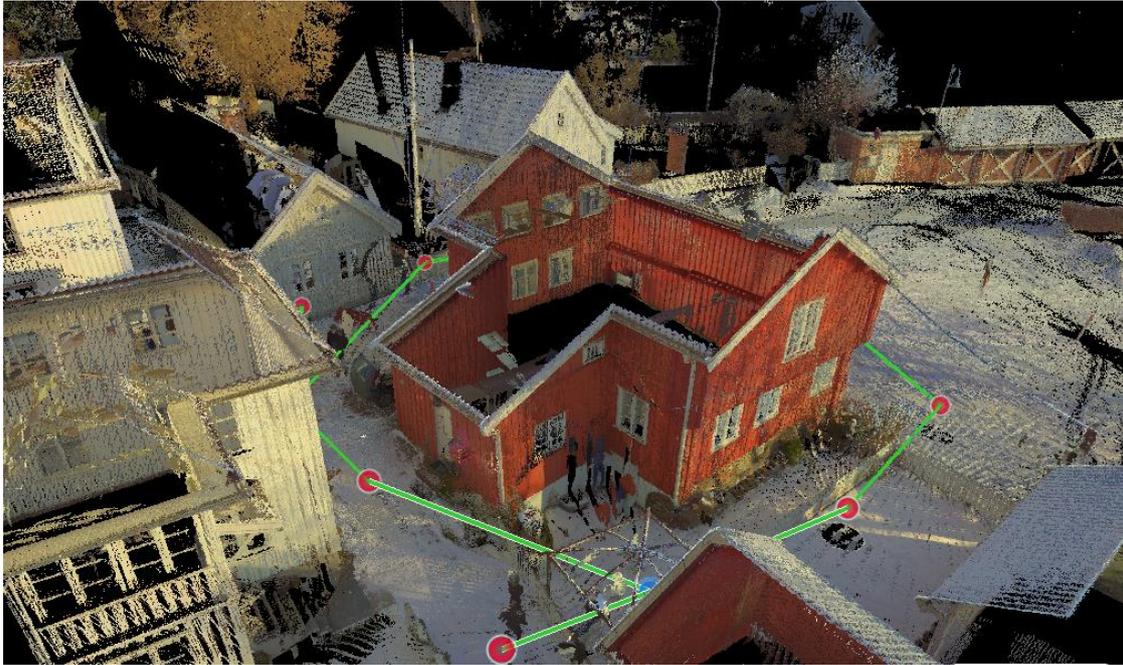
Point cloud bundle of the exterior walls, 3D view

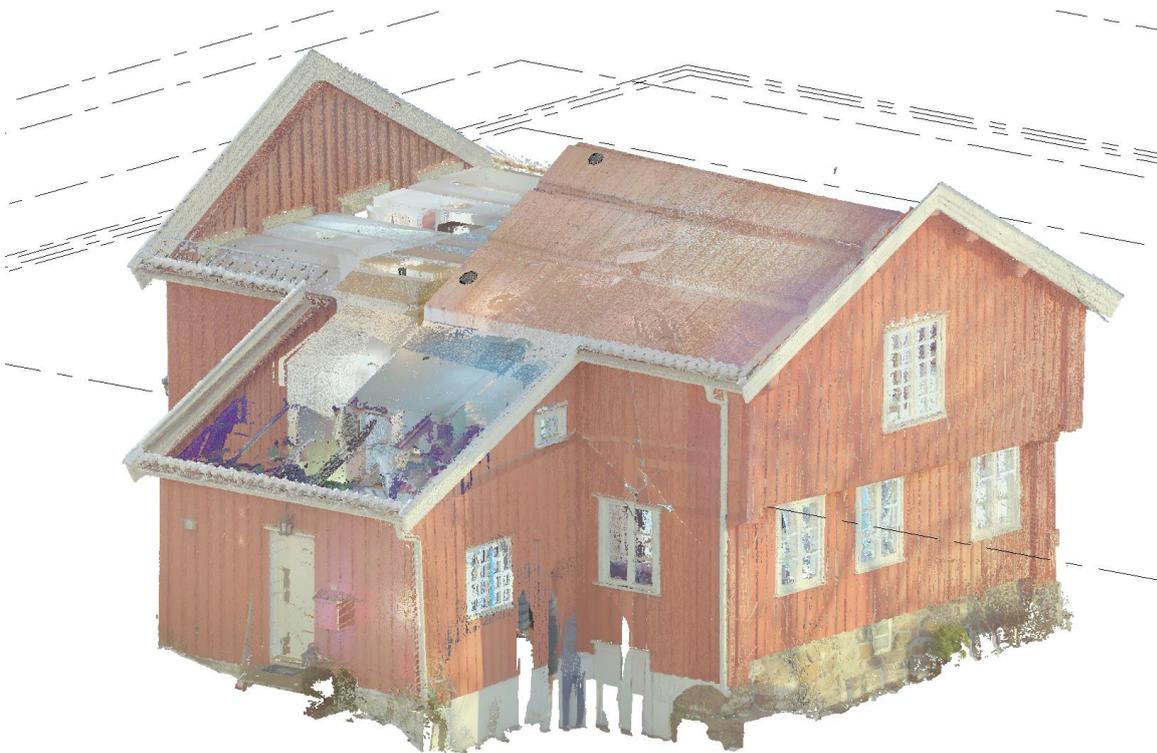
When the point cloud bundle was complete it was imported into Autodesk Revit as a IFC-file. The point cloud bundle after import is displayed in the figure below.

Point cloud bundle captured in Autodesk Revit

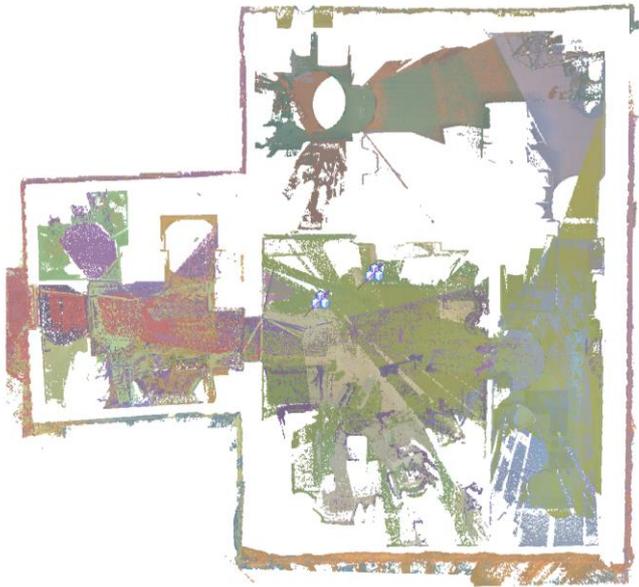
The figure below illustrates the point cloud seen from above. The next step was to create a grid and draw lines along the interior and exterior side to obtain the correct dimension of the walls.

Point cloud bundle viewed from above

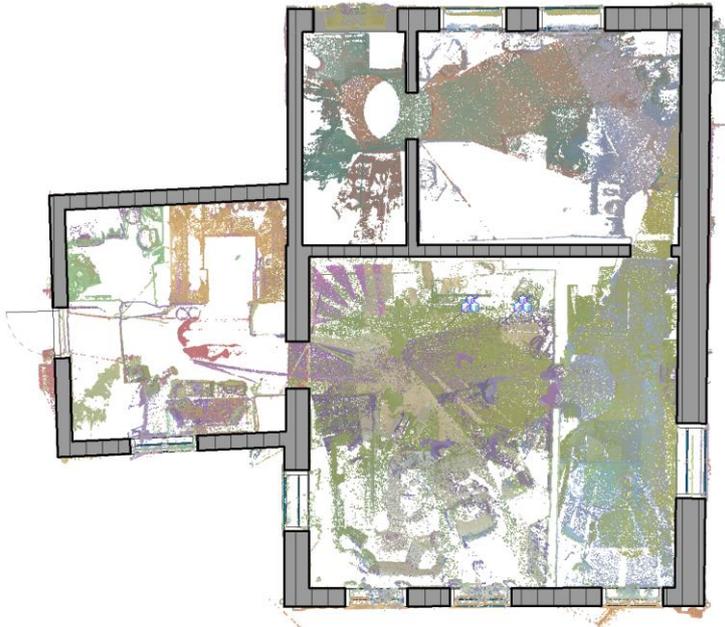
The thickness of the walls was varying a lot between the different walls. Figure below illustrates the exterior and a few interior walls modelled. The structure of the walls are created similar to the actual walls.

Point cloud visible and walls constructed

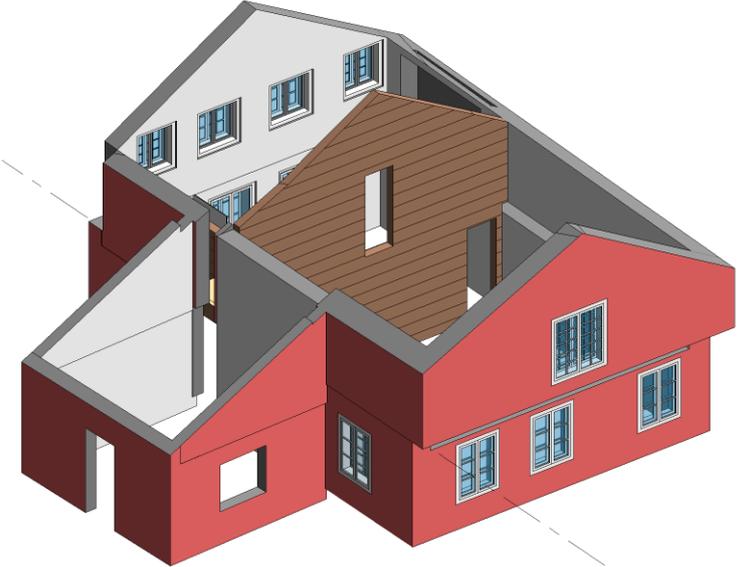
The next phase involved creating the second-floor exterior walls and the log wall inside the house. Windows was also created from scratch to be accurate to the actual windows.

Model after modelling of 1st and 2nd floor exterior walls and the log wall inside.

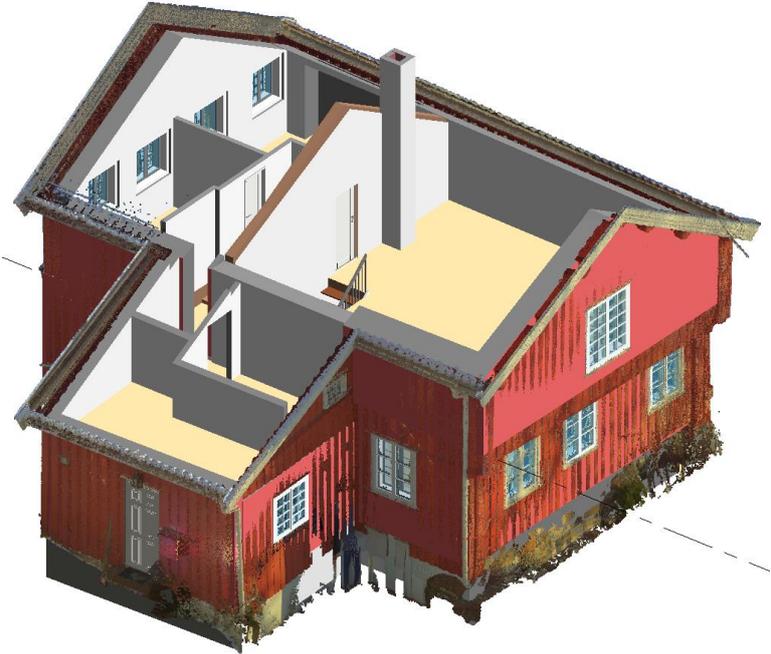
Following this the floors of first and second floor was modelled, in addition to interior walls and doors.

Model after modeling 1st and 2nd floor, interior walls and doors

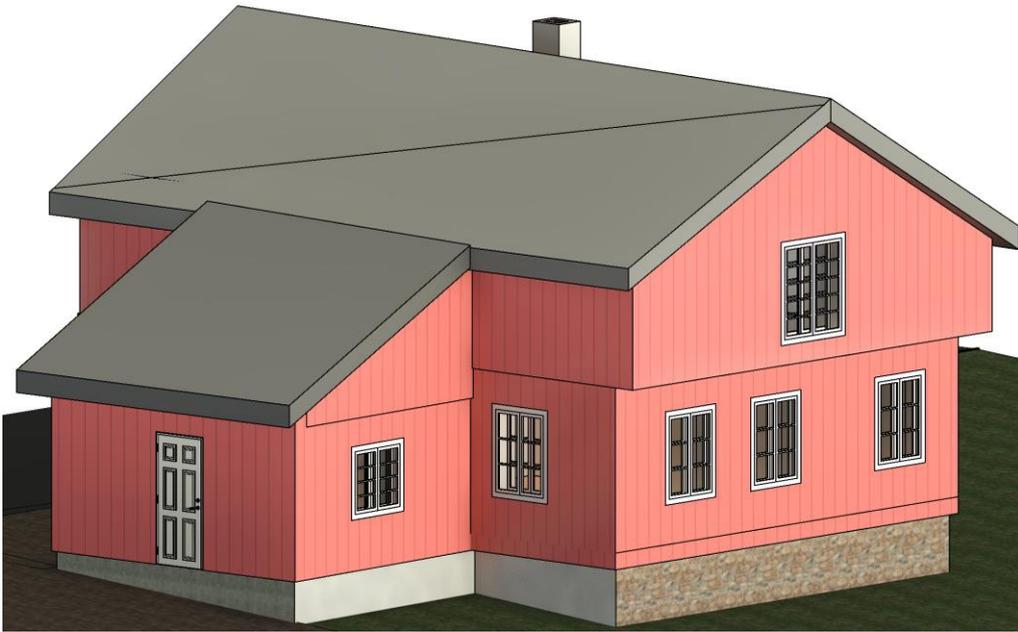
The digital model completed. South façade on the right side and the extended part on the left side

The digital model created in relationship with this master thesis can serve as a basis for a whole-building simulation. However, an identification of the remaining assemblies within the building envelope, supported by an air-tightness test to determine the leakage number would be valuable in this case.

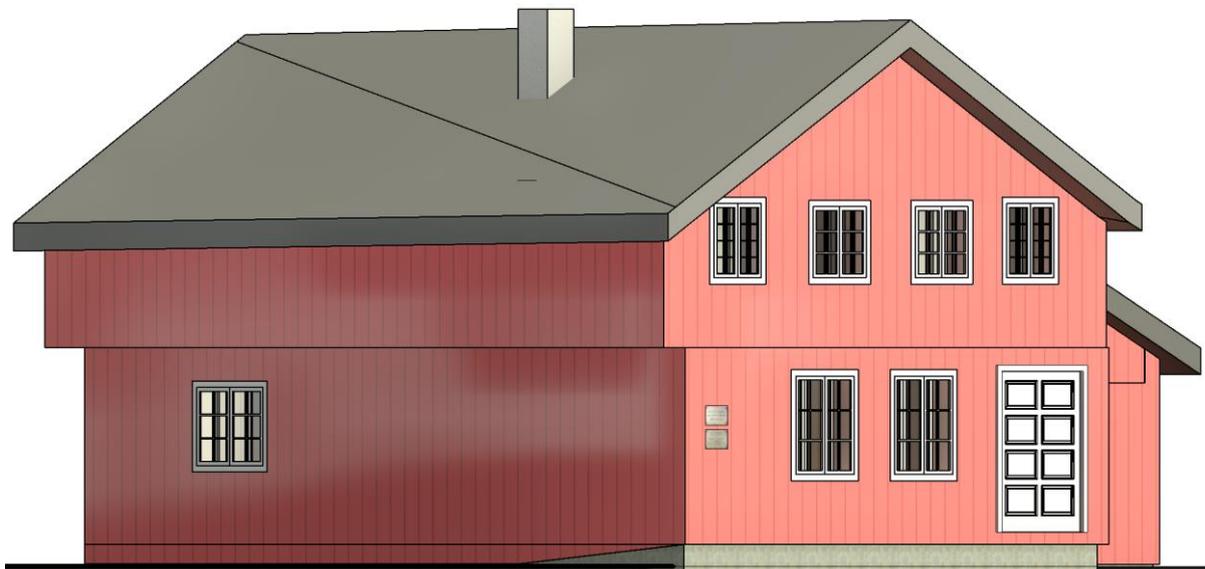
The digital model completed. View from the corner of south-east facade
