Master's Degree in
Structural Engineering and Building Technology
Department of Civil Engineering and Energy Technology

MASTER THESIS

<p>THESIS TITLE</p> <p>Hygrothermal performance of thermally upgraded log walls of an in-use cultural heritage building from the 17th century based on current and future climate scenario</p>	<p>DATE</p> <p>09.06.2021</p>
	<p>NUMBER OF PAGES</p> <p>110 + 32</p>
<p>AUTHOR(S)</p> <p>Sindre Didrichsen Kris Anders Flaskerud</p>	<p>SUPERVISOR(S)</p> <p>Dimitrios Kraniotis</p>

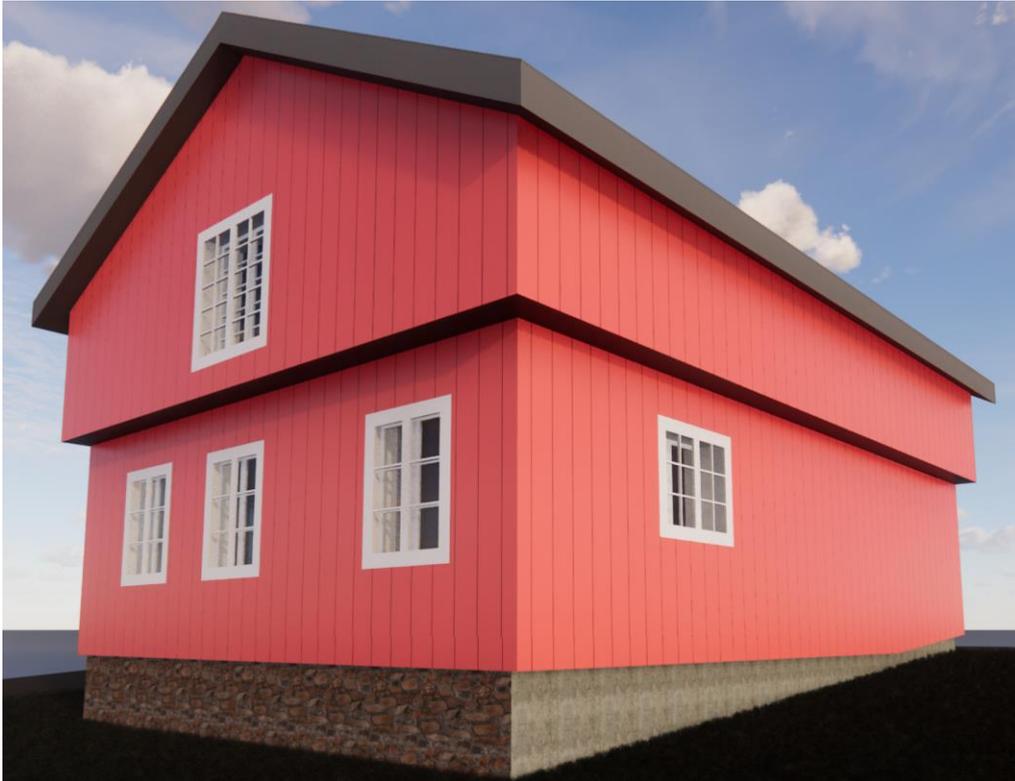
A rendered image of the digital from seen from south-west corner

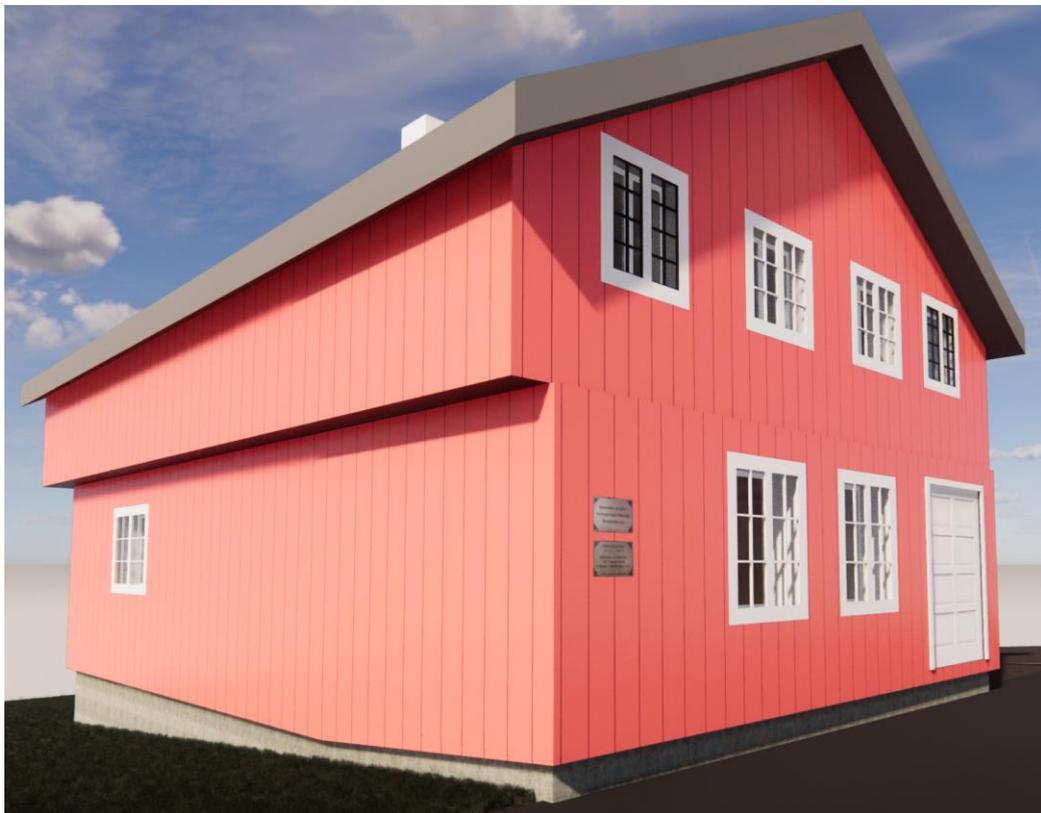
A rendered image of the digital model seen from south-east corner

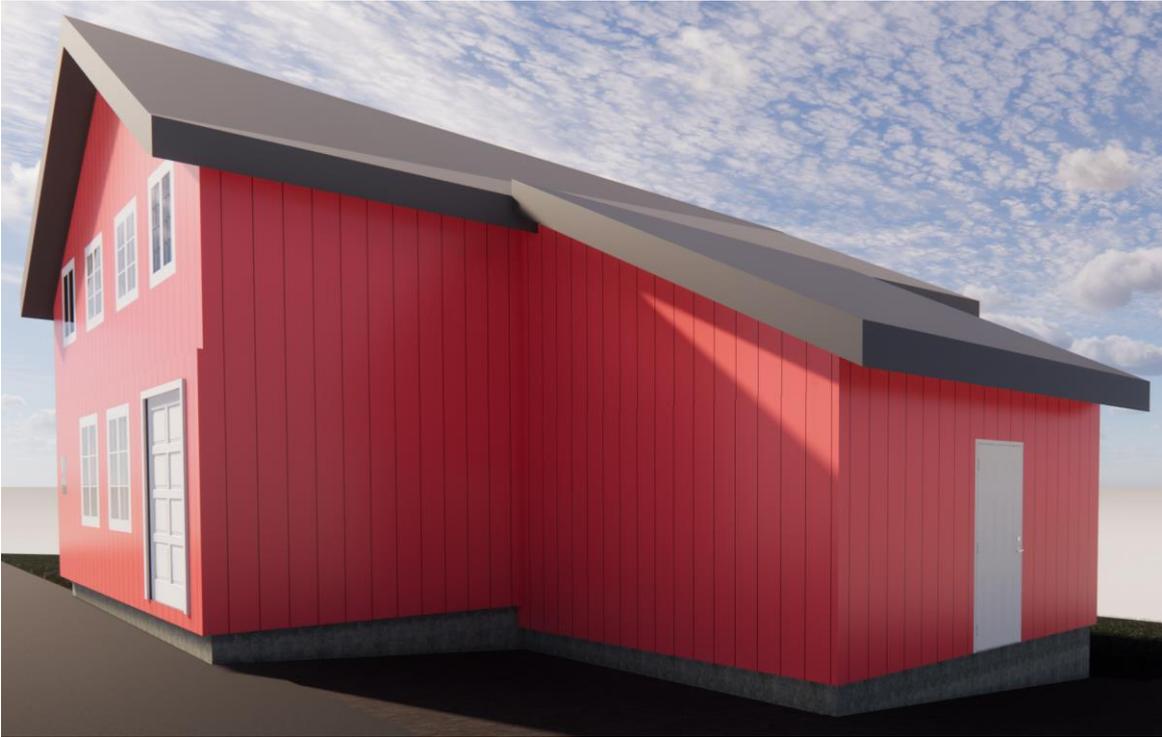
A rendered image of the digital model seen from north-east corner
